*Work Plan*

**Arizona Public Service Former  
Manufactured Gas Plant, Grant Street  
Phoenix, Arizona  
VRP #504477-00**

Prepared for  
**Arizona Public Service**

June 2015

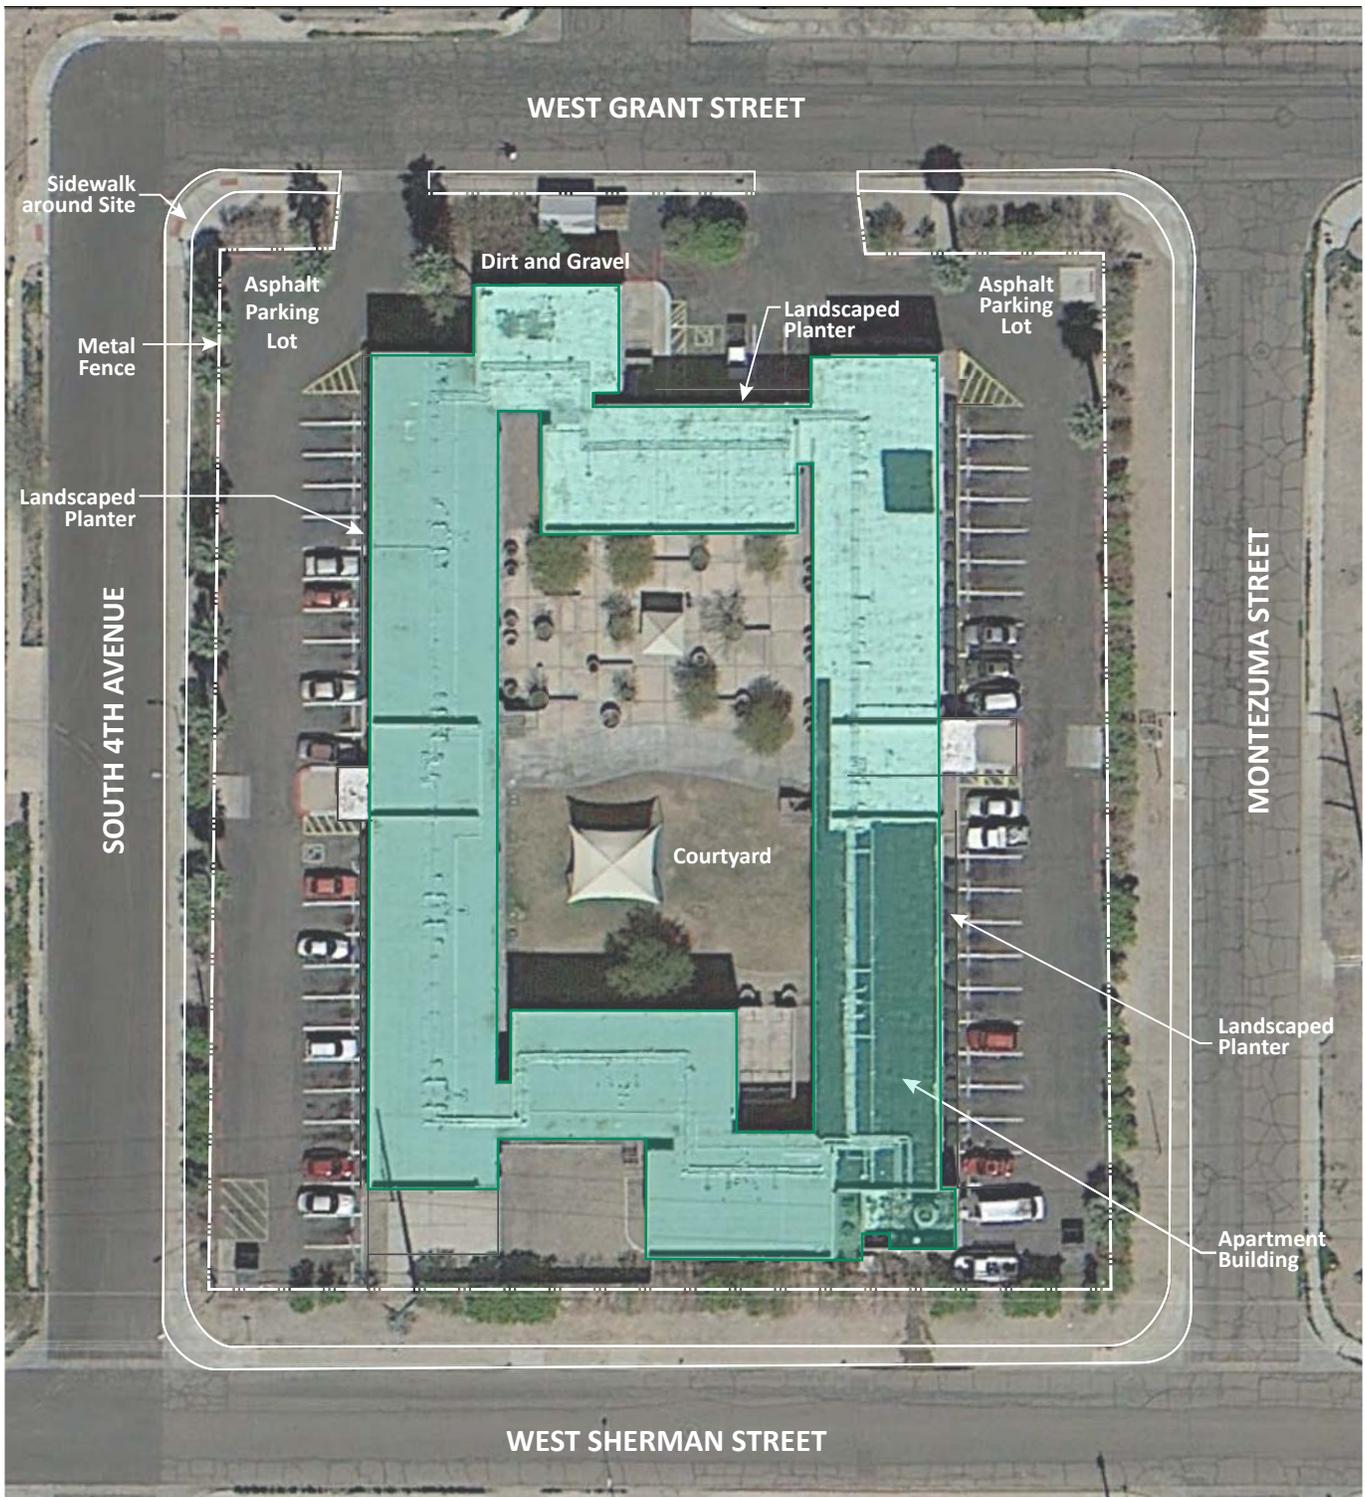
**FIGURE 1-2**  
**Site Diagram**  
 APS Grant Street Former MGP Site  
 Phoenix, Arizona

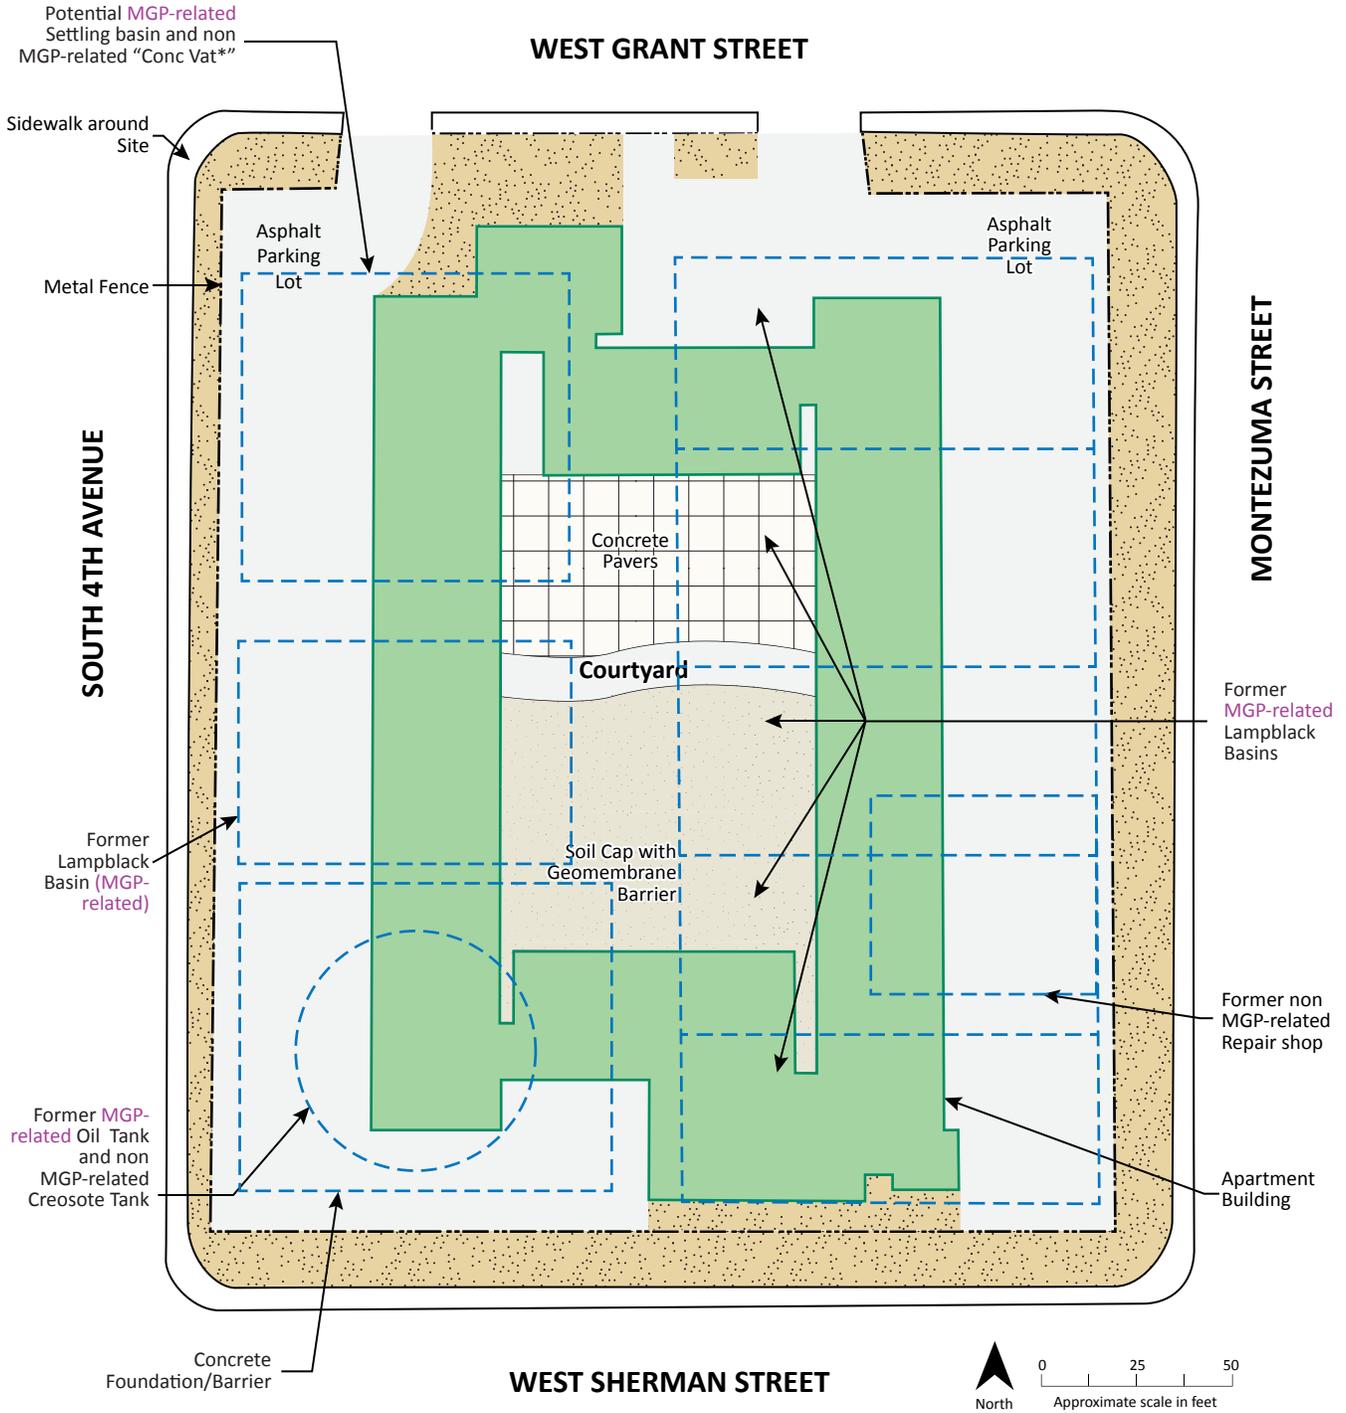
**FIGURE 2-1**  
**Former Structures**  
 APS Grant Street Former MGP Site  
 Phoenix, Arizona

\* Area identified as "Conc Vat" on 1949 Sanborn Map

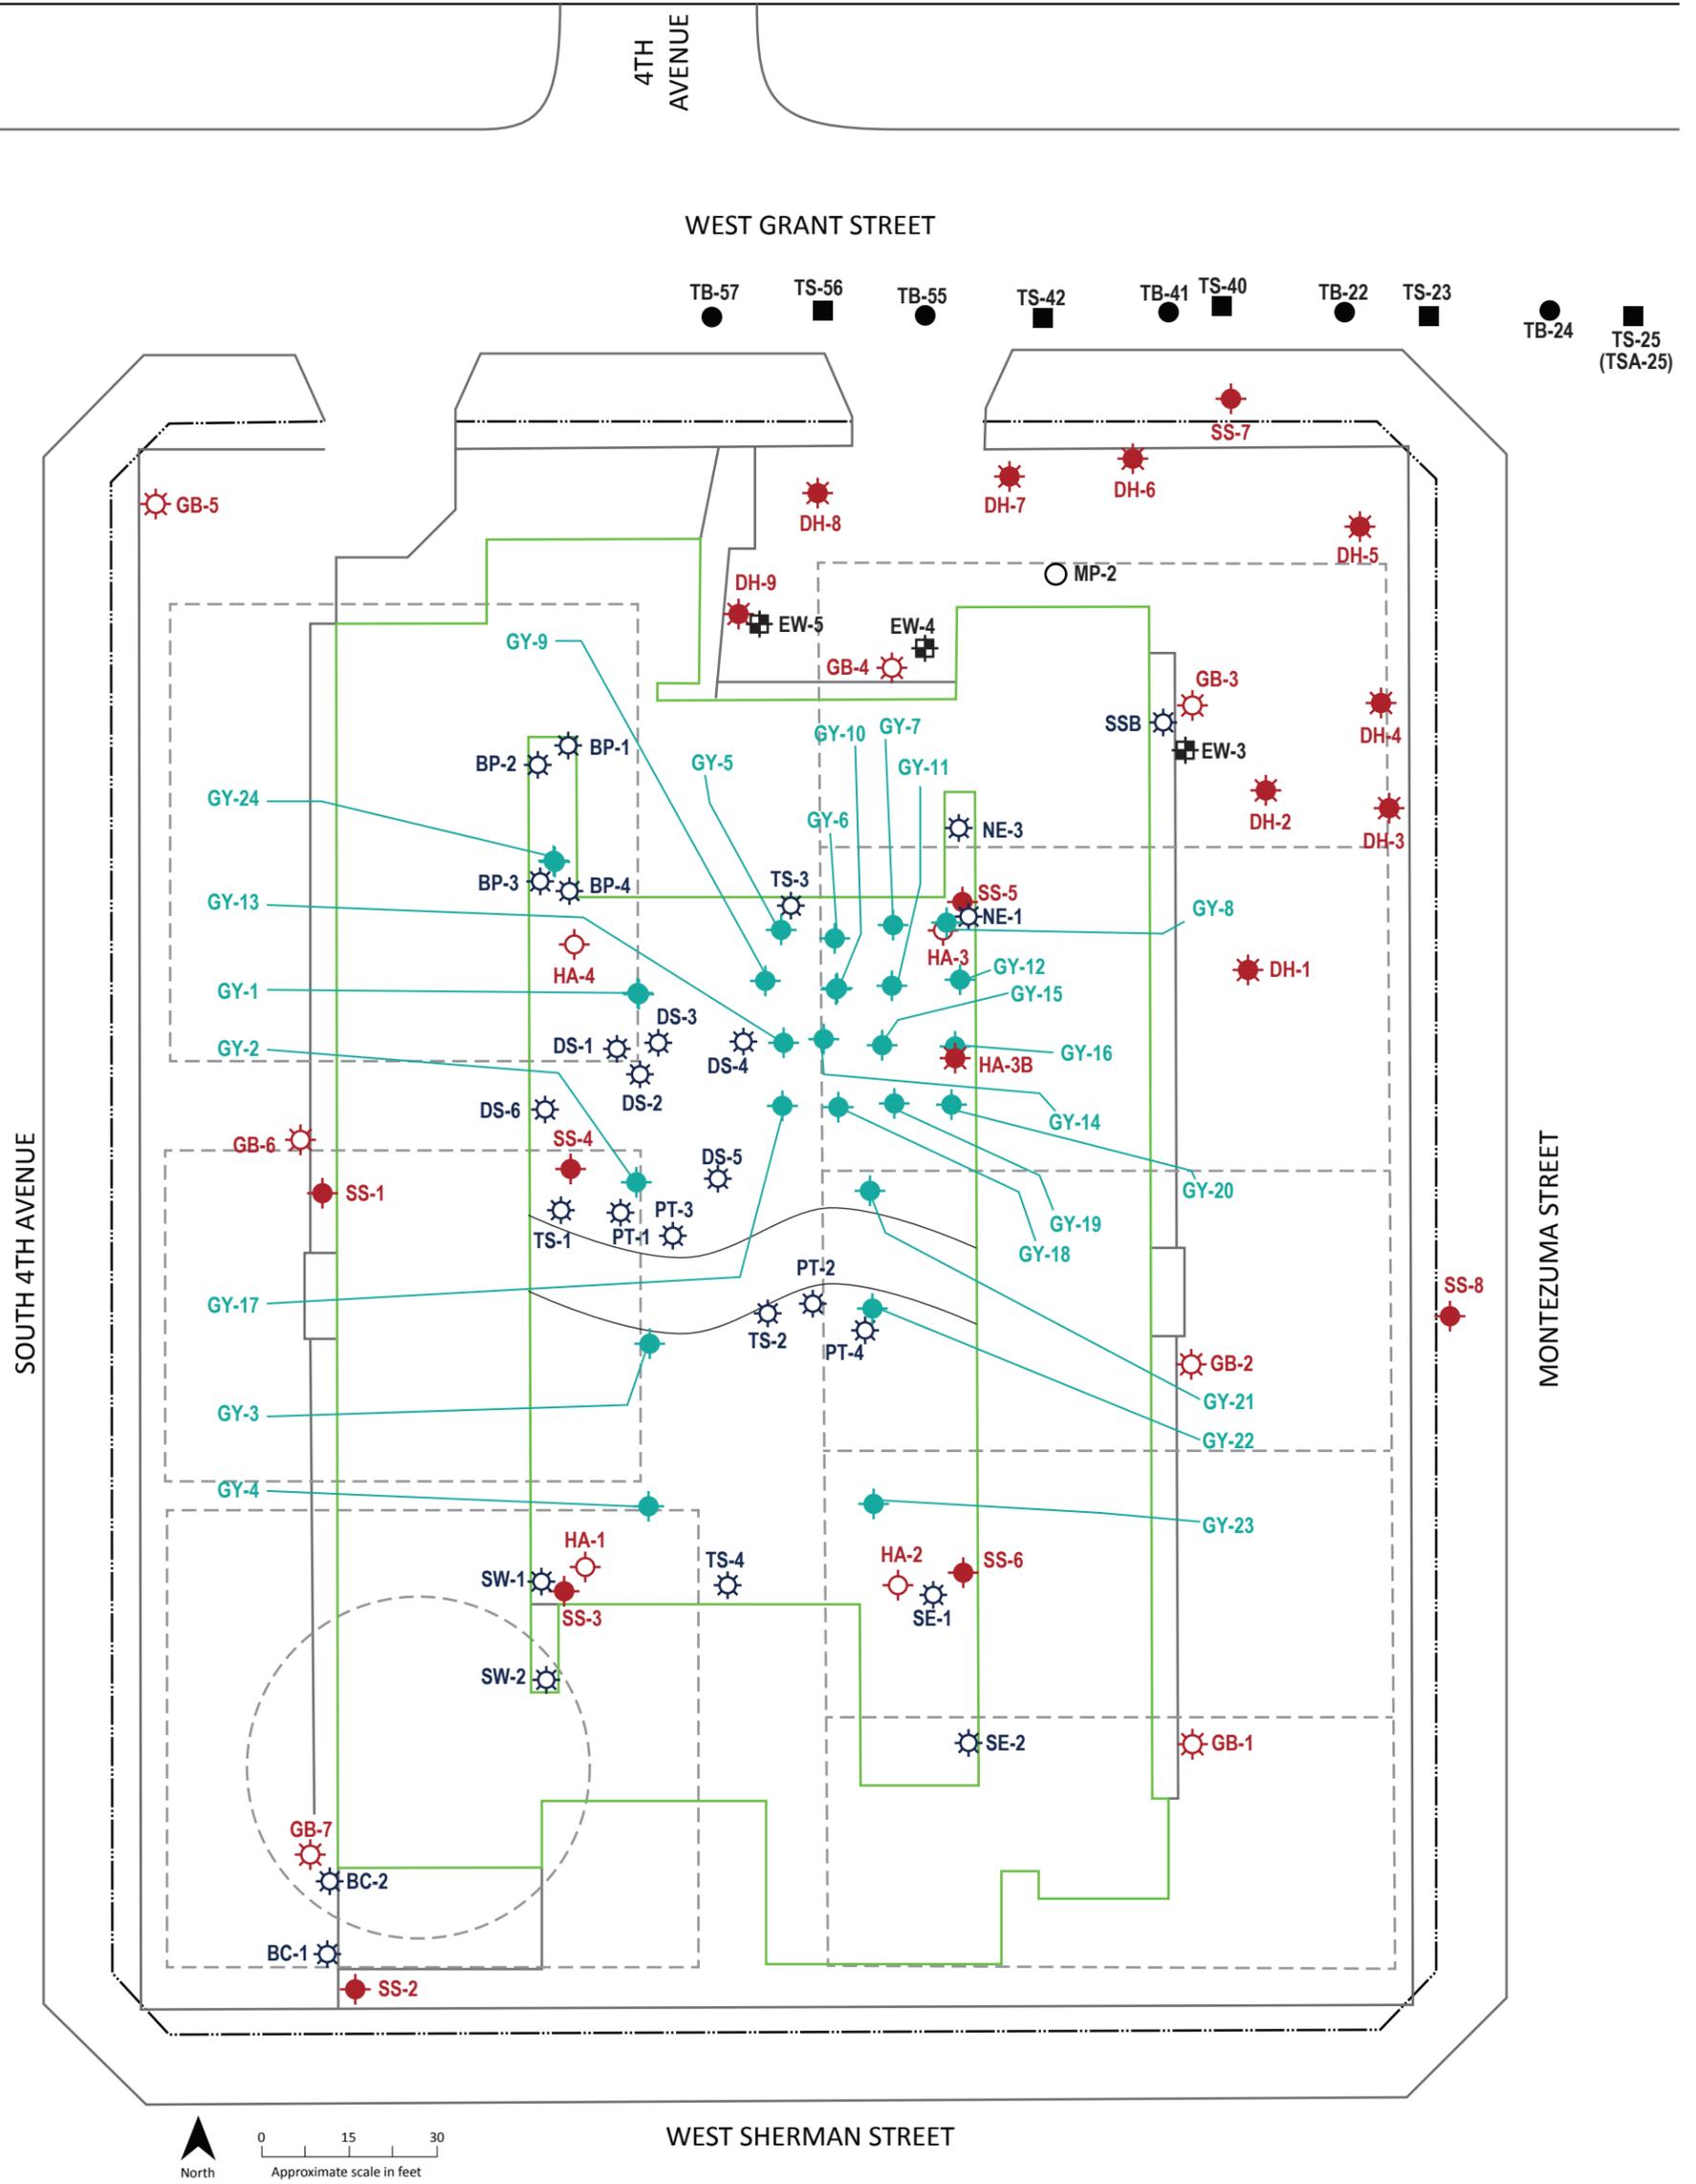
FIGURE 2-3  
**Former Soil Sampling Locations**  
 APS Grant Street Former MGP Site  
 Phoenix, Arizona

- LEGEND**
- Current Apartment Building
  - Former MGP-related Structures
  - ◆ Surface sample collected 1993.
  - ⊙ Soil Boring. Sampling conducted 1993.
  - ⊕ Hand Auger Soil Borings. Sampling 1993.
  - ⊙ Shallow Hand Auger/Soil Borings. Sampling conducted 1994.
  - ◆ Shallow soil samples collected 1998.
  - ⊙ Surface soil samples 1998.
  - Sample taken during Lamplblack pipeline removal from trench bottom 2001.
  - Sample taken during Lamplblack pipeline removal from trench sidewall 2001.
  - ⊕ Extraction Well Location. Collected during vapor extraction pilot test 1994.
  - Monitoring Point Location. Soil sample collected during vapor extraction pilot test 1994.

Boring	Depth Sampled (ft bgs)
BP-1	Surface
BC-2	Surface
DS-5	Surface
DW-2	Surface
GB1	10-12.5
GB2	8-10
GB6	10-12
GB7	8.5-10, 20-21
GY1	0.5, 1.5
GY8	0.5, 1.5
HA1	5-5.5
HA2	5-5.5
HA4	5-5.5
TB-22	5.1
TB-24	5.6
TB-41	6.6
TB-55	5.9
TB-57	6.4
TS-23	4
TS-25	4.4
TS-40	4
TS-42	4
TS-56	3.5

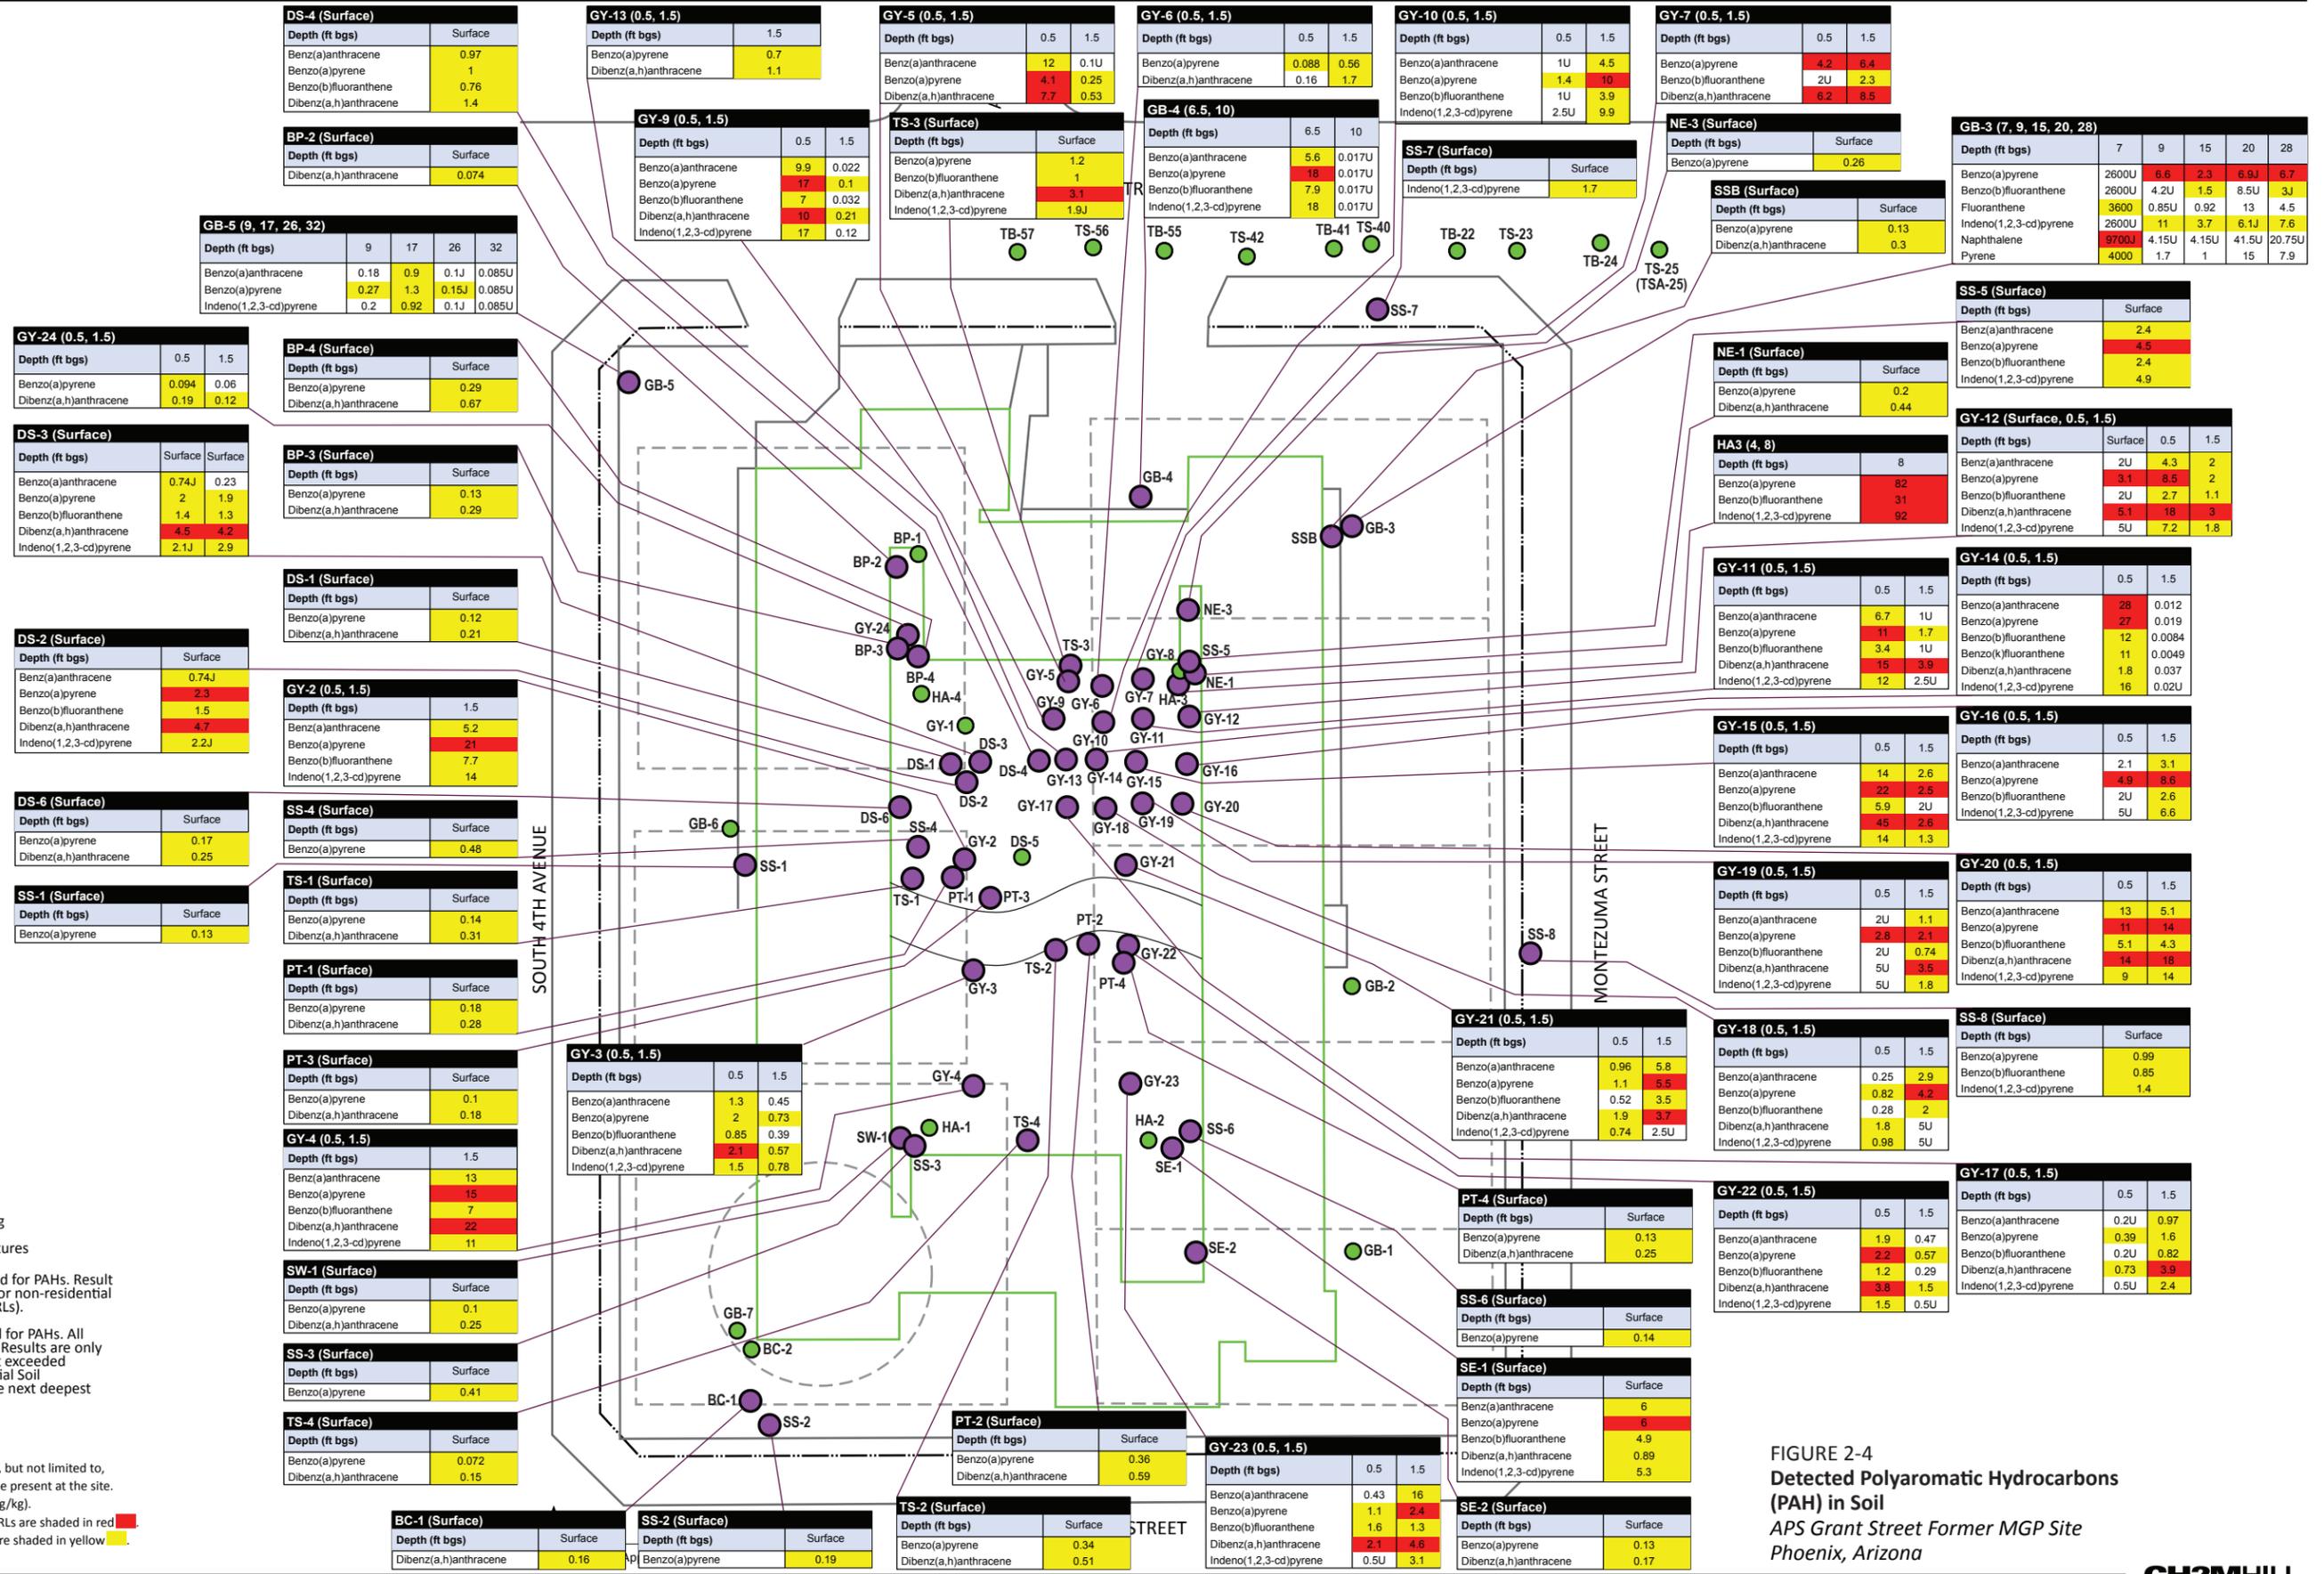
FIGURE 2-4  
Detected Polyaromatic Hydrocarbons (PAH) in Soil  
APS Grant Street Former MGP Site  
Phoenix, Arizona

Boring	Depth Sampled (ft bgs)
BC-2	Surface
BP-4	Surface
DH-2	4.5
DH-4	4.5
DH-6	4.5
DH-7	4.5
GB1	10-12.5
GB2	8-10
GB6	10-12, 20-22
GY-24	0.5, 1.5
SE-2	Surface
SW-2	Surface
TB-22	5.1
TB-24	5.6
TB-41	6.6
TB-55	5.9
TB-57	6.4
TS-23	4
TS-25	4.4
TS-4	Surface
TS-40	4
TS-42	4
TS-56	3.5

Seven PAHs were detected above residential SRLs in three of the deep soil borings (GB3, GB4, and GB5). Two PAHs were detected above non-residential SRLs in the borings GB3 and GB4. The highest concentrations were observed in the sample collected from 5 to 7 feet bgs in GB3 in the northeast corner of the Site, an area reported to contain lampblack material (Geraghty and Miller, 1994). Additionally, the sample from GB3 at 28 feet bgs also contained benzo(a)pyrene, benzo(b)fluoranthene, and indeno(1,2,3-cd)pyrene above residential and/or nonresidential SRLs. GB4 and GB5 are located at the north end and northwestern corner of the Site, respectively. Table 2-3 and Figure 2-4 present the PAH analytical results and the distribution of PAHs at the Site.

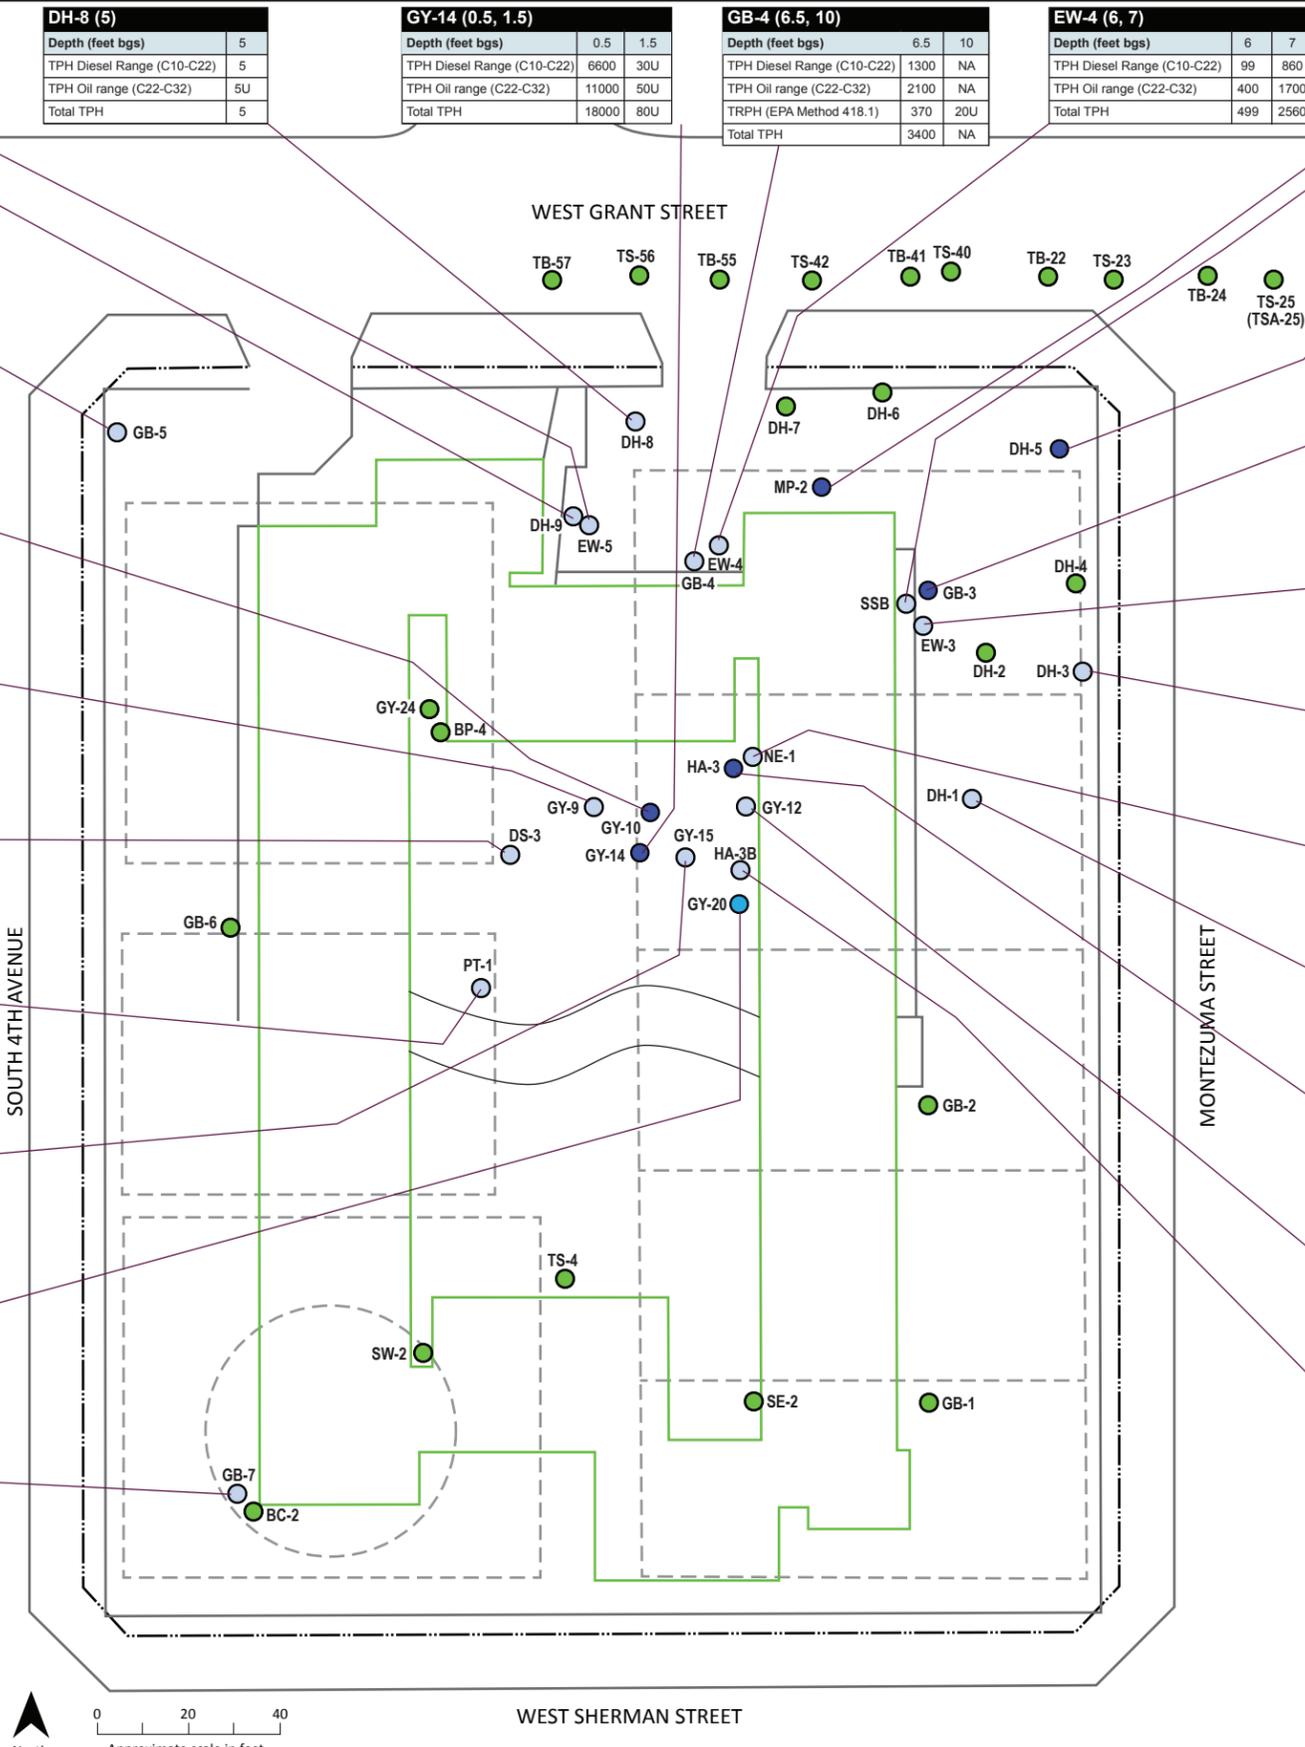
All depths sampled are listed. Results are only presented for samples with detectable levels of TPH and the next deepest sample, if available.

**FIGURE 2-5**  
**Detected Total Petroleum Hydrocarbons (TPHs) in Soil**  
 APS Grant Street Former MGP Site  
 Phoenix, Arizona

Boring	Depth Sampled (ft bgs)
EW-3	5-6
EW-4	6, 7
EW-5	5, 10
GB1	12.5
GB2	10
GB4	6.5, 10
GB5	9, 17, 26, 32
GB6	12
GB7	10
HA1	5.5
HA2	5.5
HA3	4, 8
HA4	5.5
SS-1	Surface
SS-2	Surface
SS-3	Surface
SS-4	Surface
SS-5	Surface
SS-6	Surface
SS-7	Surface
SS-8	Surface
SSB	Surface

of the borings at depths up to 10 feet bgs and analyzed for TPH and BTEX. TPH was detected in all of the samples, with the maximum total TPH concentration of 158,000 mg/kg observed at 6.5 feet bgs in boring MP-2. Additionally, benzene was detected in the same sample at a concentration of 94 mg/kg, exceeding the residential and non-residential SRLs of 0.65 and 1.4 mg/kg, respectively. Analytical results for TPH and BTEX are provided in Tables 2-4 and 2-5, respectively. Figures 2-5 and 2-6 present the distribution of TPH and BTEX at the Site, respectively.

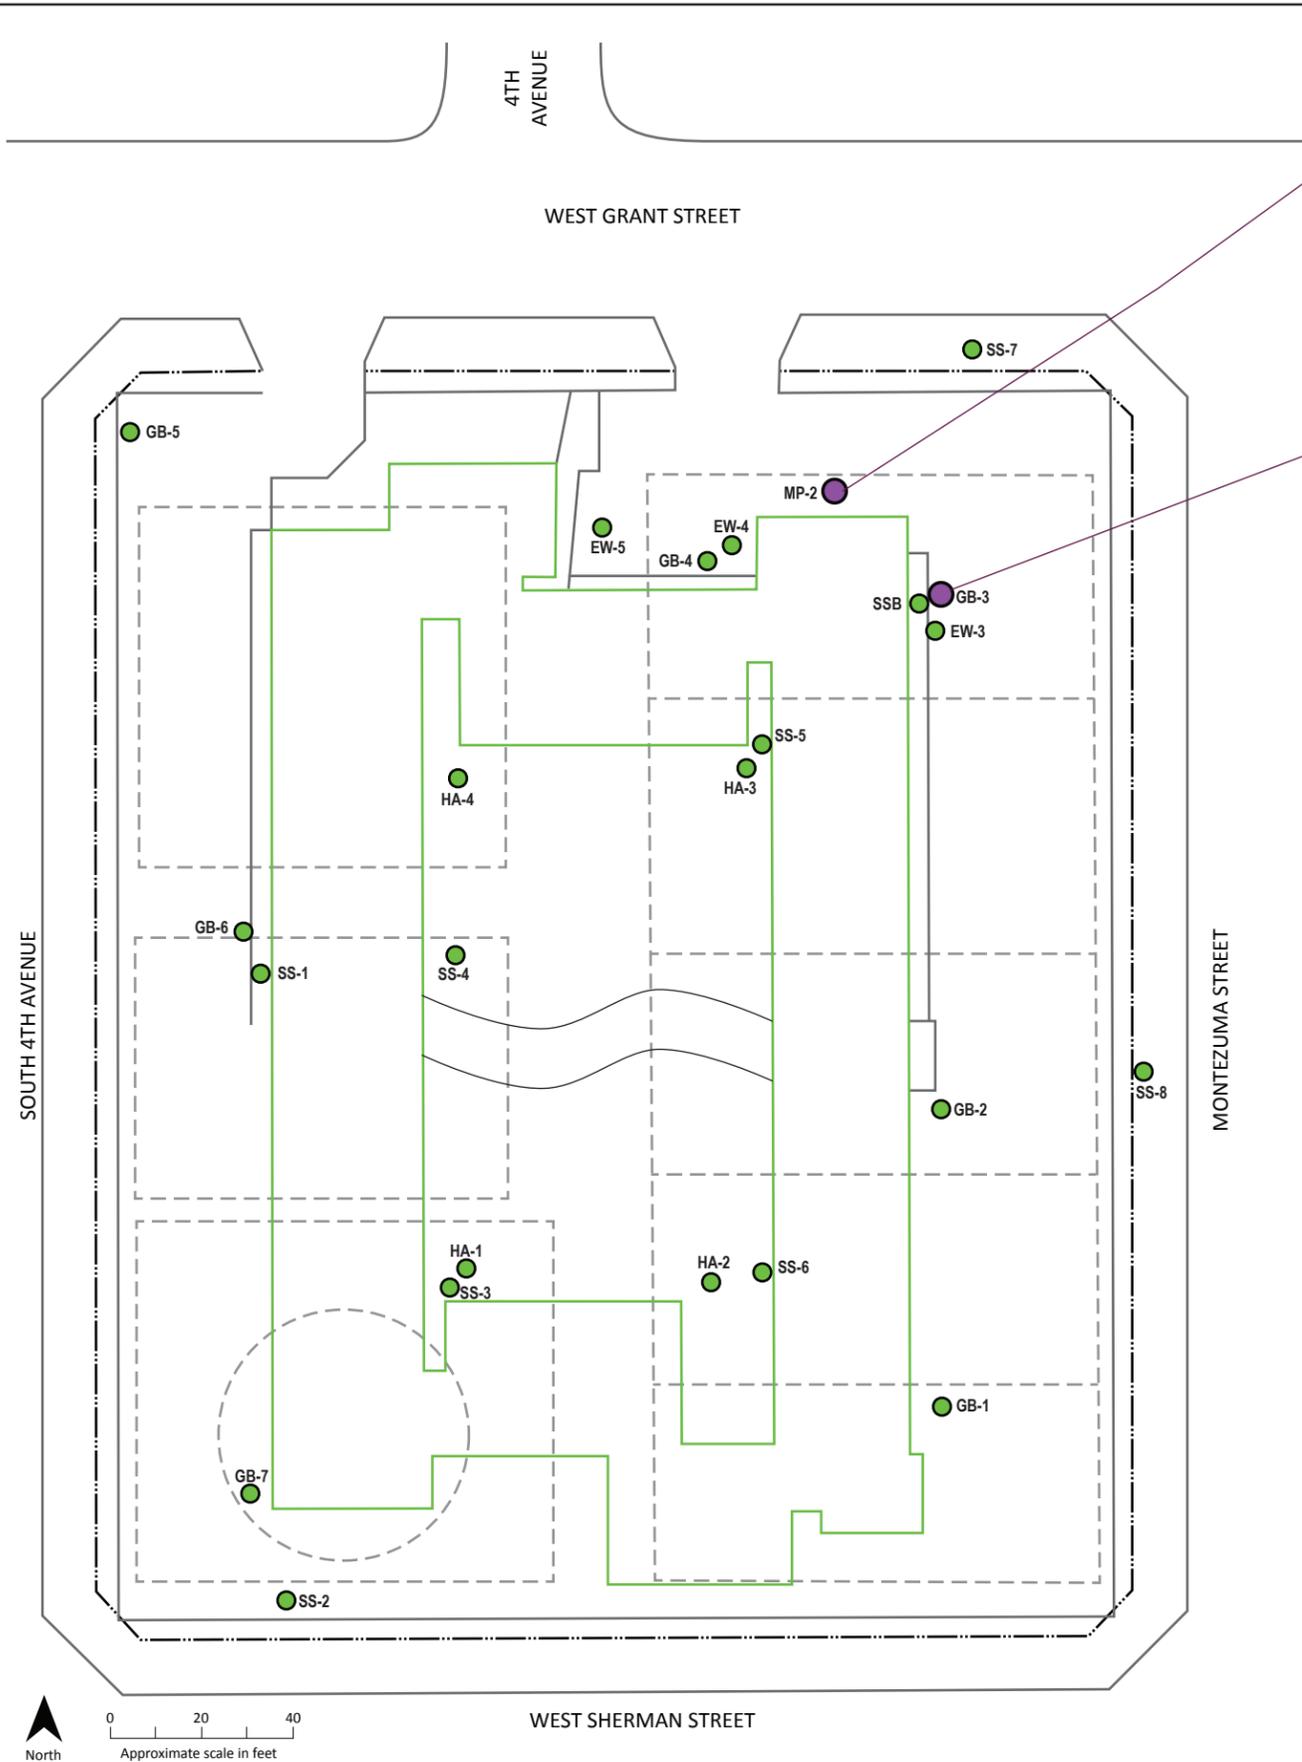
MP-2 (6.5)	
Depth (ft bgs)	7
Benzene	94

GB-3 (7, 9, 15, 20, 28)		
Depth (ft bgs)	7	9
Benzene	660	0.025U
Toluene	660	0.025U
Total Xylenes	460	0.025U

FIGURE 2-6  
**Detected BTEX in Soil**  
 APS Grant Street Former MGP Site  
 Phoenix, Arizona

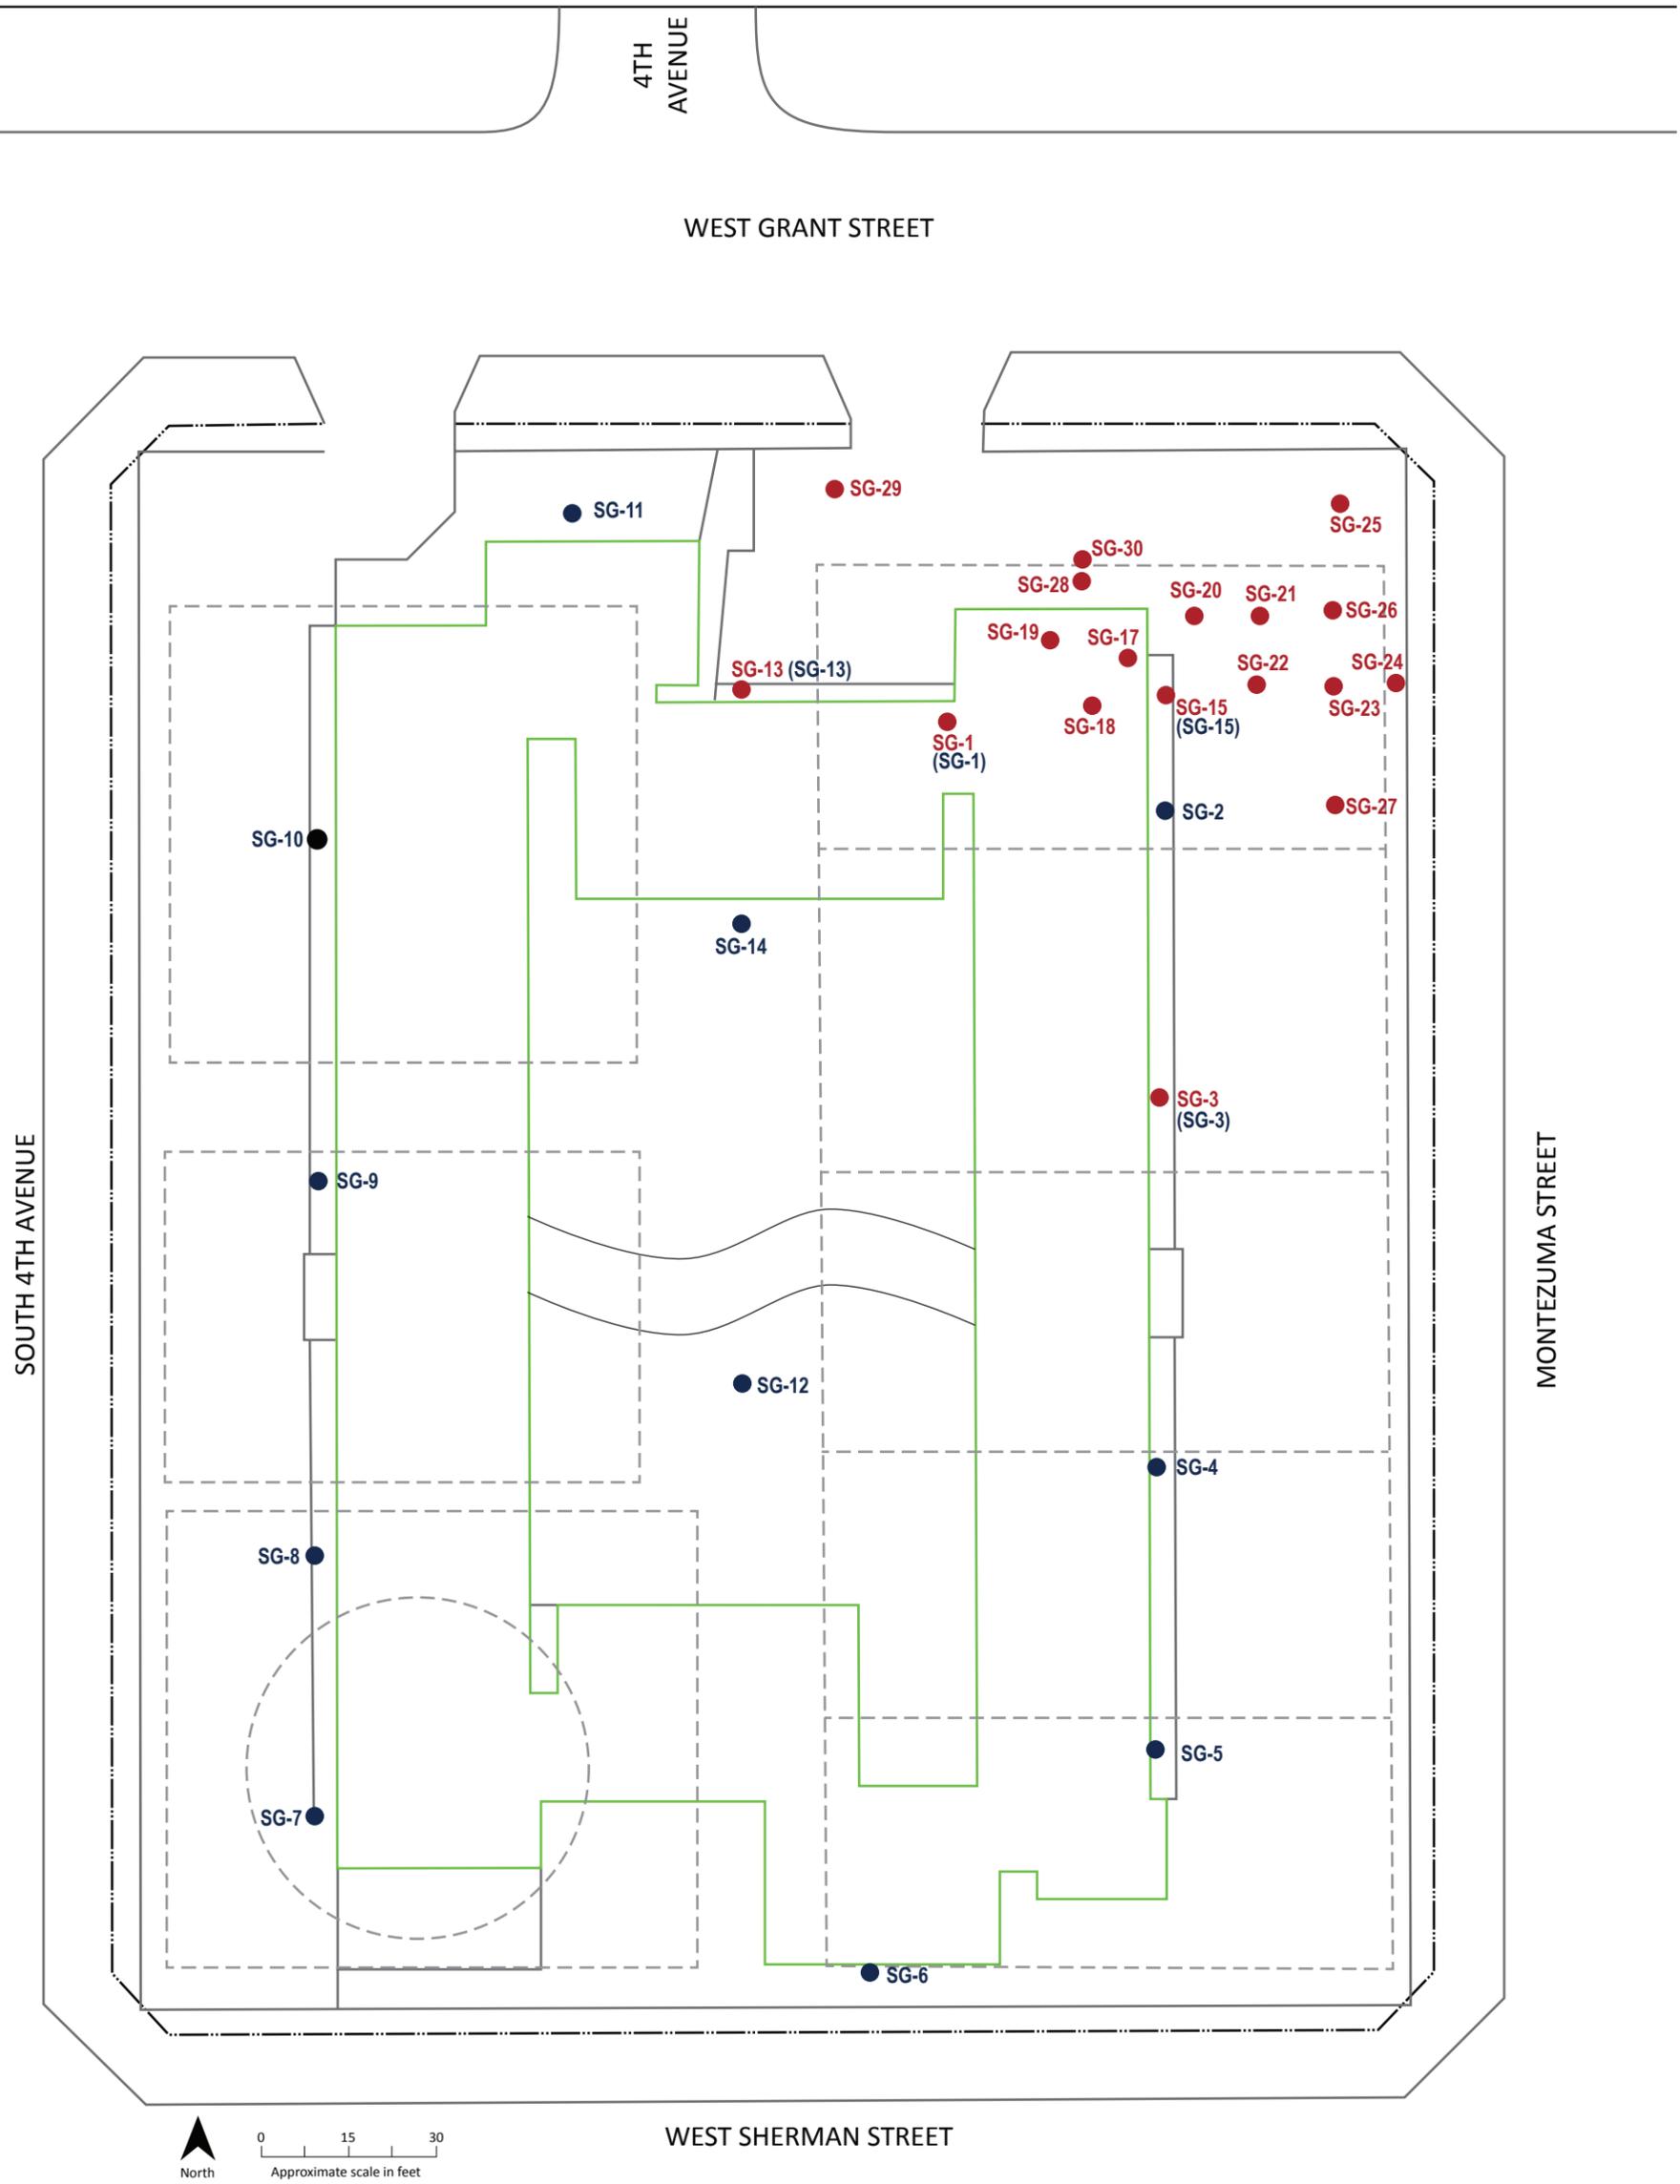
- LEGEND**
- Current Apartment Building
  - Former MGP-related Structures
  - Soil Gas Samples collected by Geraghty and Miller. Samples collected 1993.
  - Soil Gas Samples collected by Geraghty and Miller. Samples collected 1994.

FIGURE 2-7  
**Soil Vapor Sampling Locations**  
 APS Grant Street Former MGP Site  
 Phoenix, Arizona
