*Work Plan*

**Arizona Public Service Former  
Manufactured Gas Plant, Grant Street  
Phoenix, Arizona  
VRP #504477-00**

Prepared for  
**Arizona Public Service**

June 2015

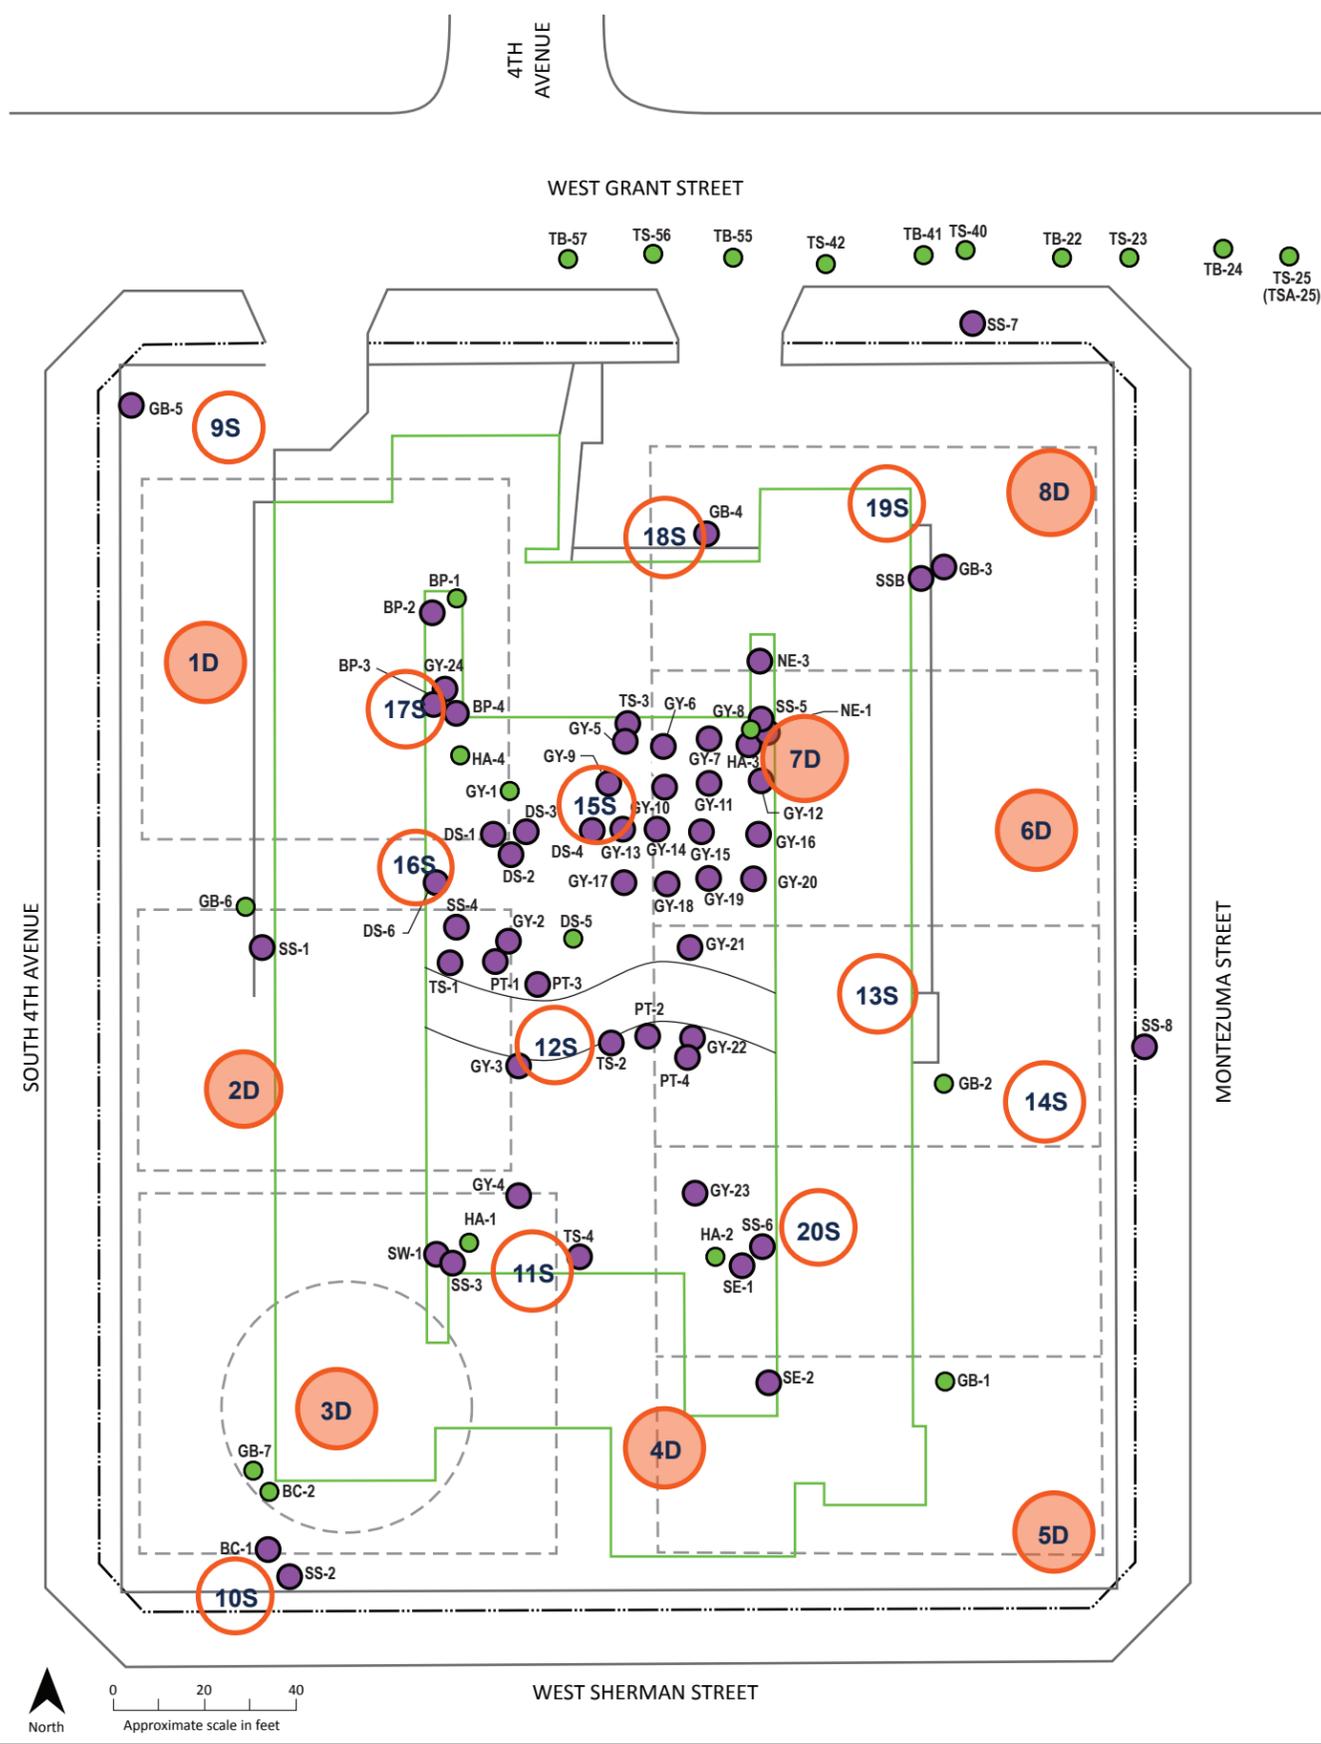
- Current Apartment Building
- Former MGP-related Structures
- Sampling locations analyzed for PAHs. Result did not exceed residential or non-residential Soil Remediation Limits (SRLs).
- Sampling locations where PAH concentrations exceeded residential and/or non-residential SRLs. Figure 2-4 provides additional information on concentrations of PAHs in the subsurface.
- 4D Deep Soil Boring for Site Characterization
- 9S Shallow Soil Boring for Site Characterization

**FIGURE 3-1**  
**Detected Polyaromatic Hydrocarbons (PAH)**  
**in Soil and Proposed Boring Locations**  
*APS Grant Street Former MGP Site*  
*Phoenix, Arizona*

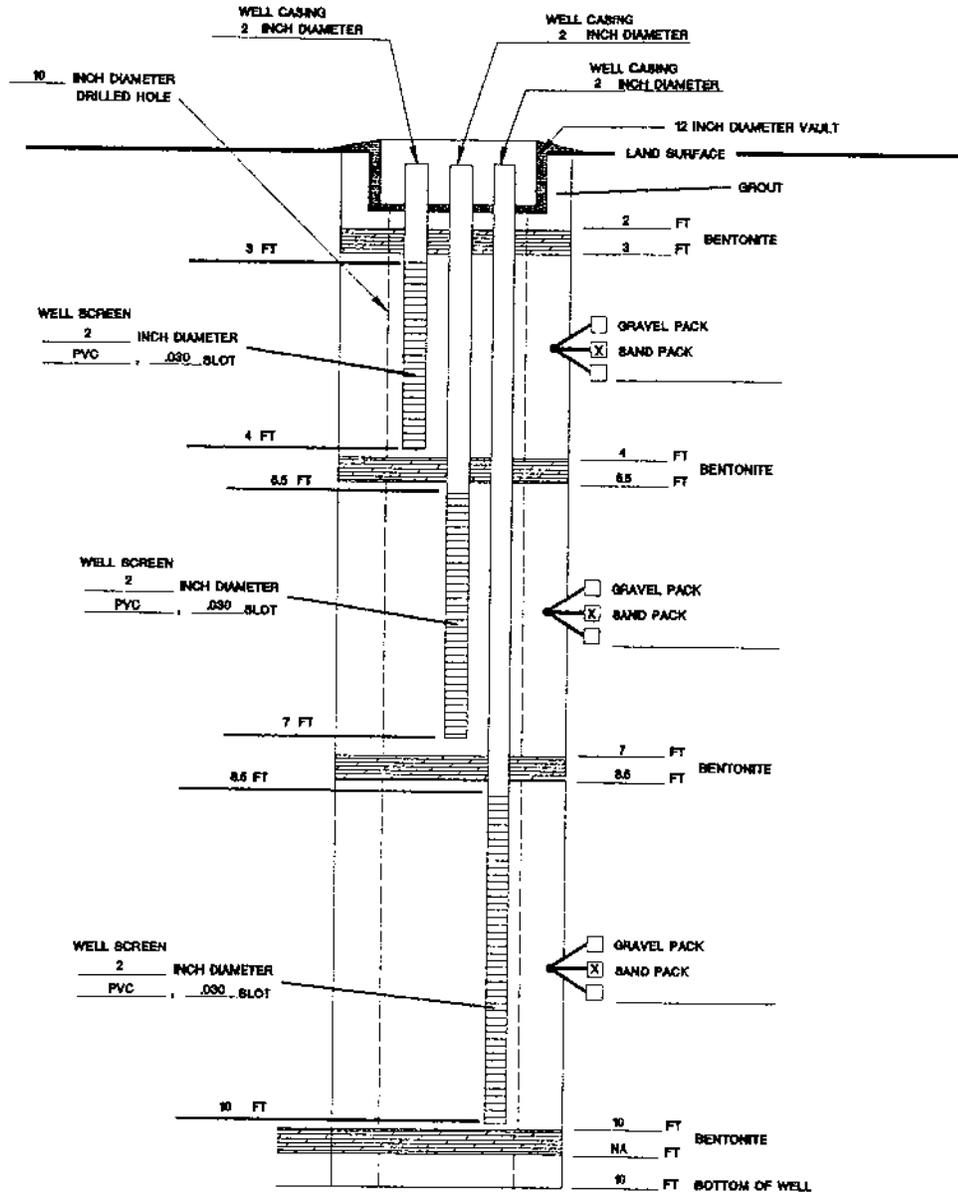
PROJECT GRANT STREET WELL EW-2  
 TOWN/CITY PHOENIX  
 COUNTY MARICOPA STATE AZ  
 PERMIT NO. NONE REQUIRED  
 LAND-SURFACE ELEVATION \_\_\_\_\_ FEET  SURVEYED  
 AND DATUM \_\_\_\_\_ FEET  ESTIMATED  
 INSTALLATION DATE(S) MAY 9, 1994  
 DRILLING METHOD HOLLOW STEM AUGER  
 DRILLING CONTRACTOR GEOMECHANICS BW  
 DRILLING FLUID NONE  
 DEVELOPMENT TECHNIQUE(S) AND DATE(S)  
NA

FLUID LOST DURING DRILLING NA GALLONS  
 WATER REMOVED DURING DEVELOPMENT NA GALLONS  
 STATIC DEPTH TO WATER NA FEET BELOW M.P.  
 PUMPING DEPTH TO WATER NA FEET BELOW M.P.  
 PUMPING DURATION NA HOURS  
 YIELD NA G.P.M. DATE NA  
 SPECIFIC CAPACITY NA GPM/FT  
 WELL PURPOSE VAPOR EXTRACTION / MONITOR FOR VAPOR EXTRACTION PILOT TEST.  
 REMARKS \_\_\_\_\_  
 PREPARED BY MIKE BRILZ
