Draft
Corrective Measure Implementation Report for
SWMU 11 Dighole

Marine Corps Air Station Yuma
Yuma, Arizona

25 July 2007

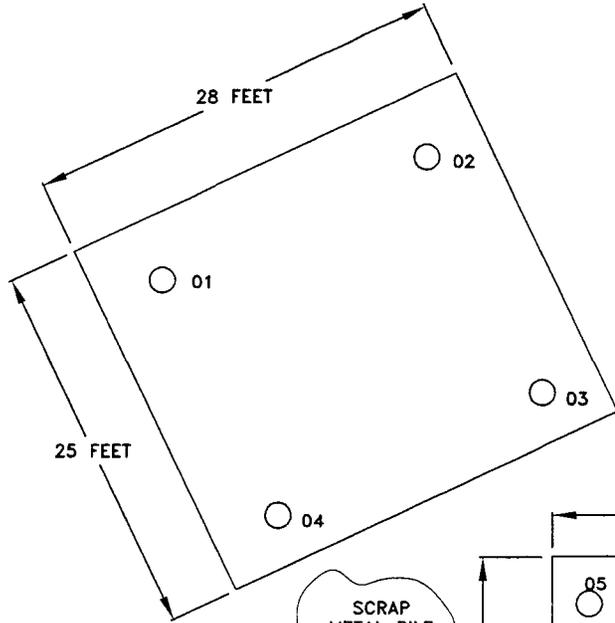
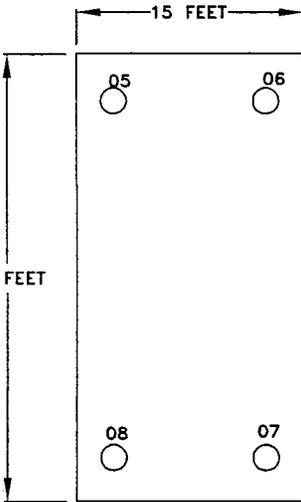
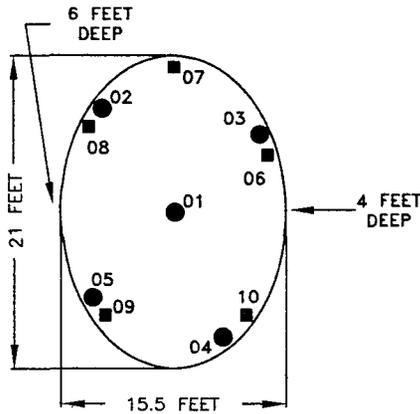
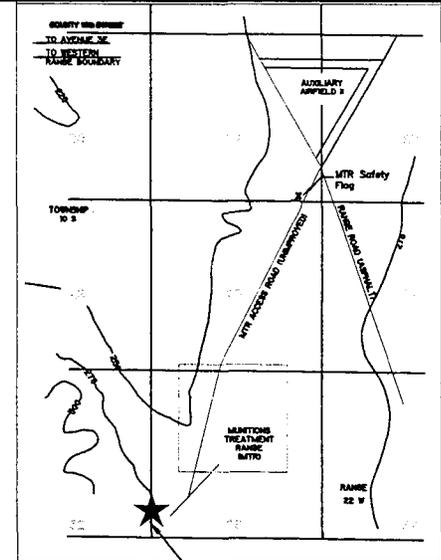
SCRAP METAL PILE

Location of SWMU 11 Dighole

Excavation of the SWMU 11 Dighole was conducted on 10 April 2007. A backhoe, operated by MCAS Yuma personnel, was used to excavate soil from the SWMU 11 Dighole based on the marked limits from the geophysical survey. CDM and MCAS Yuma staff visually observed the excavated soils and the excavation limits to further direct the backhoe operations. All excavated material (soil and metal fragments) was placed by the backhoe onto plastic sheeting adjacent to the site.

Excavated soil was placed on plastic sheeting next to the dighole, and left onsite pending analytical results. Soil sampling results indicated that no contamination exists in the excavated soil (see Section 5.2) and the excavated soil was backfilled into the SWMU 11 Dighole on 20 June 2007. After backfilling, the majority of the plastic sheeting placed under the excavated soil was collected and disposed of as non-hazardous solid waste. Some plastic sheeting was unrecoverable and was left on-site to be collected as possible during future range clearance activities.
