YPG-141

RESPONSE TO COMMENTS ON DRAFT FINAL VERSION OF RFI REPORT
DATED FEBRUARY 2012

YPG-141
GEOPHYSICAL
SURVEY RESULTS
U.S. Army Garrison
Yuma Proving Ground

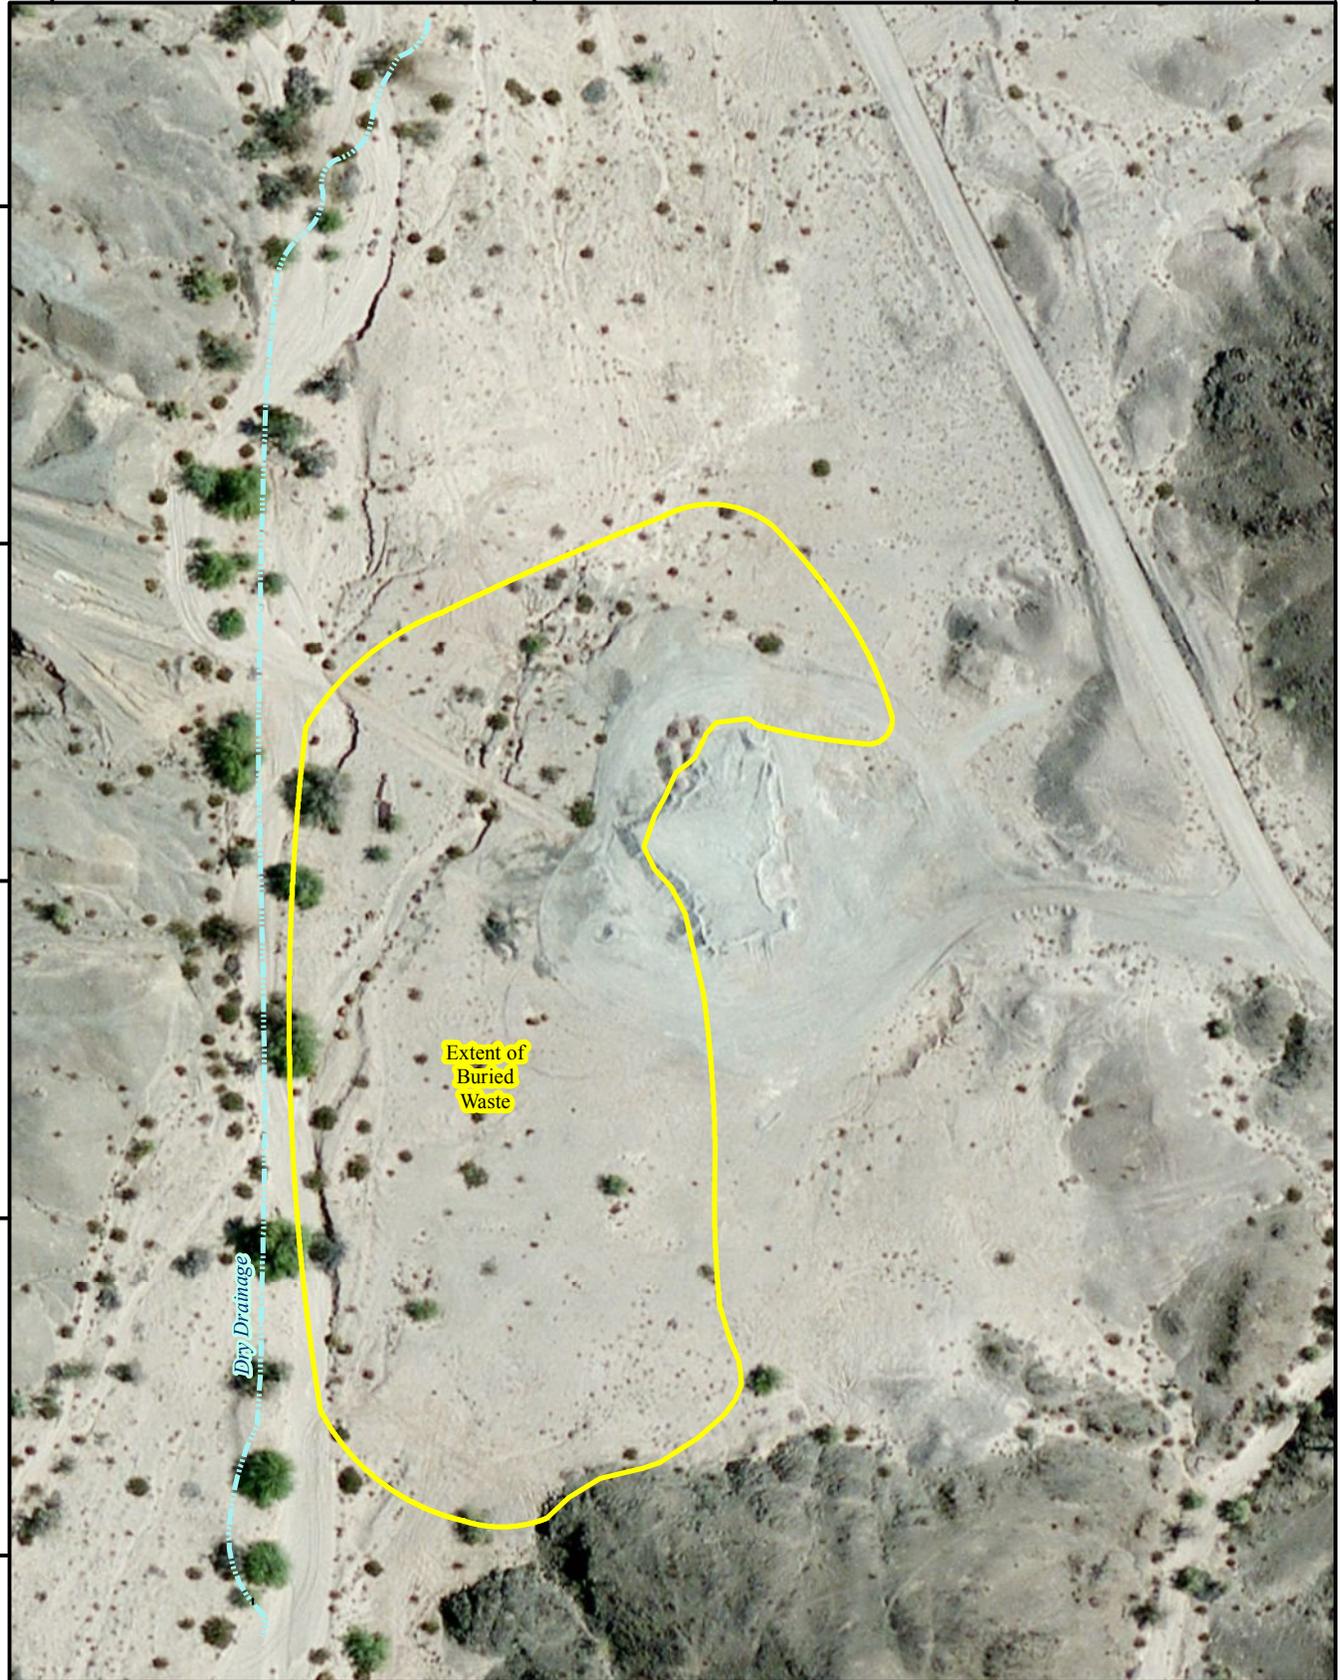
YPG-141
SITE MAP

Extent of Buried Waste

Dry Drainage

Site YPG-141 is located approximately 1 mile northeast of the Main Administrative Area, north of Barranca Road and west of Laguna Army Airfield, and the site consists of approximately 4.1 acres (Figures 2.1 and 2.2). Disposal activities reportedly occurred at the site from 1964 to 1967. Prior to a surface debris removal action of November 2009, abundant glass debris, burnt wood, and various metal scrap including cast-iron pipes, cans, cable, wire, metal banding/strapping, and other miscellaneous debris were present at the surface and within the drainage channel in the northwestern portion of the site (Section 4.1.1; Appendix F). In addition, metallic anomalies identified during a geophysical survey indicated the presence of buried waste in the south central region of the landfill (Section 3.3; Jason, 2007). A large pile of gravel-sized crushed concrete is present near the center of the site, and is believed to come from a housing/administration area demolition project. Following the November, 2009 removal of

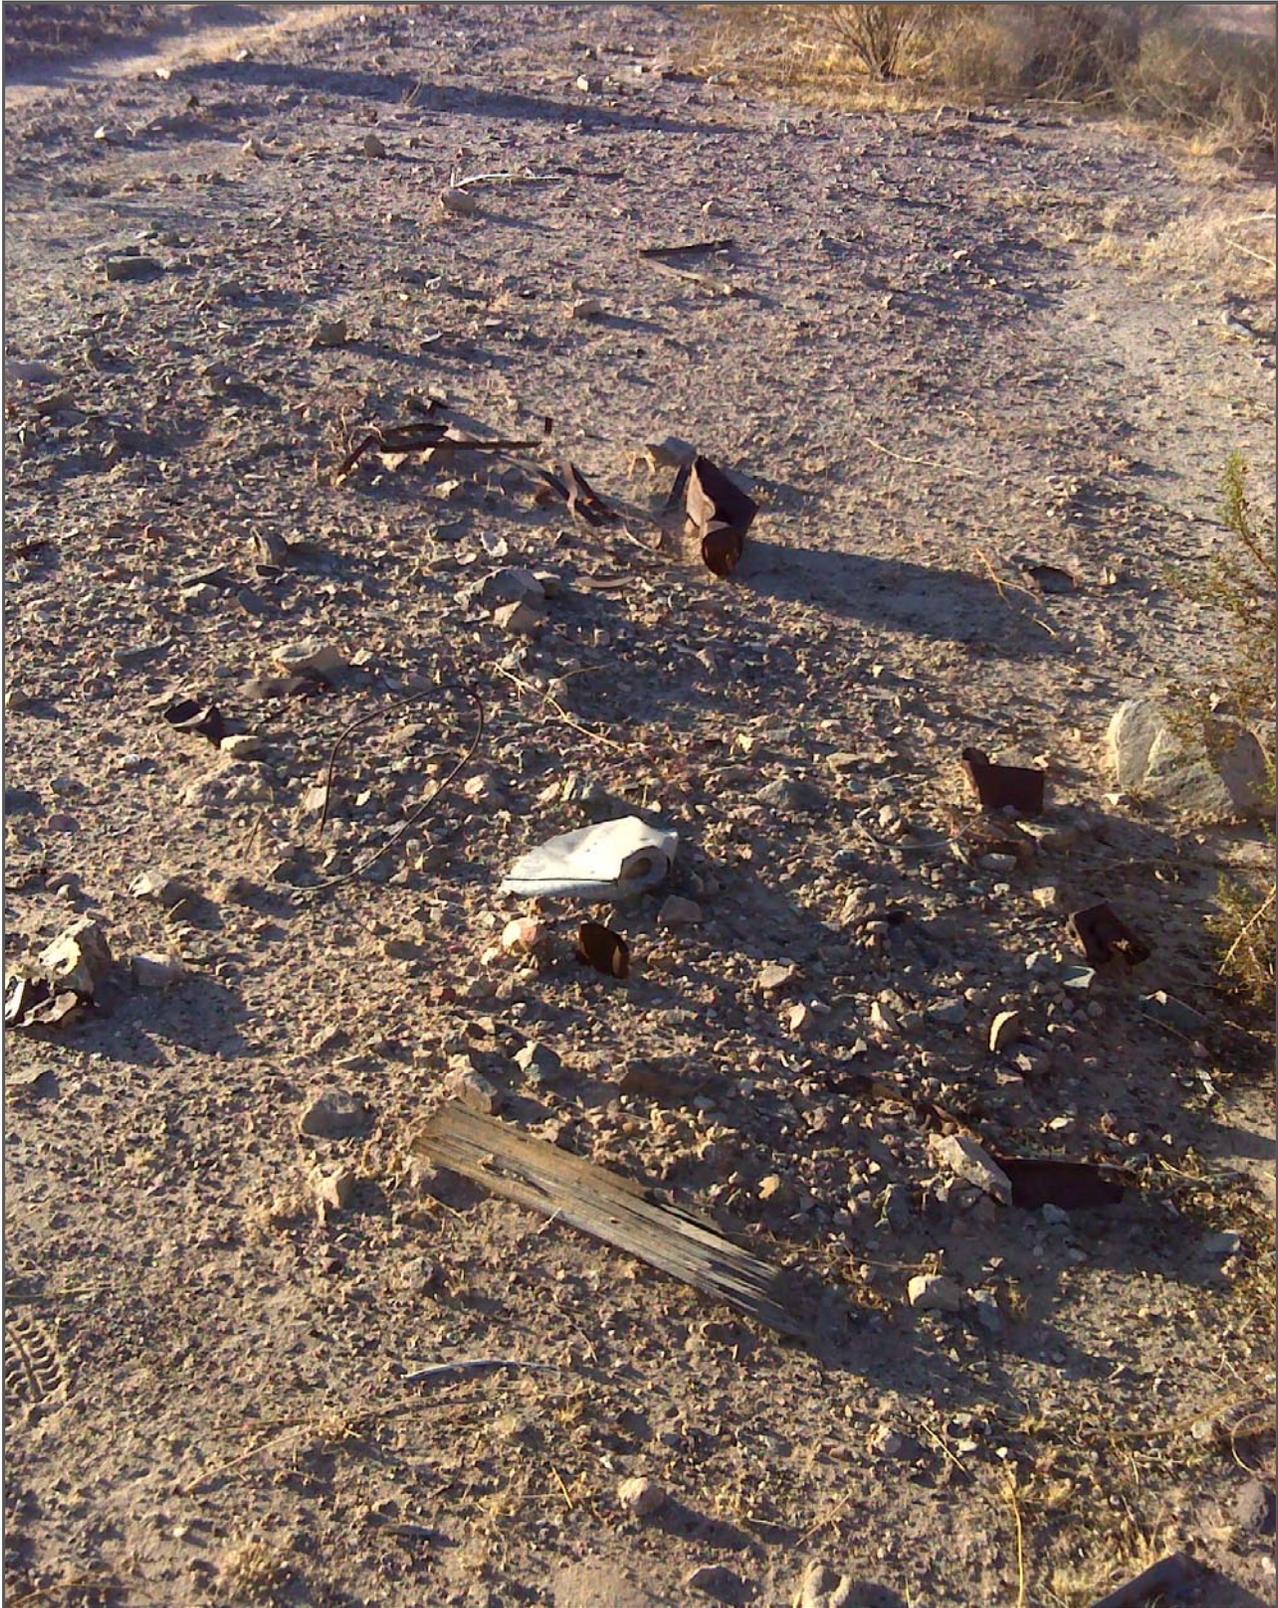
Surface Debris at Inactive Landfill YPG-141

Much of the site has been disturbed by past landfill disposal activities and has little to no vegetation (Figure 2.3). In the undisturbed parts of the site, there are scattered small bushes and trees, including bursage, creosote, and paloverde. The site is generally flat and is located along a drainage plain which drains from north to south. A main drainage channel is located along the west side of the landfill. Bedrock outcrops border the south-southeastern edges of the site. Surface debris (including abundant glass debris, burnt wood, and various metal scrap including pipes, cans, cables, wires, metal banding/strapping, etc.) were present at the surface and within the drainage channel in the northwestern portion of the site, and were removed in November, 2009 (Parsons, 2010).
