**RCRA FACILITY INVESTIGATION REPORT FOR  
INACTIVE LANDFILL YPG-178  
U.S. ARMY GARRISON YUMA PROVING GROUND**

**U.S. ARMY GARRISON YUMA PROVING GROUND**

*June 2012*

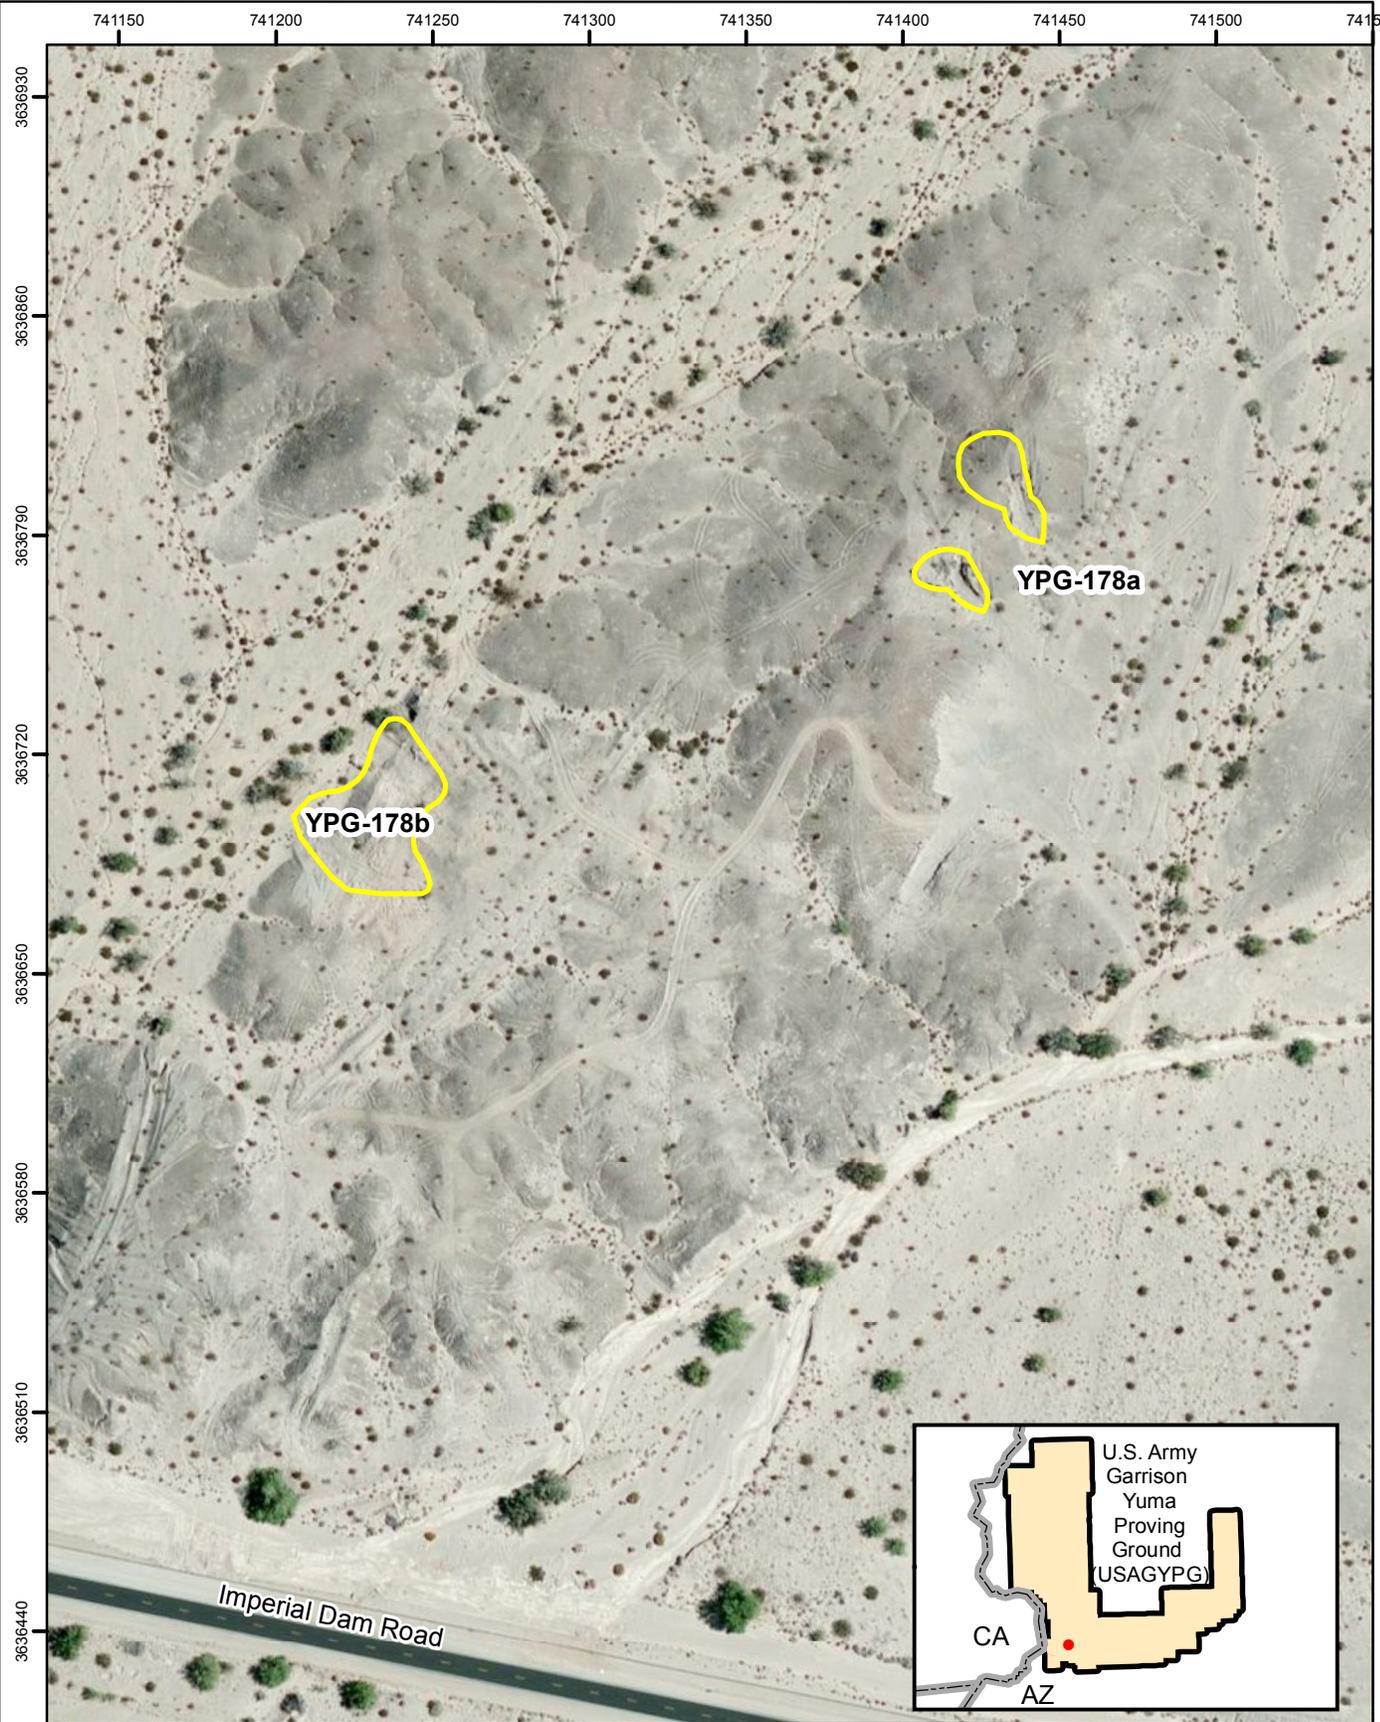
**YPG-178  
SITE MAP**

Extent of Buried Waste

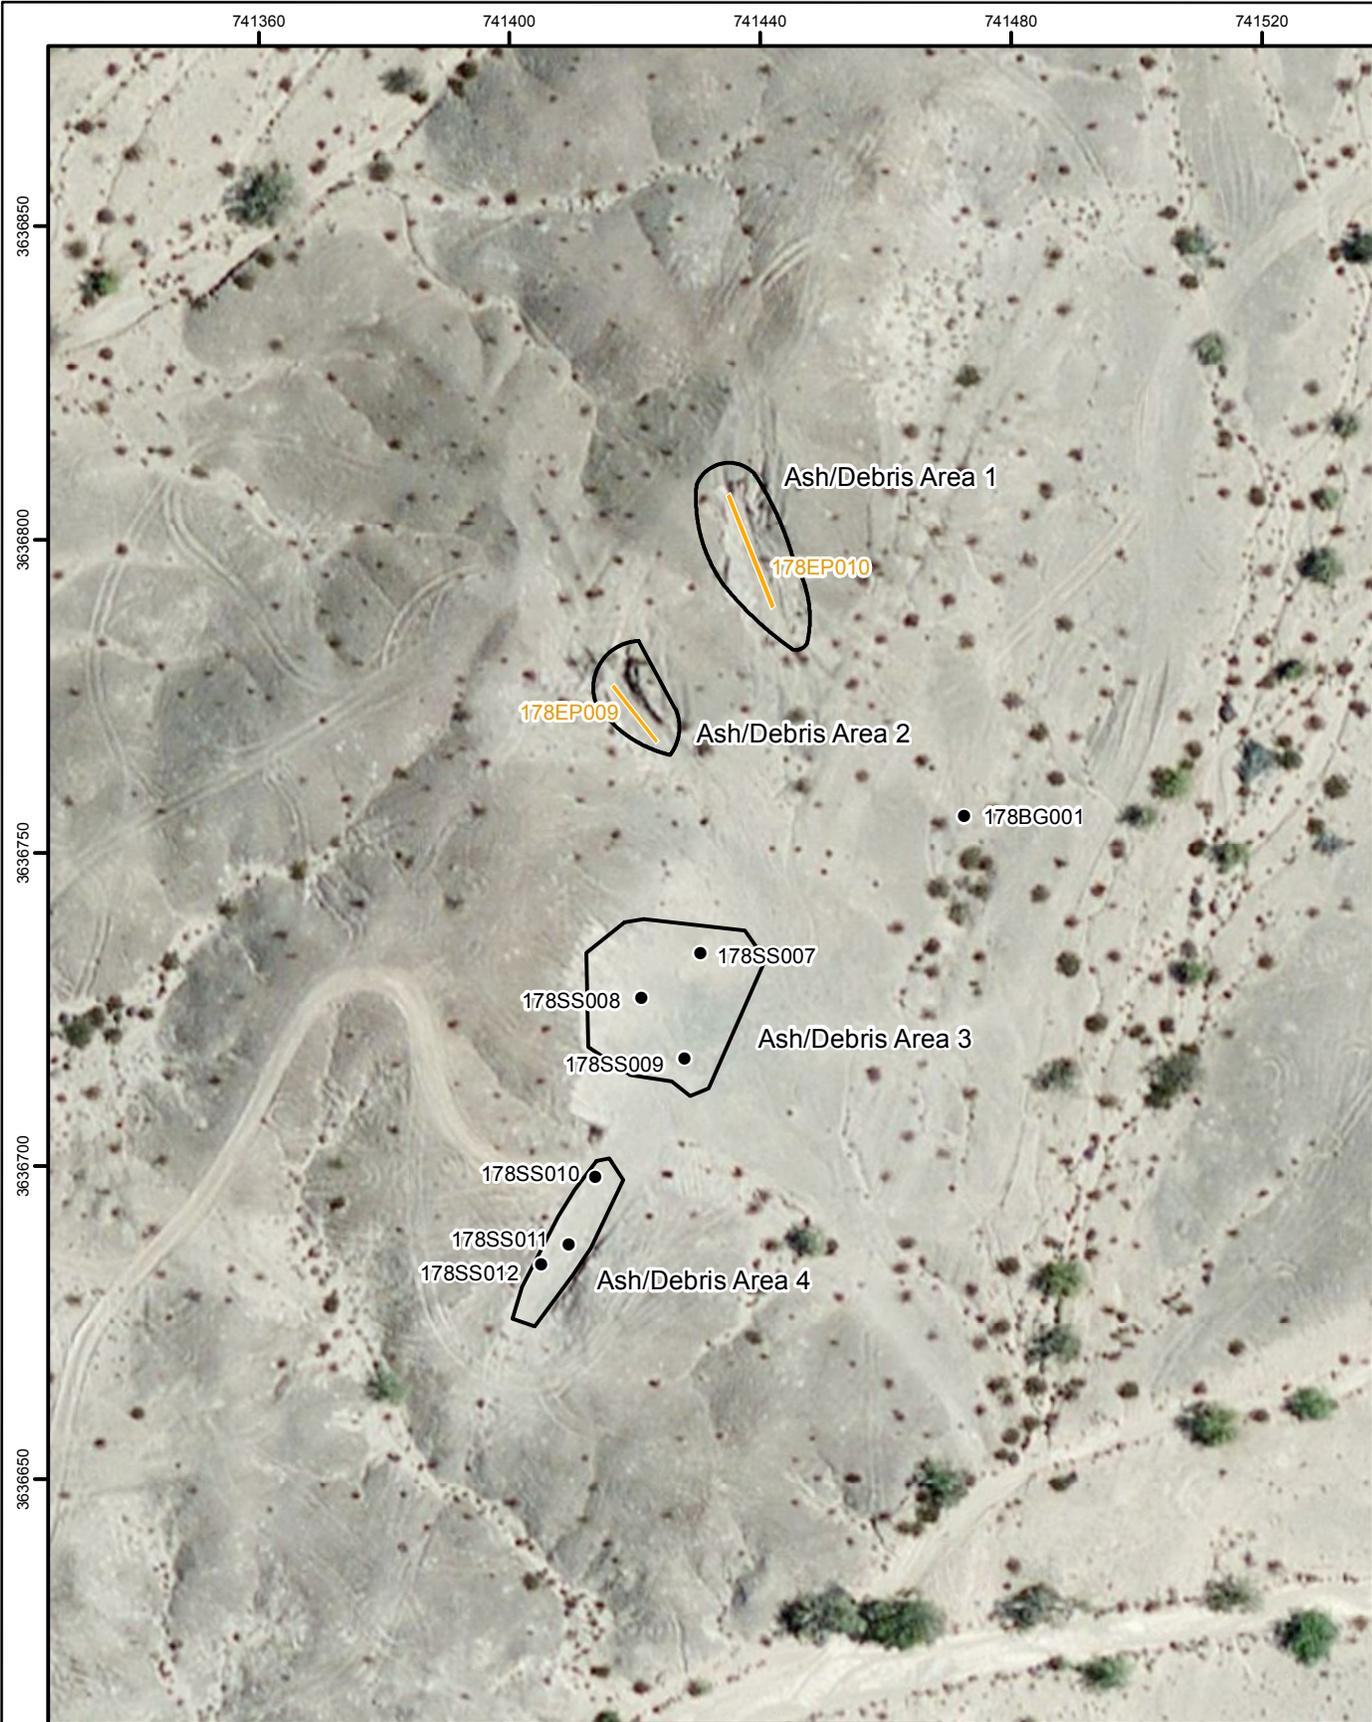
YPG-178a  
 SOIL REMOVAL AREAS  
 AND SAMPLES

- Surface Soil Sample Location
- Test Pit Containing Waste
- Debris/Ash Removed During November 2009 Removal Action

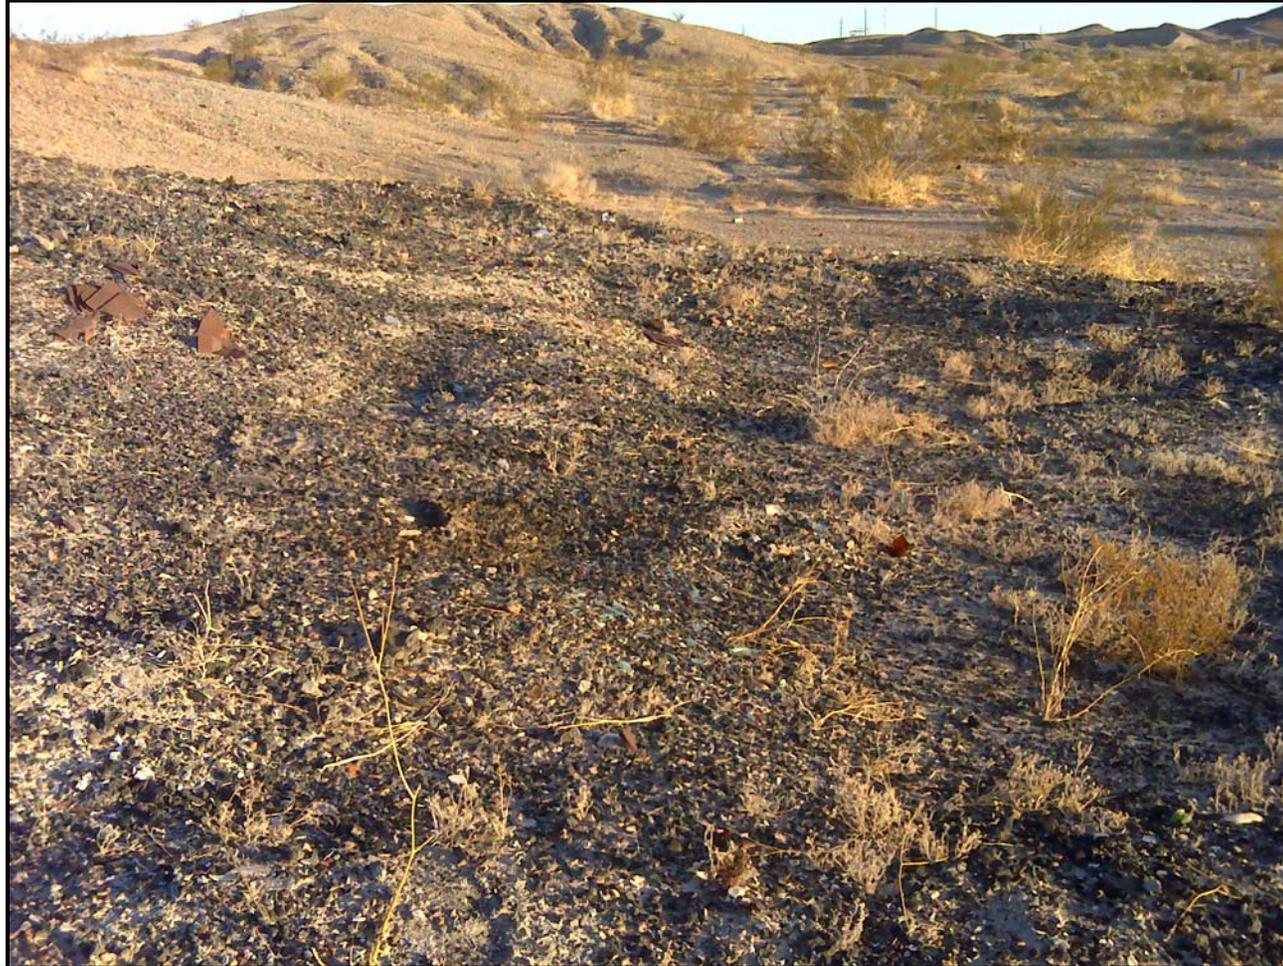
FIGURE 4.3

**YPG-178a Prior to 2009 Removal Action**

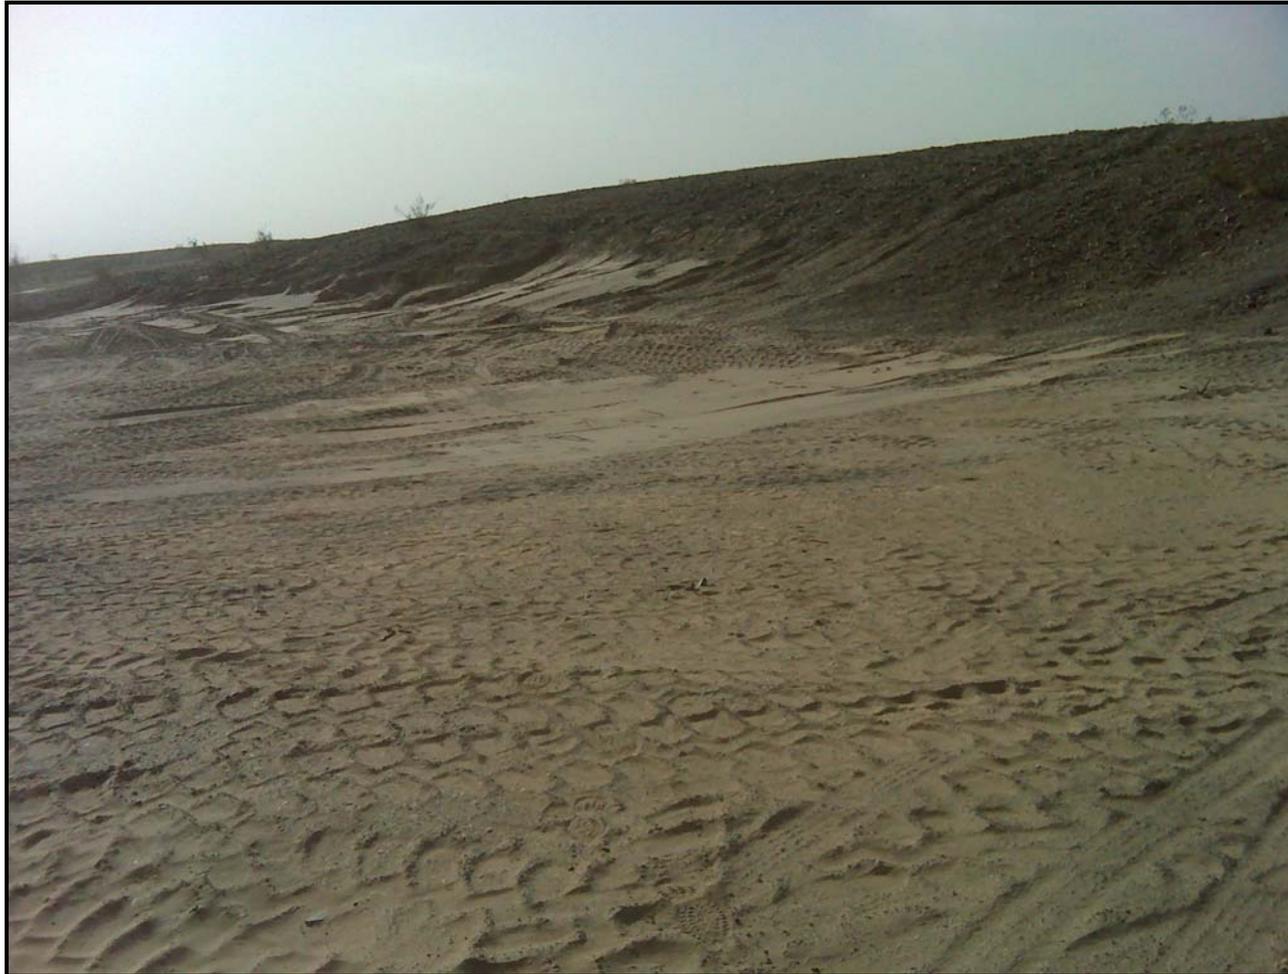
**YPG-178a Following 2009 Removal Action**

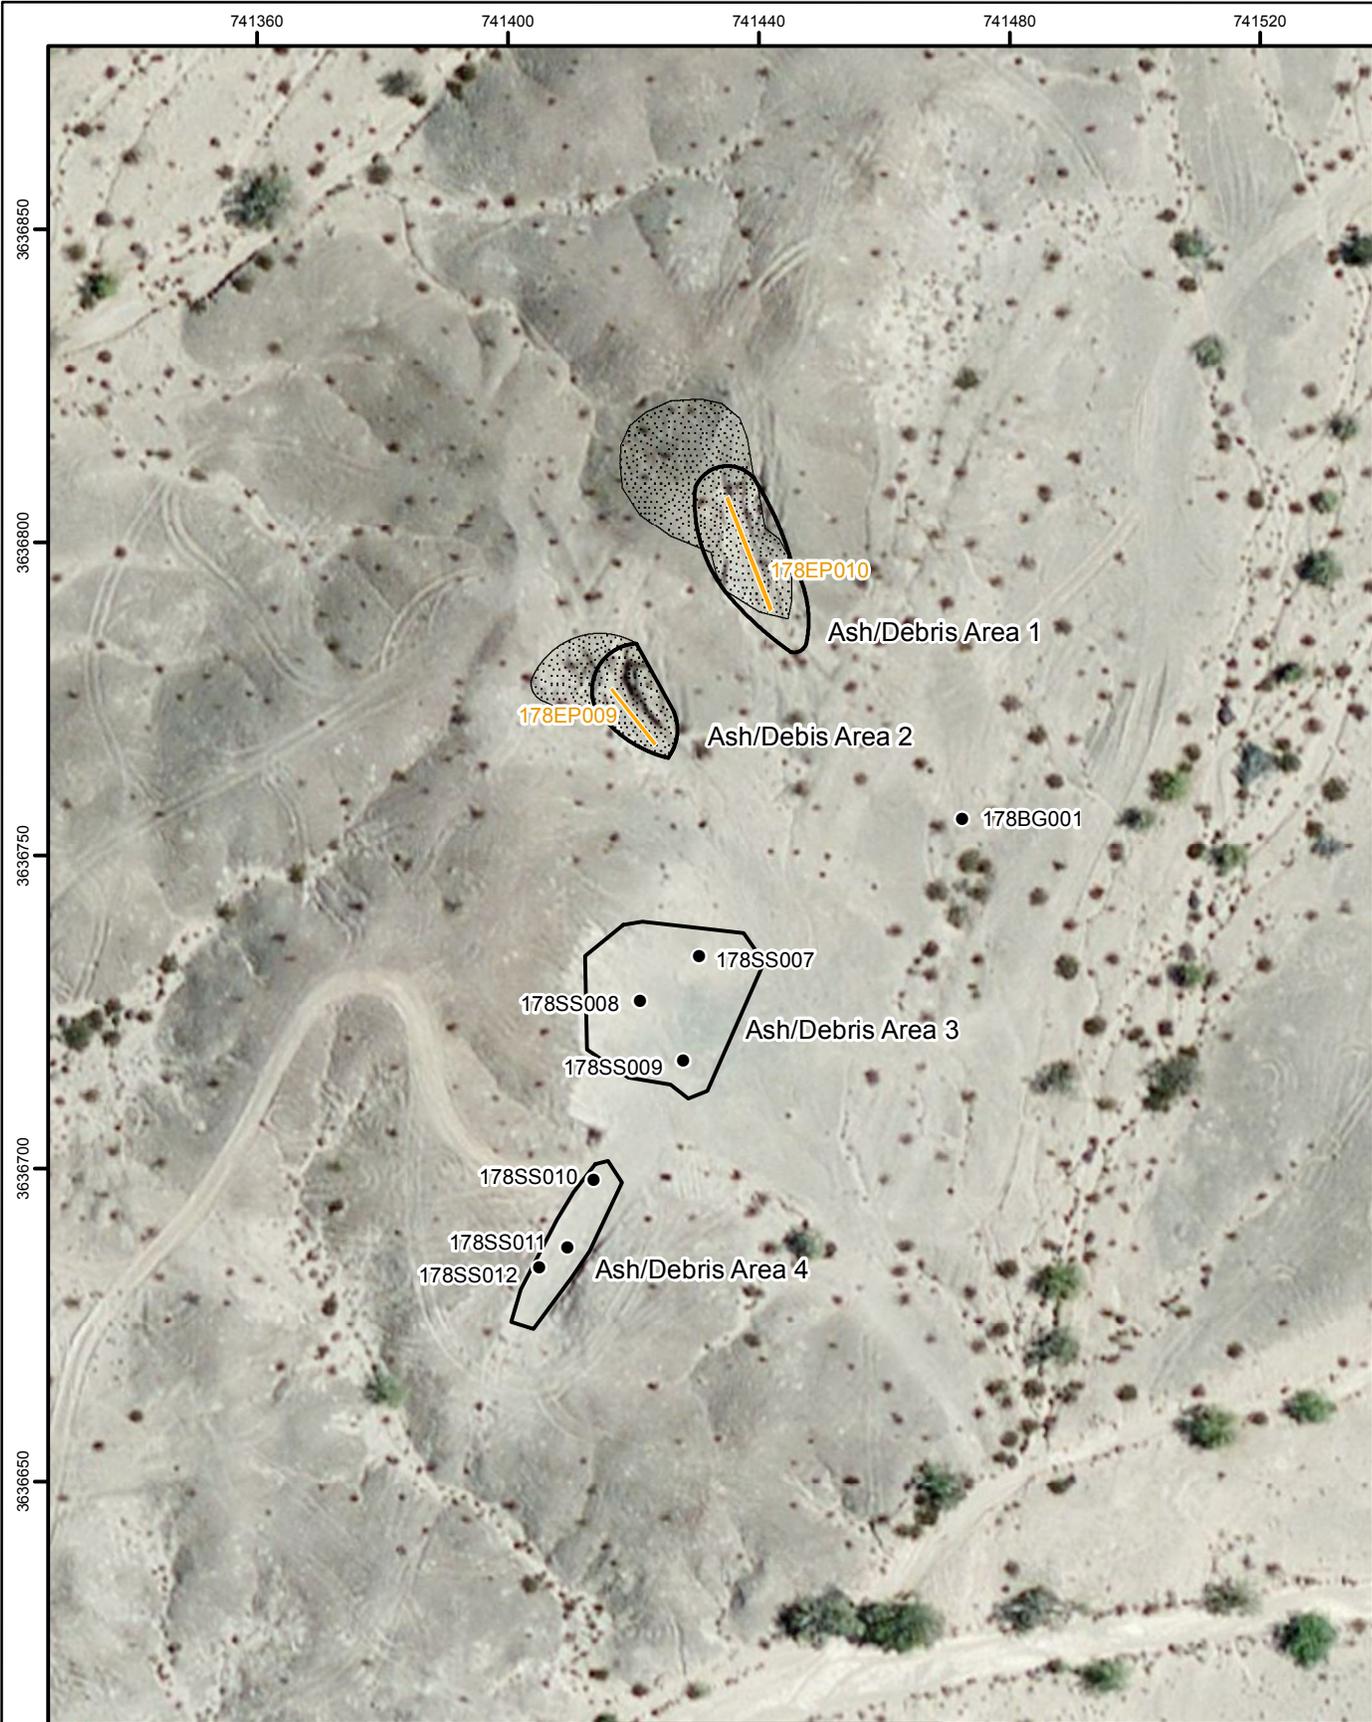
YPG-178a  
 SOIL REMOVAL AREAS  
 AND EXTENT OF  
 BURIED DEBRIS/ASH

During the RFI, nine surface soil samples were collected from Areas 3, 4, 5 and 7, to determine if chemical constituents from the ash/debris have been released into the surrounding soil. Ten test pits were also excavated in Areas 1, 2, and 6 to further delineate the extent of ash/debris underlying the rock covered hillside. Two additional test pits were excavated to represent background conditions. Results of the test pit excavations show that ash/debris was encountered within six of these pits. Based on results of the test pit excavations, the approximate extent of remaining waste at Areas 1, 2, and 6 was estimated. The footprint of remaining waste underlying the gravel hills is presented on Figures 4.5 and 4.6.

- Surface Soil Sample Location
- Test Pit Containing Waste
- ▭ Debris/Ash Removed During November 2009 Removal Action
- ▭ Approximate Extent of Buried Debris/Ash

A Corrective Measures Study is recommended to evaluate the impacts to the site due to the remaining ash/debris present at Areas 1 and 2 (YPG-178a) and Area 6 (YPG-178b) (Figures 4.5 and 4.6). However, based on waste characterization and test pit sampling of the ash and debris, the remaining waste was determined to be non-hazardous. Additionally, the HRA and Ecological Risk Assessment (ERA) results indicate no unacceptable risks to human or ecological receptors were identified. Future impacts to groundwater from site related chemical constituents are not expected, since sampling results did not exceed the GPLs. Therefore, no further action to mitigate risks to human health or the environment is required.

There were several large piles of ash and debris (including glass, burnt wood, cans, and scrap metal) at YPG-178a and b (Jason, 2007). These piles and associated soils were excavated and disposed at the USAGYPG landfill. The ash/debris piles were excavated and removed from Areas 3 and 4 at YPG-178a (Figure 4.1) and Areas 5 and 7 at YPG-178b (Figure 4.2) until there was no visible evidence waste. Ash/debris and associated soil was also partially removed from Areas 1 and 2 at YPG-178a (Figure 4.1) and Area 6 at YPG-178b (Figure 4.2). The extent of ash/debris at these areas was larger than originally estimated and further removal was postponed until additional investigation to delineate the extent could be performed. The footprints of the approximate ash and debris removed from YPG-178 in 2009 are illustrated in Figures 4.5 and 4.6, as are the extents of buried ash/debris material.

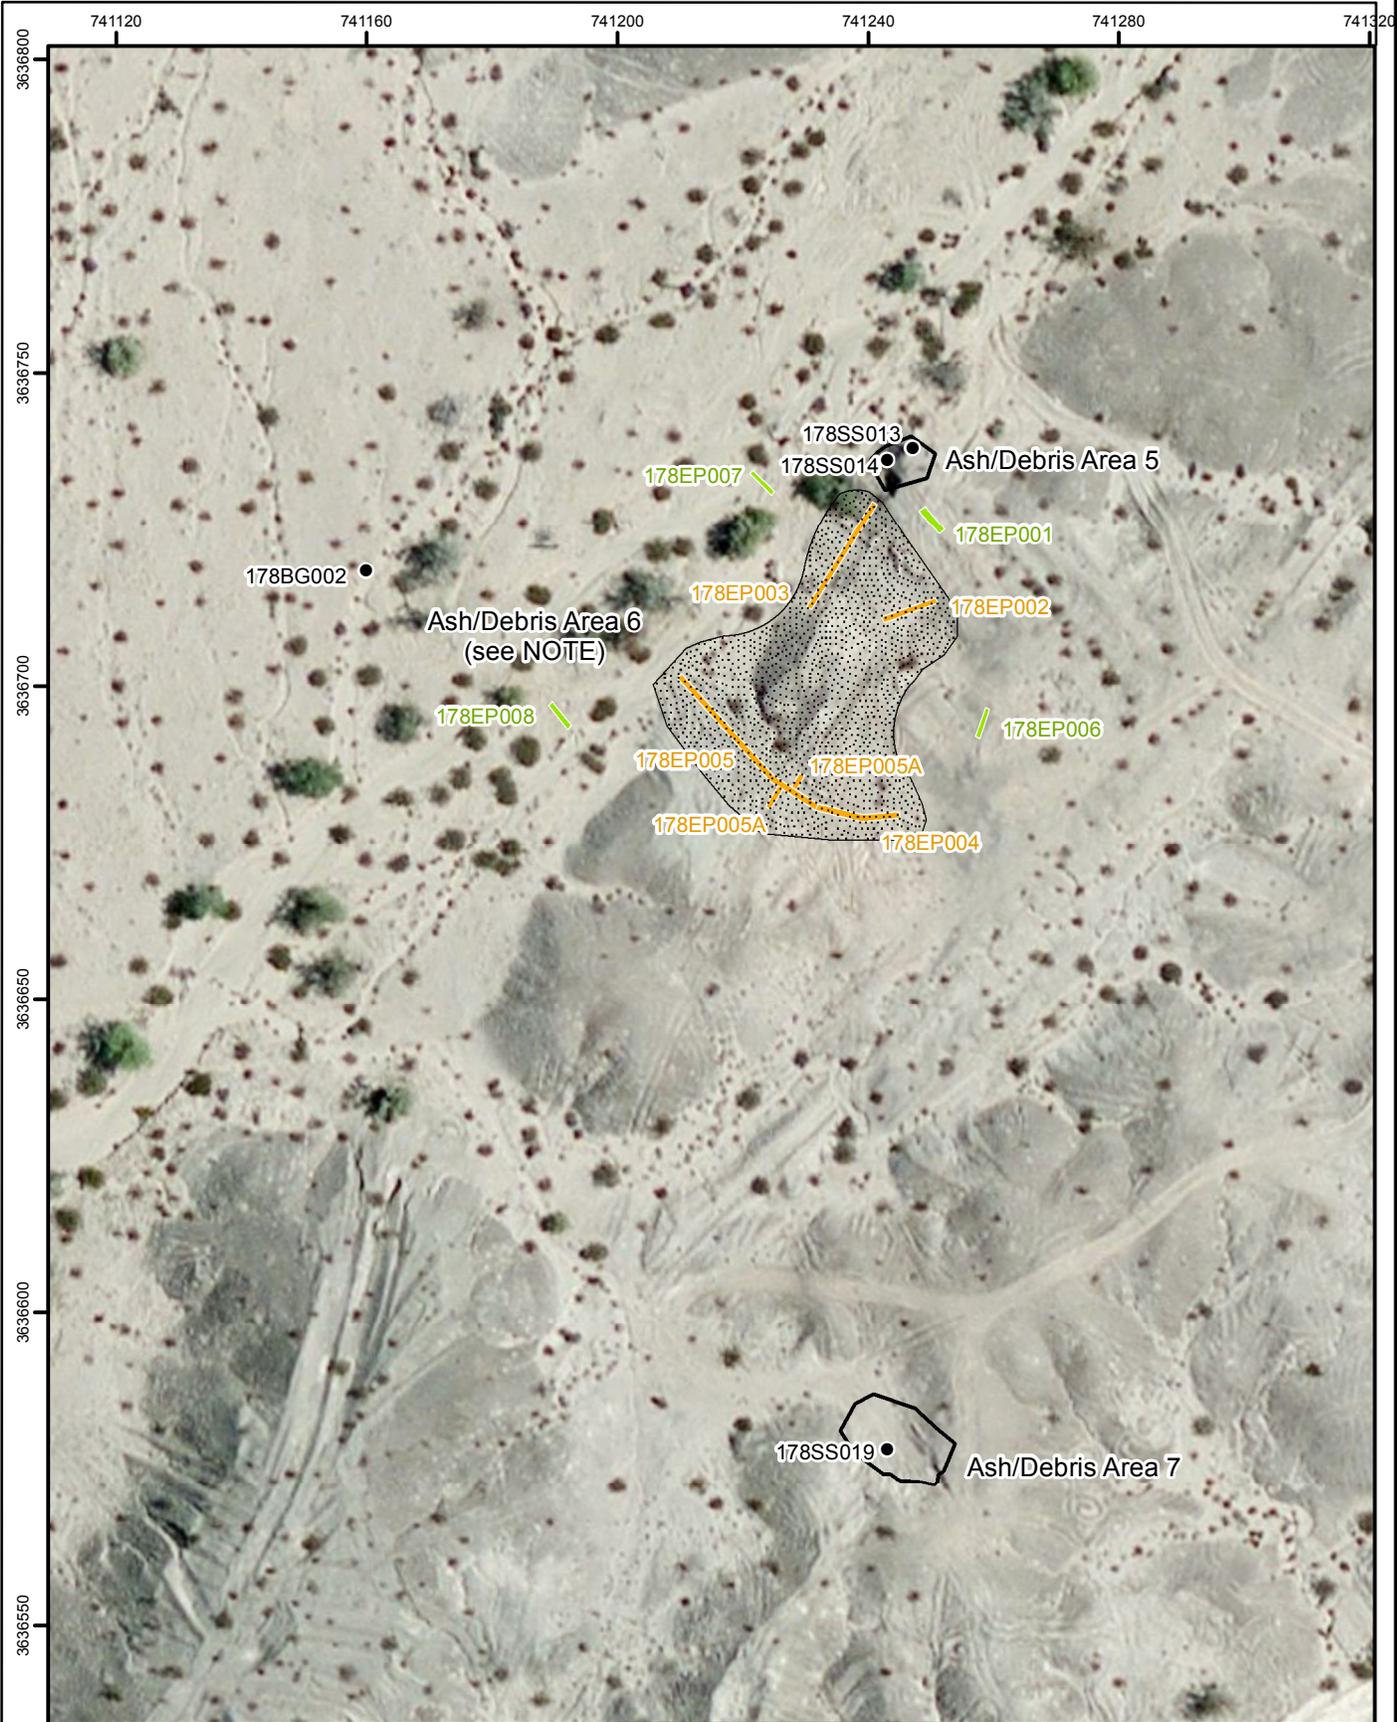
- Surface Soil Sample Location
- Test Pit Containing Waste
- Test Pit Not Containing Waste
- Debris/Ash Removed During November 2009 Removal Action
- Approximate Extent of Buried Debris/Ash
