**RCRA FACILITY INVESTIGATION REPORT FOR
INACTIVE LANDFILL YPG-028
U.S. ARMY GARRISON YUMA PROVING GROUND**

U.S. ARMY GARRISON YUMA PROVING GROUND

August 2012

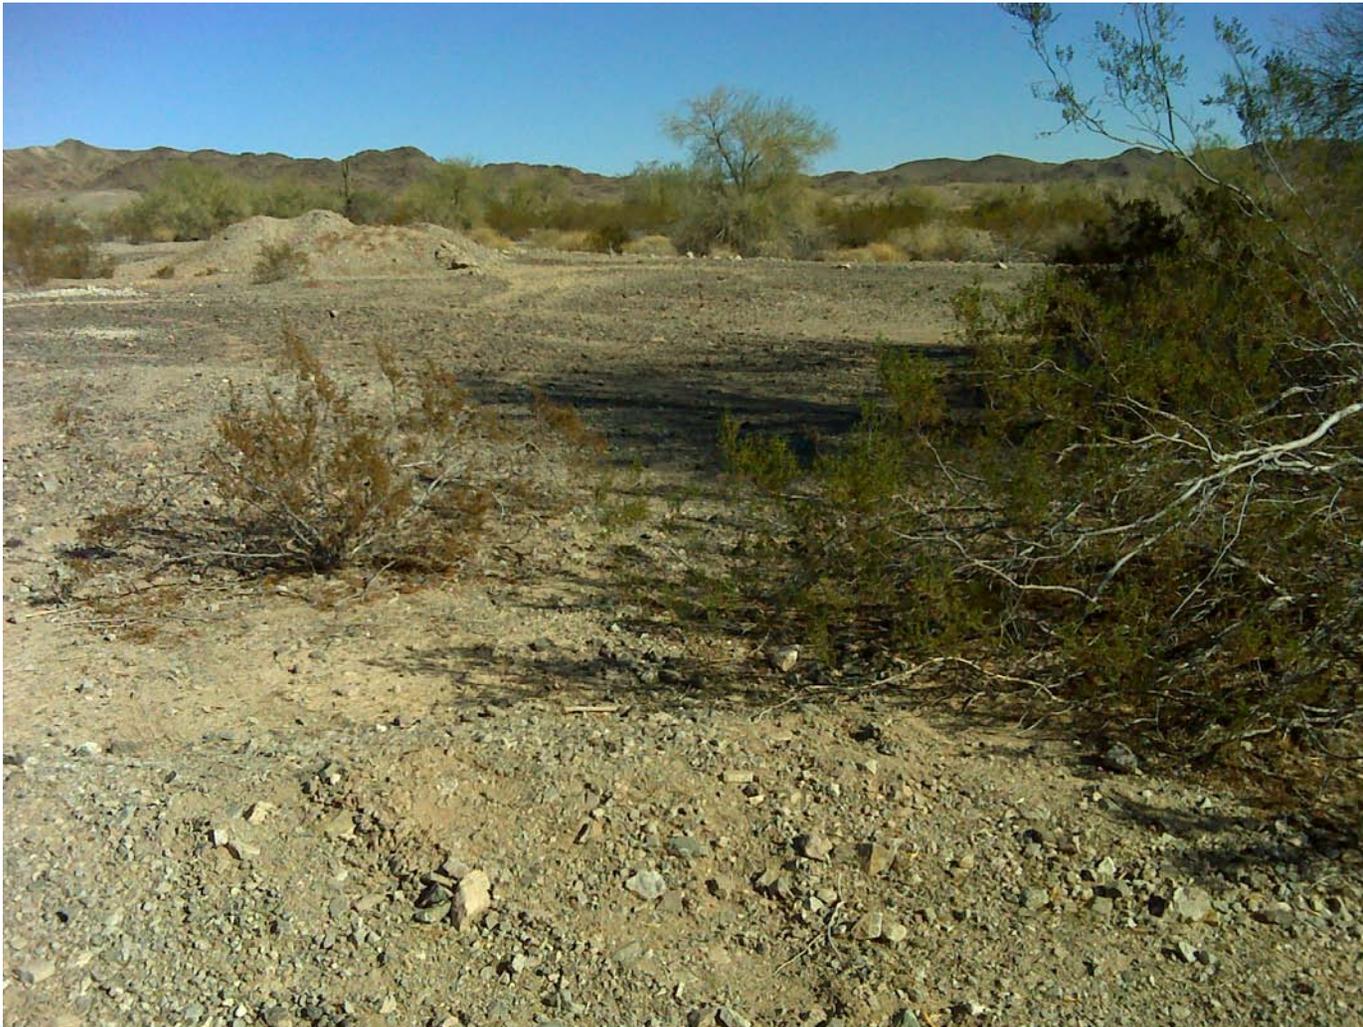
FIGURE 2.3

Inactive Landfill YPG-028

Prior to a surface removal action in November, 2009, scattered pieces of broken glass and rusted metal were present at the site, along with a relatively large, shallow excavation and related soil piles near the northwest corner of the site. A small collapse feature containing visible, partially buried glass and metallic waste was present at the site, which coincided with a metallic geophysical anomaly identified during the previous magnetometer geophysical survey performed at the site (Jason, 2007).

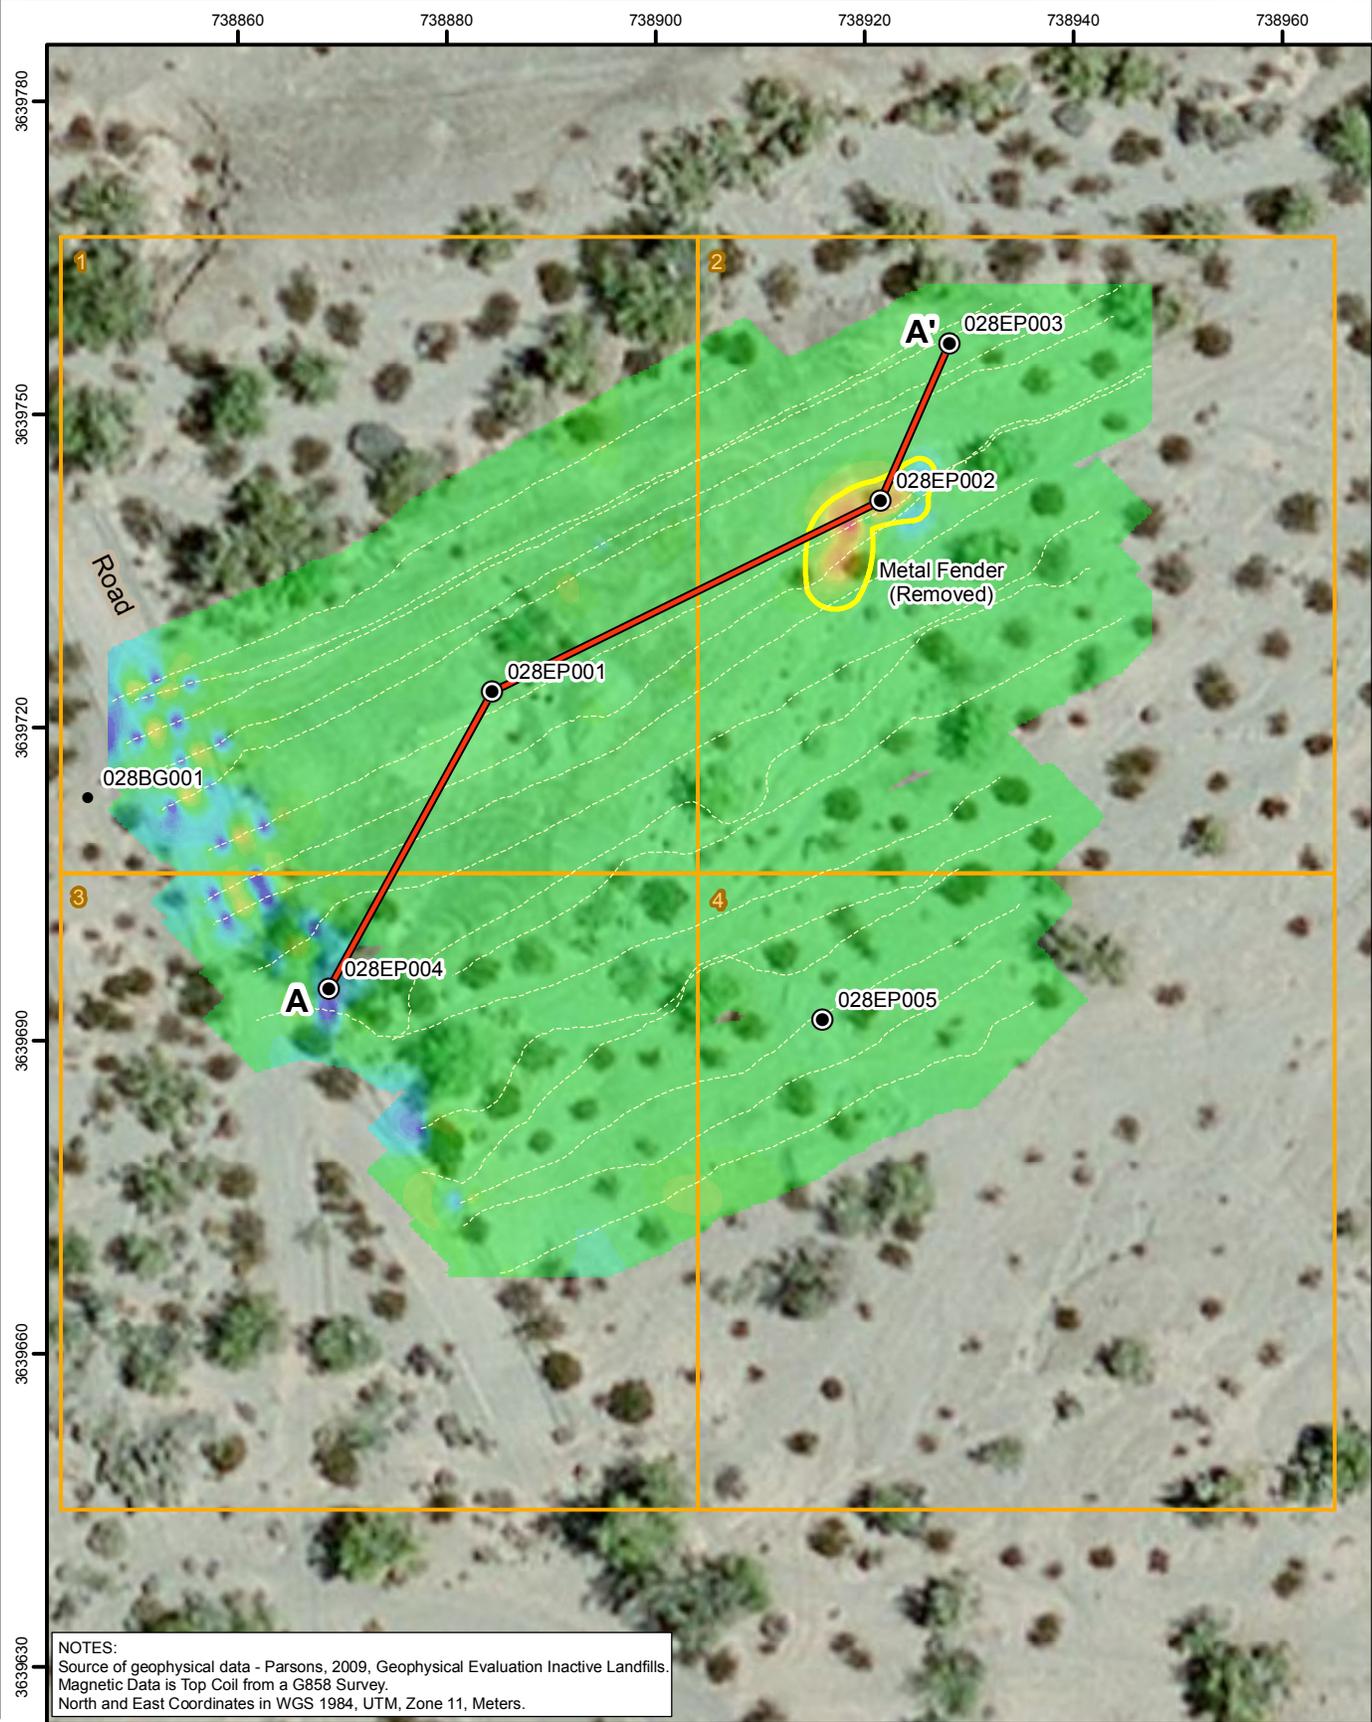
YPG-028
 2009
 MAGNETIC DATA

NOTES:
 Source of geophysical data - Parsons, 2009, Geophysical Evaluation Inactive Landfills.
 Magnetic Data is Top Coil from a G858 Survey.
 North and East Coordinates in WGS 1984, UTM, Zone 11, Meters.

Following the removal action, a geophysical survey was conducted at the site. Results showed that one large anomaly was identified near the area where the fender was previously located. Other smaller anomalies were identified along the road. Visual inspection results show these anomalies are associated with roadside debris and not buried waste. All other areas of the site did not appear to contain buried metal debris.

During the geophysical survey conducted in 2006 (Jason, 2007), a cesium gradiometer magnetometer was used to determine the extent of the metallic buried waste at the abandoned landfill YPG-028. The magnetometer was found to be effective in identifying suspect burial areas. One depression was noted to coincide with metallic anomalies identified during the geophysical survey.

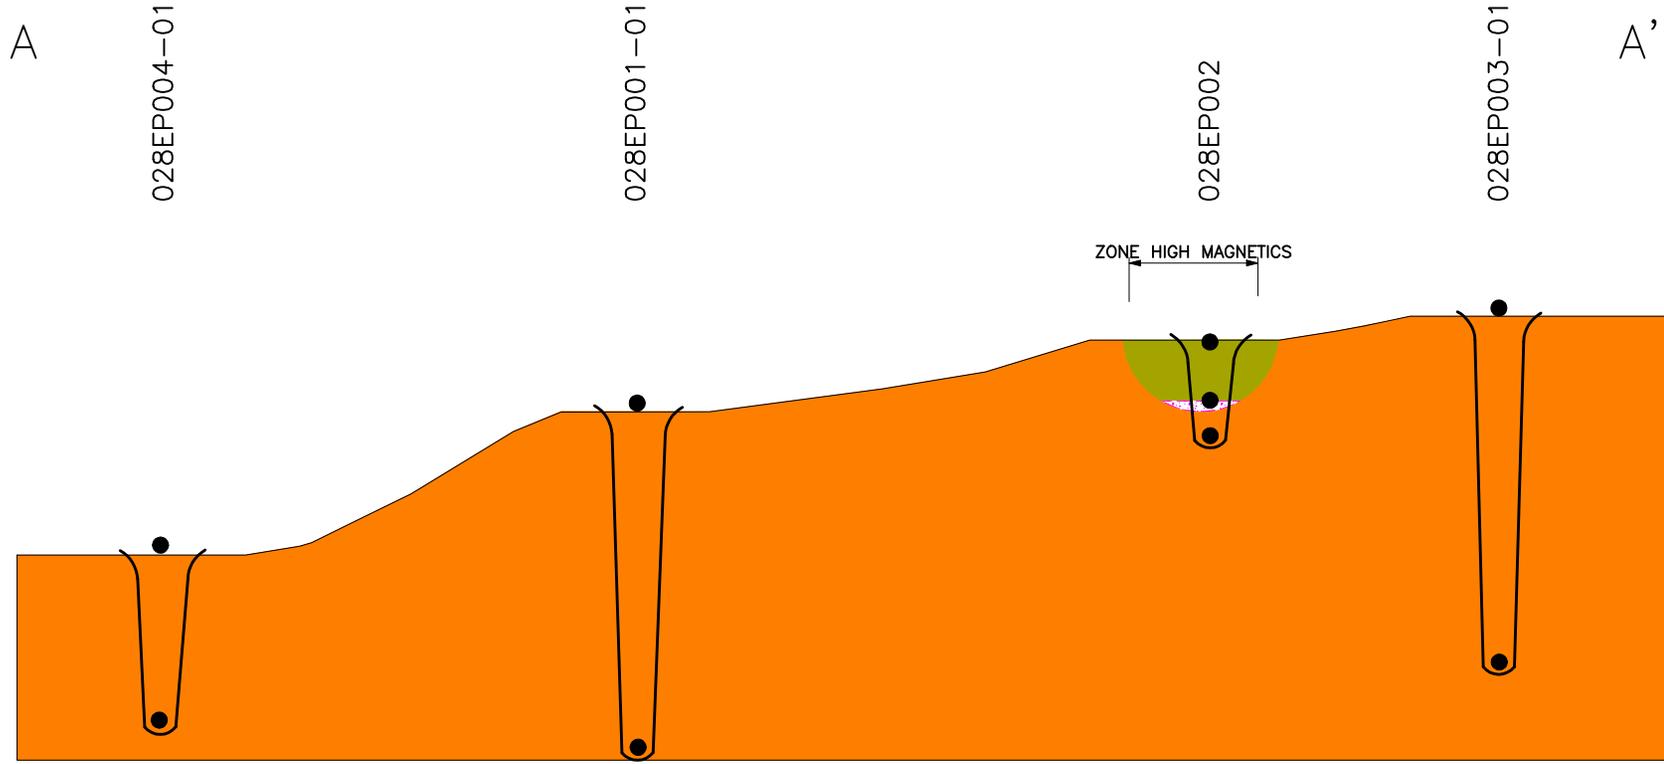
- SAND, silty with gravel
- FILL
- WASTE
- TEST PIT EXCAVATION
- SAMPLE LOCATION

Investigation of the area consisted of excavating five test pits and one additional background test pit. Debris was encountered within one of the five test pits and correlated with the location of the magnetic anomalies identified during the geophysical survey. Debris at this test pit included broken glass, decomposed aluminum, and pieces of concrete.

| Sample Location | Total Depth (ft) | Total Width (ft) | Total Length (ft) | Sample Depth 1 (ft bgs) | Sample Depth 2 (ft bgs) | Sample Depth 3 (ft bgs) | Notes |
|---|---|---|---|---|---|---|--|
| 028EP002 | 4.5 | 2.67 | 12 | 0-0.5 | 2.5-3 | 4-4.5 | Waste present from 2.5 to 3 ft bgs; waste consisted of decomposed aluminum, broken glass, and concrete pieces. |
