YPG-029

RESPONSE TO COMMENTS ON DRAFT FINAL VERSION OF RFI REPORT
DATED NOVEMBER 2011

**RCRA FACILITY INVESTIGATION REPORT FOR
INACTIVE LANDFILL YPG-029
U.S. ARMY GARRISON YUMA PROVING
GROUND**

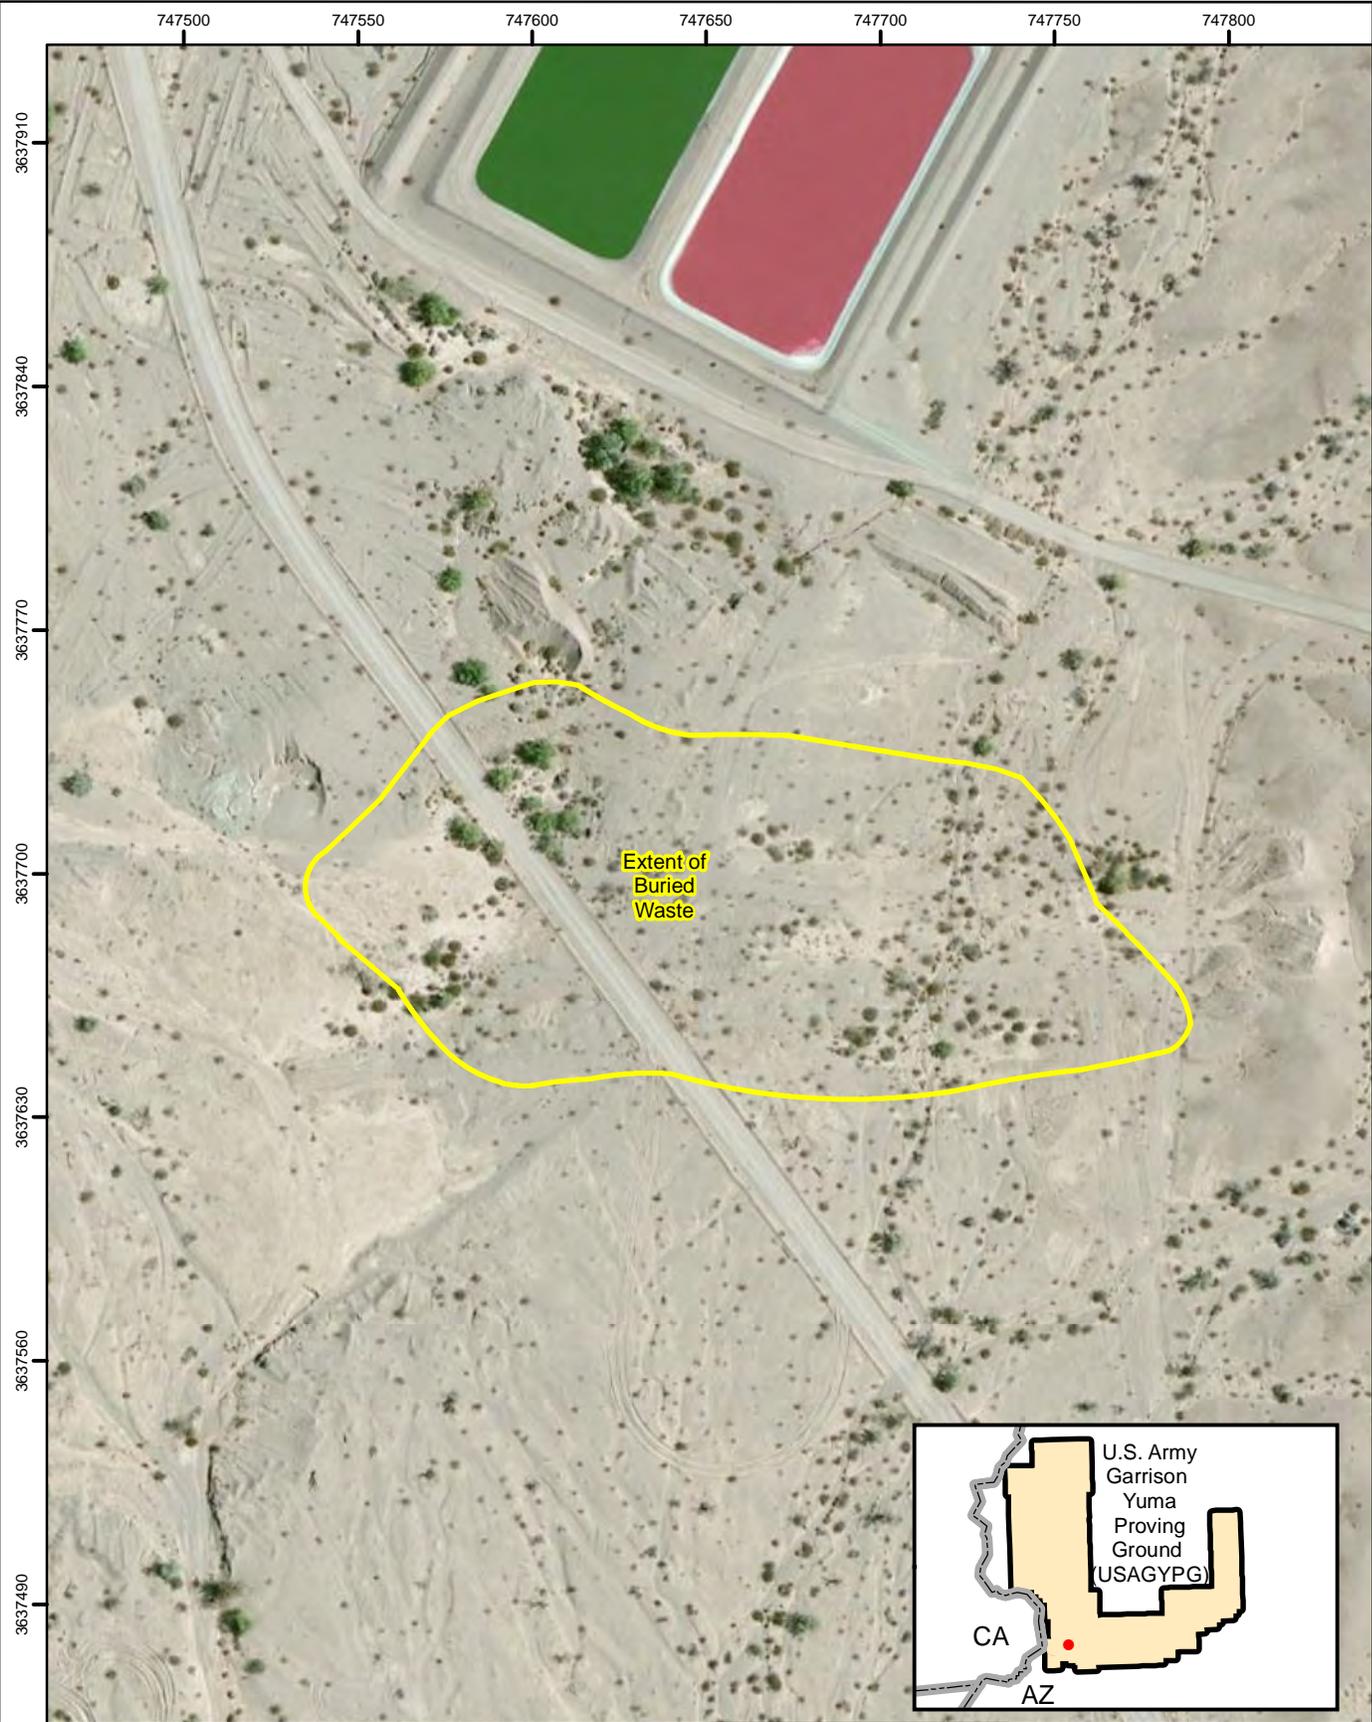
YPG-029
SITE MAP

Extent of Buried Waste

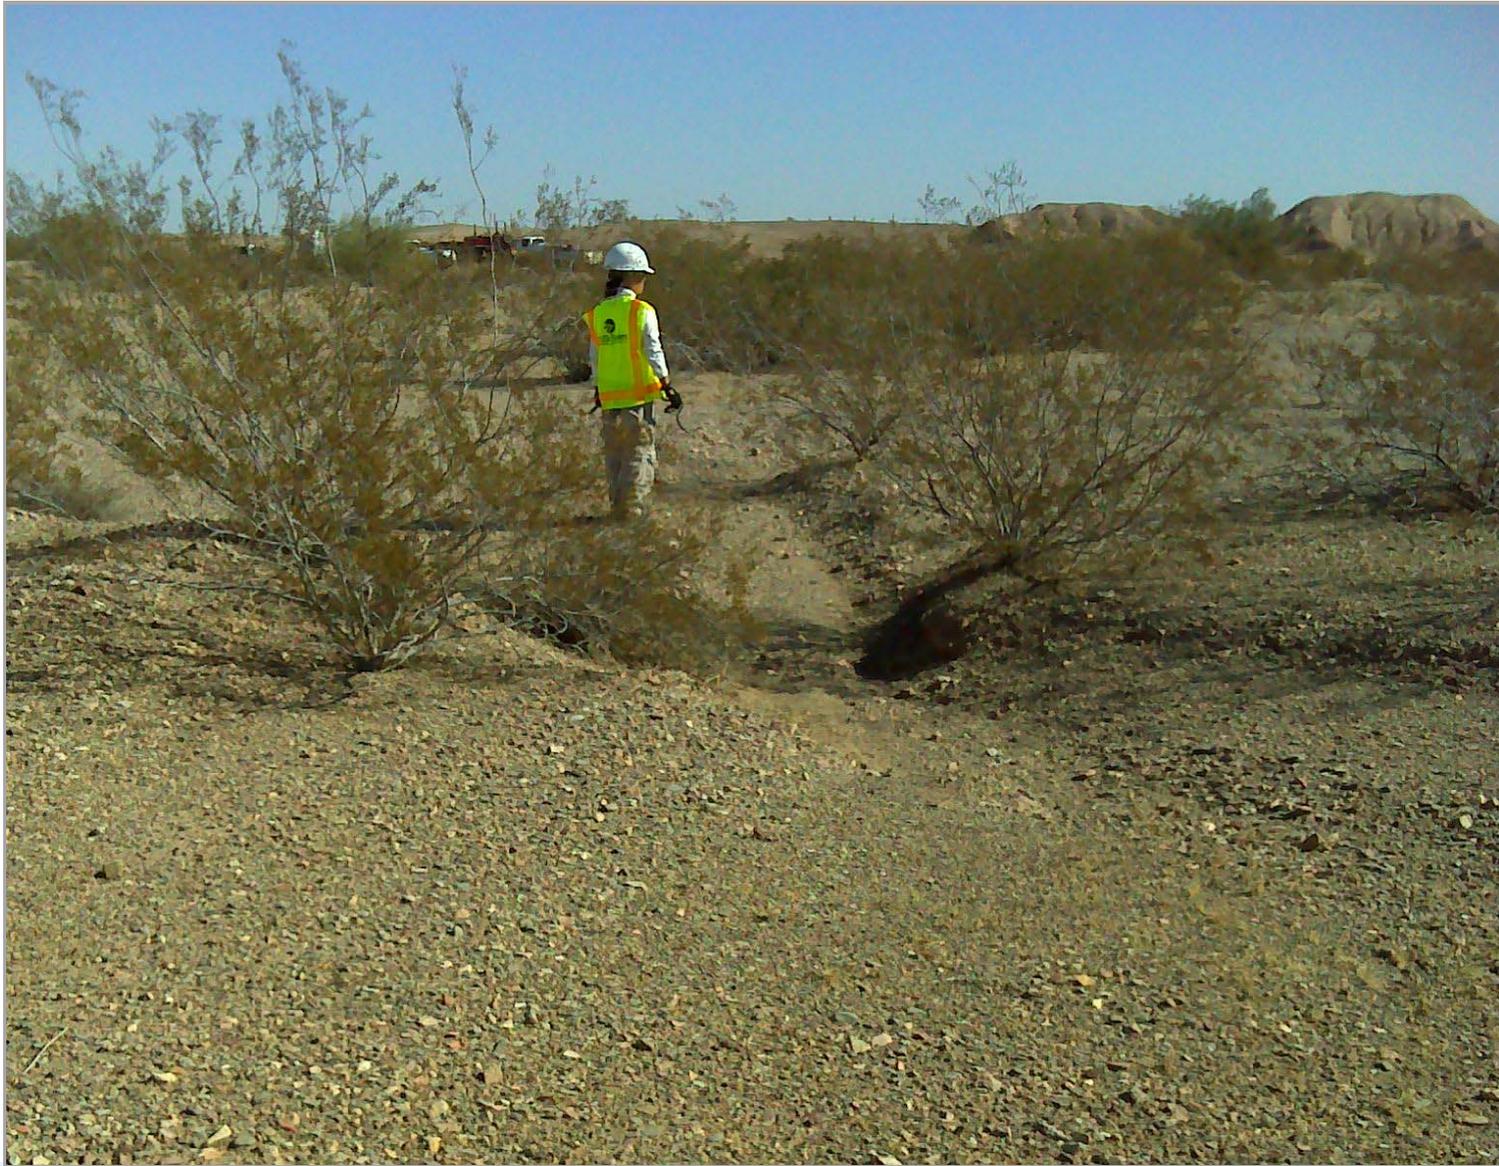
Inactive Landfill YPG-029

Much of the site has been disturbed by past landfill disposal activities and has little to no vegetation (Figure 2.3). In the undisturbed parts of the site, there are scattered small bushes and trees, including bursage, creosote, and paloverde. The site is relatively flat with depressions (i.e., sinkholes) located in the south central region of the landfill. Surface debris, including broken glass, metal, and a metal box, were removed in November 2009 (Parsons, 2010).

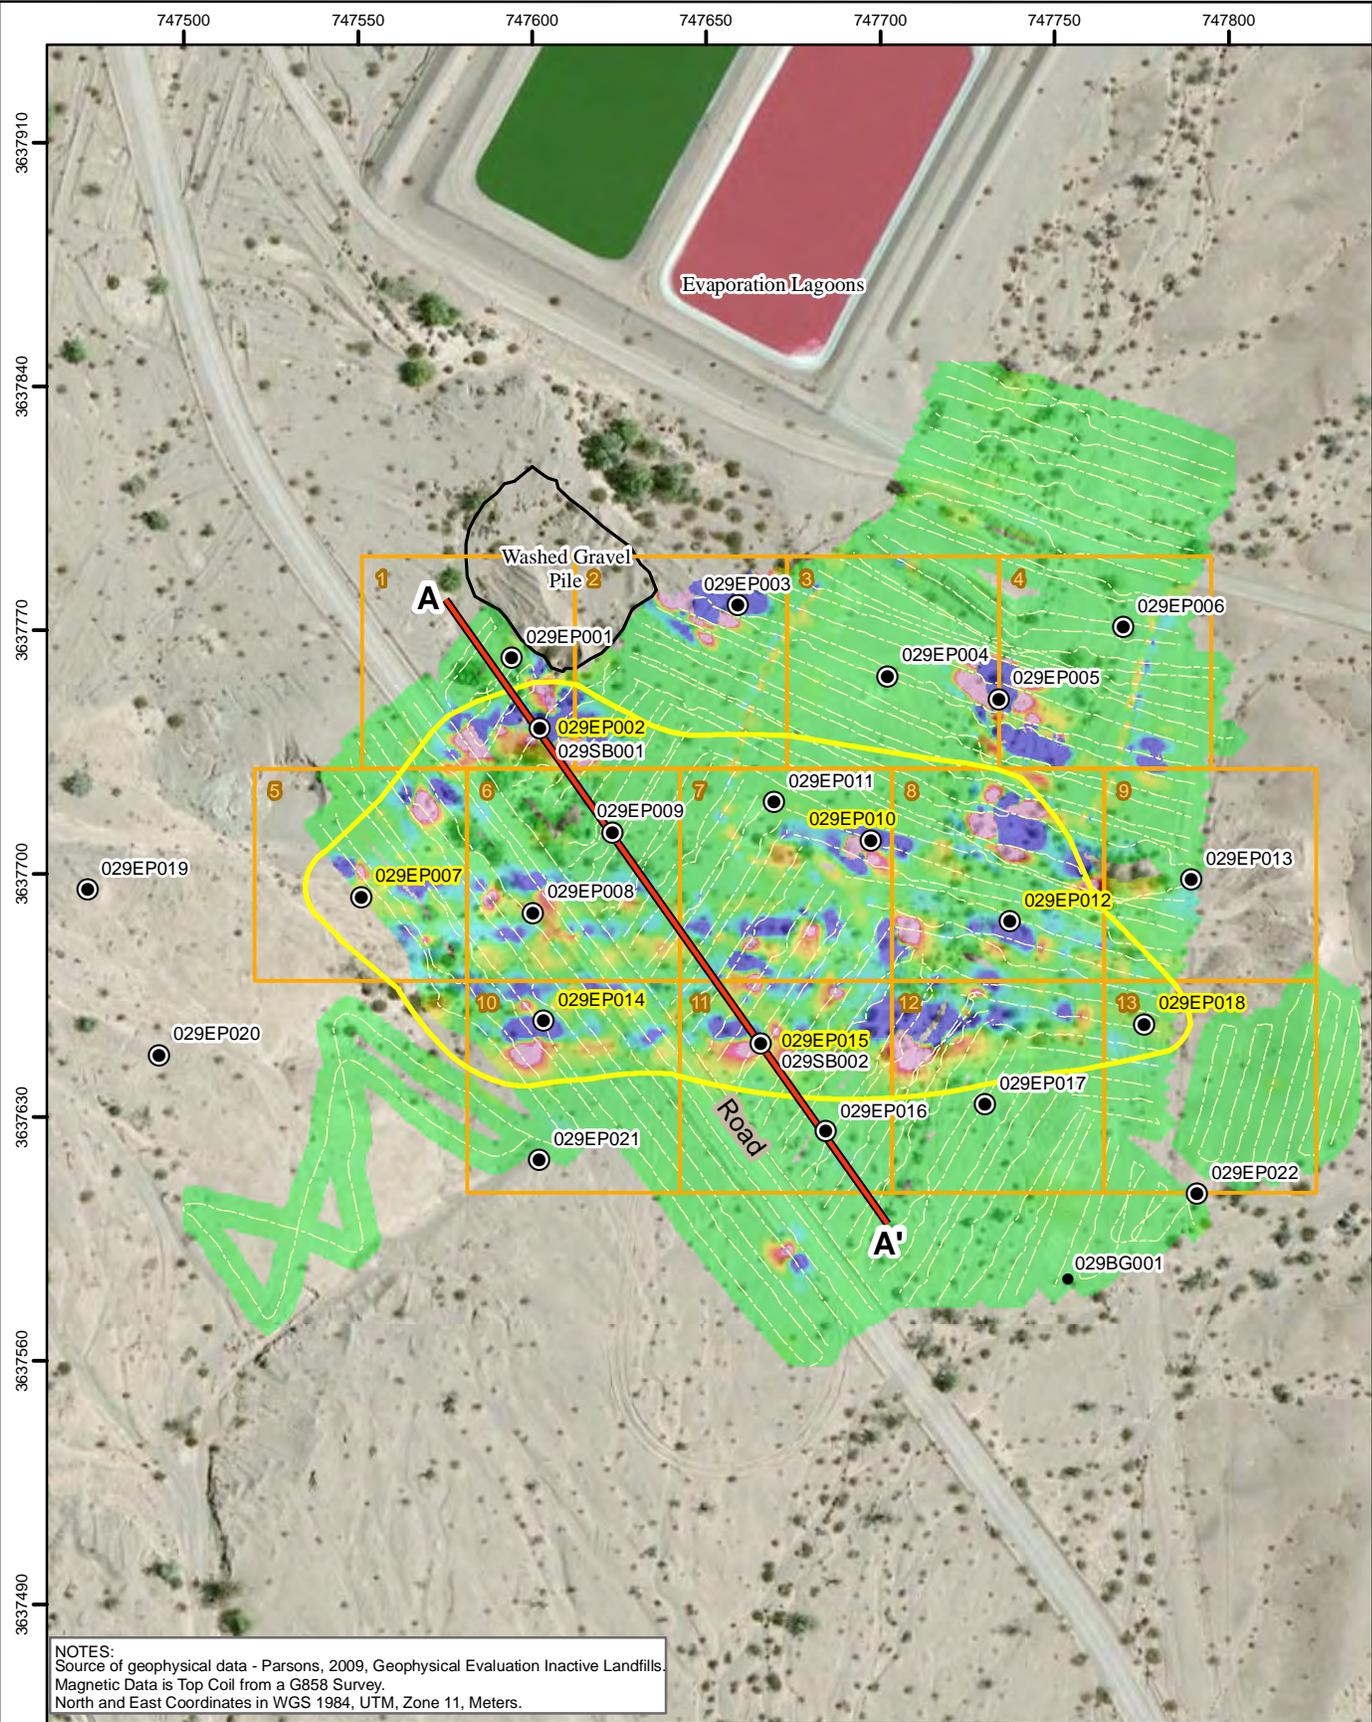
FIGURE 4.1
 YPG-029
 GEOPHYSICAL
 SURVEY RESULTS
 U.S. Army Garrison
 Yuma Proving Ground

A magnetometer G-858 geophysical survey was conducted on the site following the surface debris removal. The G-858 was also used for the previous magnetic geophysical survey (Jason, 2007). Geophysical results show linear magnetic anomalies extending east to west across the center of the site that may indicate the shallow burial of metal debris (Figure 4.1). These anomalies also coincide with a series of depressions observed during the surface debris removal action. Based on the geophysical survey, it is unlikely that there is significant metal debris buried in the north and south end of the site. A dirt road runs through the southwest corner of the site, which appears to have been constructed after the landfill was closed. This is based on the presence of geophysical anomalies present beneath and on either side of the road. This road is used for ongoing training and is regraded as needed.

NOTES:
 Source of geophysical data - Parsons, 2009, Geophysical Evaluation Inactive Landfills.
 Magnetic Data is Top Coil from a G858 Survey.
 North and East Coordinates in WGS 1984, UTM, Zone 11, Meters.

Test pit locations were selected following the general strategy outlined in the RFI Work Plan (Parsons, 2010). Based on the results of geophysical survey (Section 4.1.2), the area of YPG-029 was divided into thirteen 200 ft by 200 ft grids, and one or two biased test pits were excavated within each grid cell (Figure 4.1). Eight test pits (029EP002, 029EP003, 029EP005, 029EP008, 029EP010, 029EP012, 029EP014, and 029EP015) were excavated at the locations of linear dipole magnetic anomalies found

of the landfill. Once the surface was cleared, a post-removal geophysical survey was conducted to obtain additional information about the potential locations of subsurface debris. The geophysics indicated a shallow burial area extending east to west across the site, and no significant buried metallic waste on the north and south ends of the site. Investigation of the area consisted of excavating 22 test pits and one additional test pit used to represent background conditions. Debris was encountered within seven of these pits and correlated with the location of geophysical anomalous zones. Debris identified within the test pits included glass and plastic bottles, wood, metal banding, small pieces of tar, metal pipe, aluminum cans, Styrofoam™ cups, food packaging, children's toys, clothing items, and a 1959 Arizona license plate. Each test pit excavation was supervised by UXO technicians who visually inspected the material for evidence of munition debris. No evidence of munition debris was identified during the excavations.

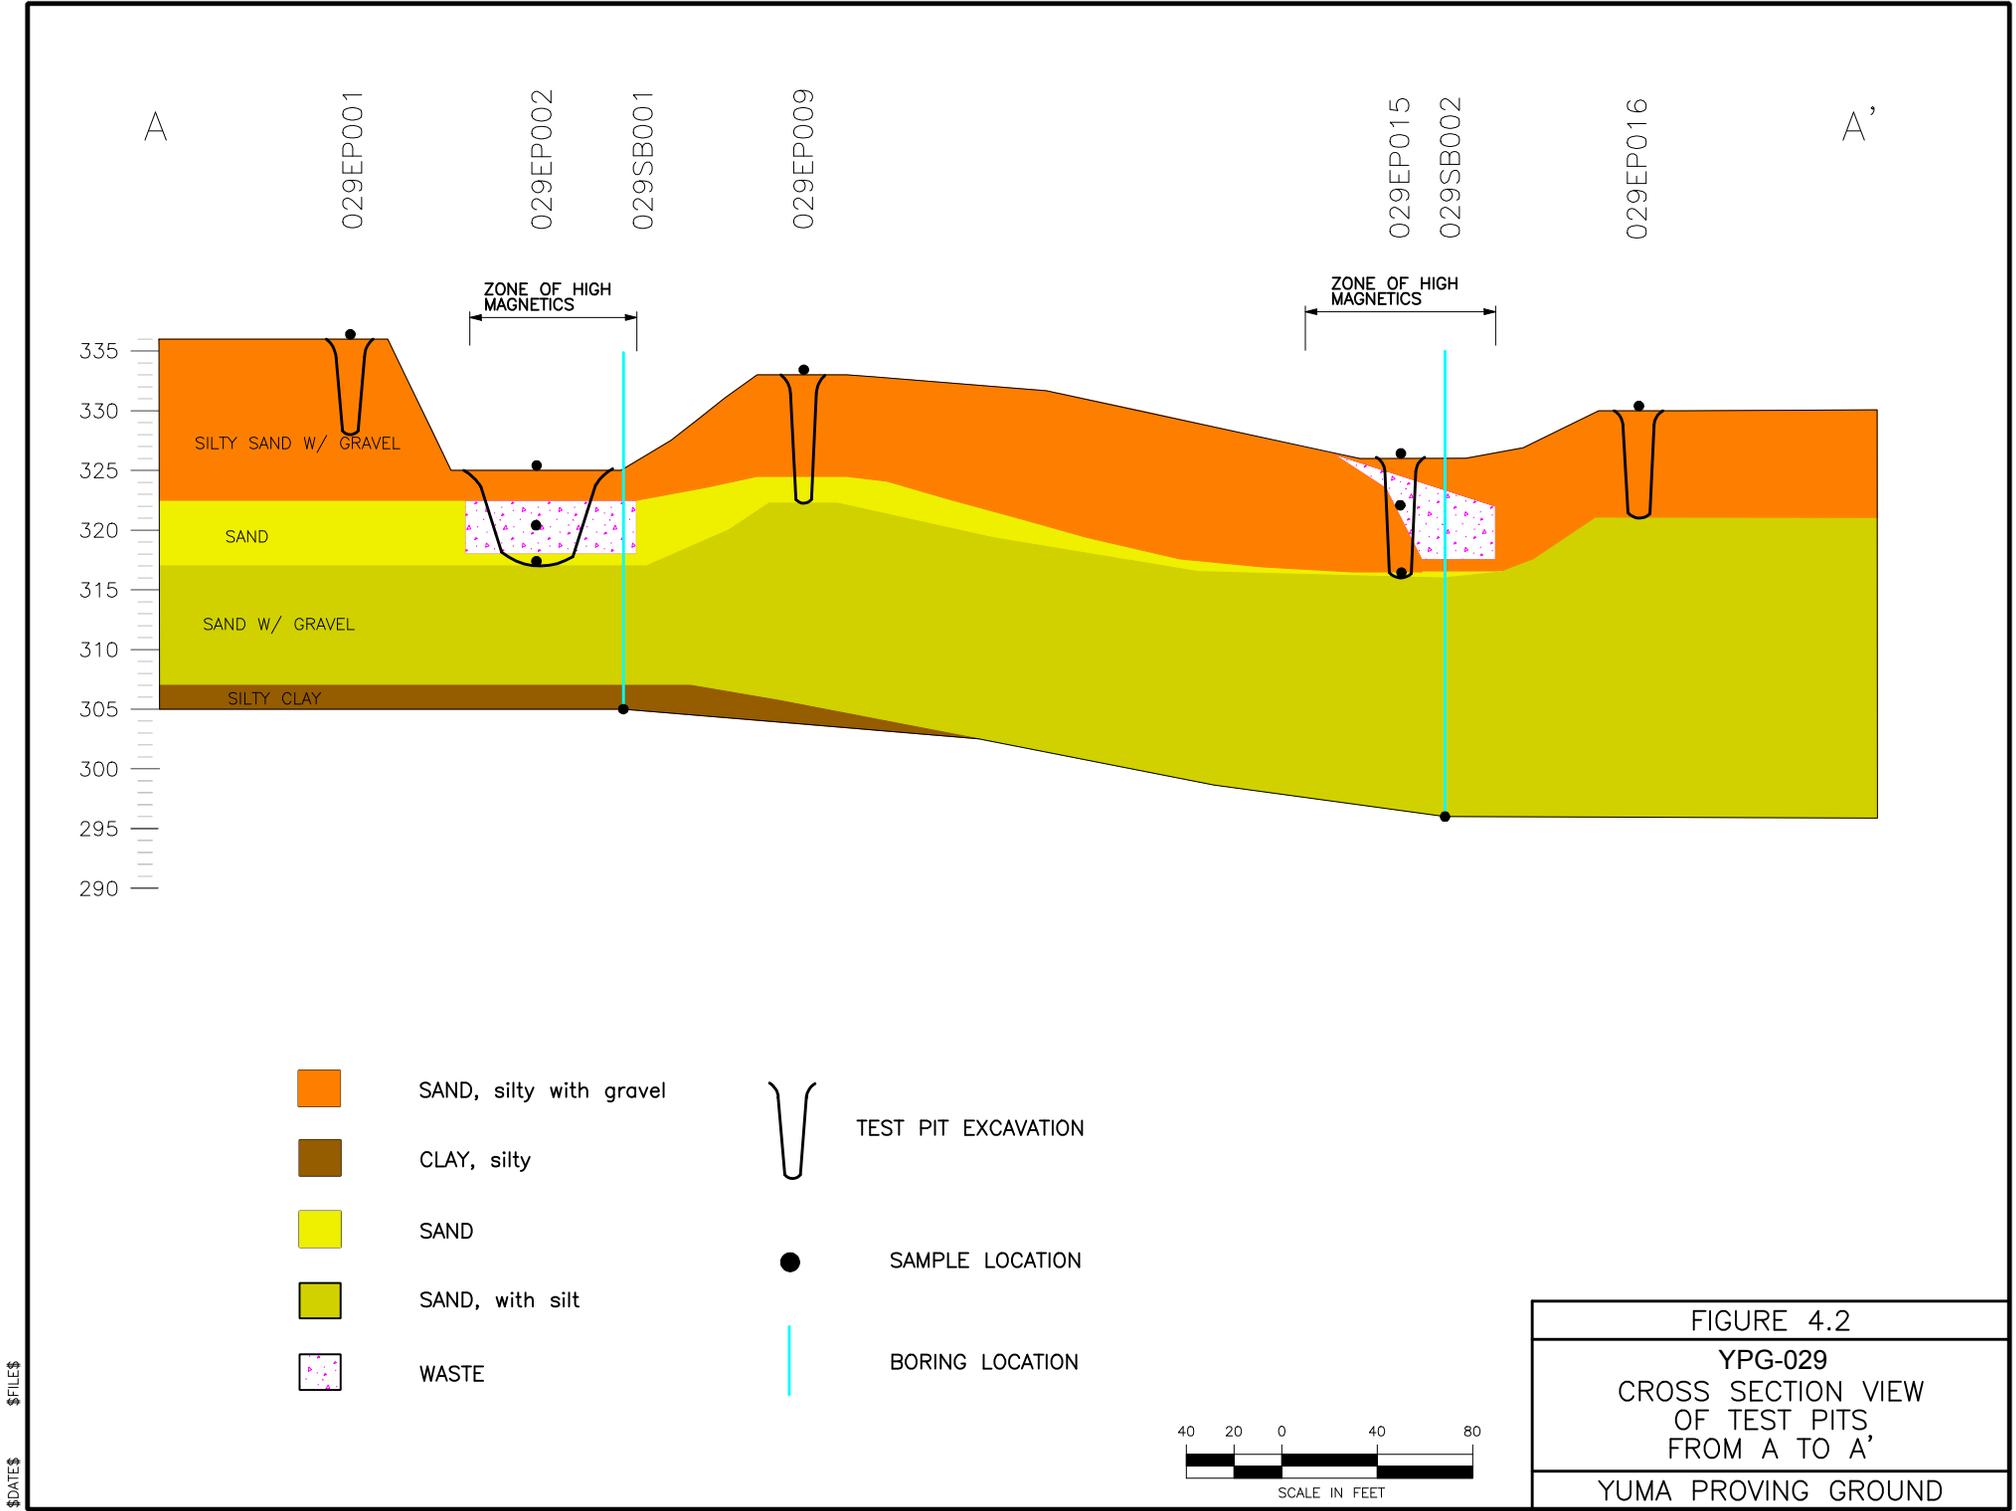
FIGURE 4.2
YPG-029
CROSS SECTION VIEW OF TEST PITS FROM A TO A'
YUMA PROVING GROUND

Two soil borings were completed adjacent to two test pits excavated where waste was encountered to define the vertical extent of contamination and determine if waste extended beyond the vertical boundary of the landfill. Each soil boring was completed to a depth of 30 feet past the bottom of the adjacent test pit excavation. Debris was not found in either boring past the bottom of the adjacent test pit. Split spoon samples were collected from the borings to retain as much of the in-place texture as possible. Soil samples appeared to contain the original layered texture and are believed to be native. The lack of any additional waste and the presence of the original soil layering indicate that the landfill burial was probably a cut and fill operation. A dozer was probably used

to cut a long linear trench and debris was buried in the trench and either burned or soil was pushed over the trench. This type of disposal operation was common for small landfill sites operating during the 1950-1960 time-frame.

Based on geophysical data, waste was not expected to be found in test pits 029EP007 and 029EP018; however, during the excavation waste was encountered between 2-7 ft bgs at 029EP007 and between 1-5 ft bgs at 029EP018. The thickness of waste did not extend the entire length of 029EP018 and had a maximum thickness of four feet in the center of the test pit and rapidly thinned to the south end of the pit. No waste was present in the south end of the pit. Since waste was encountered at these locations additional test pits were added to the program to delineate the horizontal extent of waste and define the boundaries of the landfill. Test pits 029EP019 and 029EP020 were added to define the western boundary of the landfill due to the waste encountered at 029EP007. No waste was found in these two step-out test pits. Two additional step-out test pits (029EP021 and 029EP022) were added to define the southern boundary of the landfill due to waste found within 029EP014 and 029EP018.
