**Phoenix-Goodyear Airport (PGA) Area/Western Avenue Plume
Community Advisory Group (CAG) Meeting**

**Thursday, May 7, 2009 at 6:30 p.m.
Avondale City Hall, Mojave Room
11465 W. Civic Center Drive, Avondale, AZ 85323**

FINAL MINUTES

Phoenix-Goodyear Airport-North (PGA-North) Superfund Site

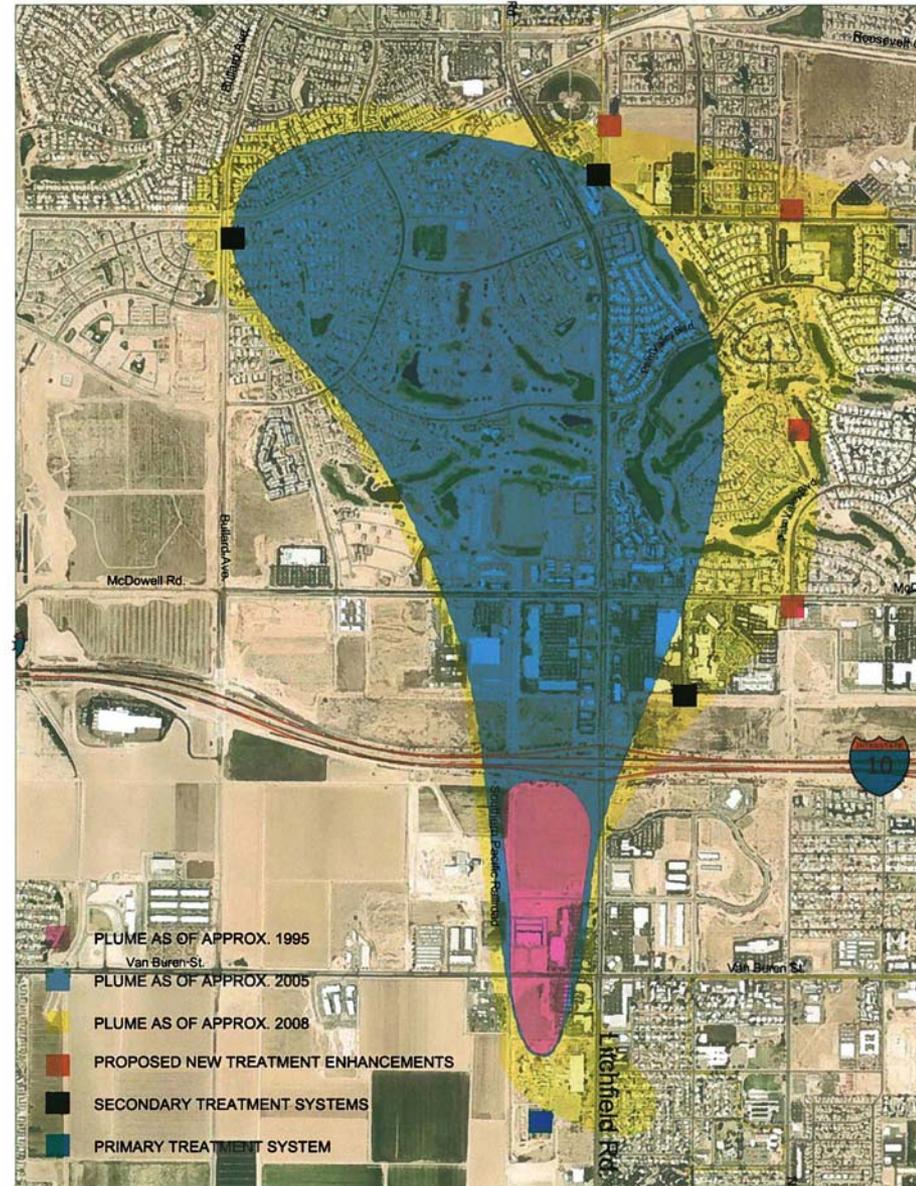
The Groundwater Plume

- Pink** – Approx. Plume in 1995.
- Blue** – Approx. Plume in 2005.
- Yellow** – Approx. Plume in 2008.

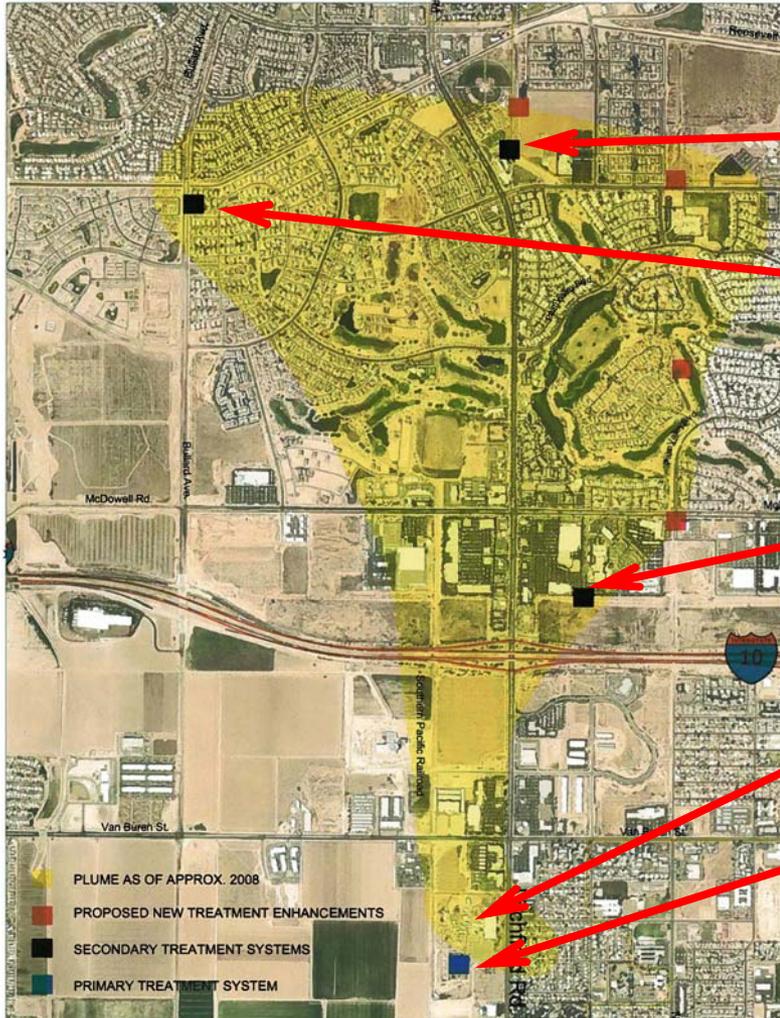
Existing Treatment Systems

EA-06 Groundwater Treatment System

33A Groundwater Treatment System

EA-05 Groundwater Treatment System

Soil Vapor Extraction System

Main Groundwater Treatment System

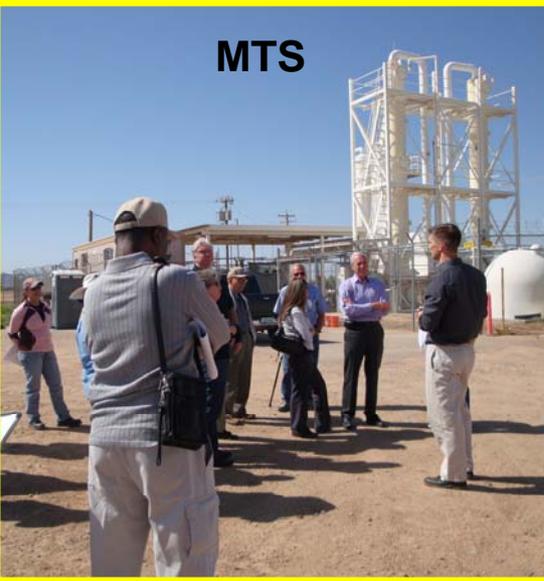
Groundwater Treatment Systems

Main Treatment System

- Built in 1994
- 7 Ext. Wells, 6 Inj. Wells
- 600 GPM
- Volume of Water Treated
 - > 6.25 billion gallons
- Mass Contaminant removed
 - ~ 28,500 pounds

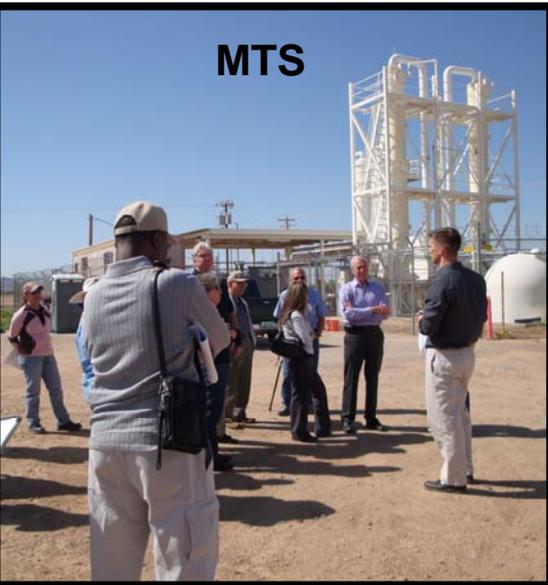
Groundwater Treatment Systems

33A

- Operating Since 1997
- 1 Ext Well, clean water to RID Canal
- 750 GPM
- Volume of Water Treated
 - >4.3 Billion Gallons
- Mass Contaminant removed
 - ~ 7,720 pounds

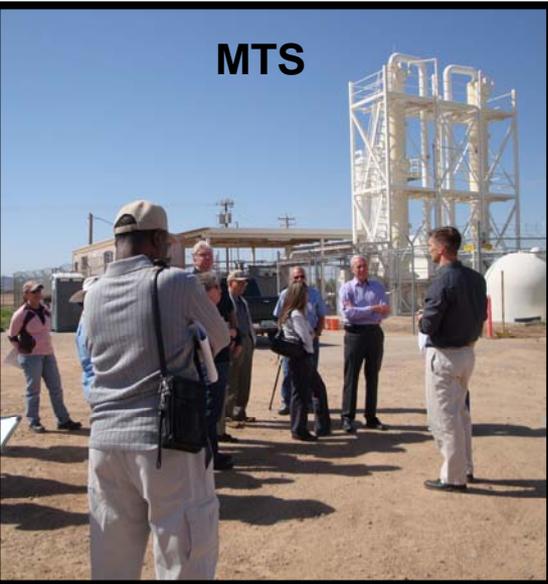
Groundwater Treatment Systems

EA-05

- Operating Since March 2008
- 1 Ext. Well, 1 Inj. Well
- 500 GPM
- Volume of Water Treated
 - 200 million gallons
- Mass Contaminant removed
 - ~ 70 pounds

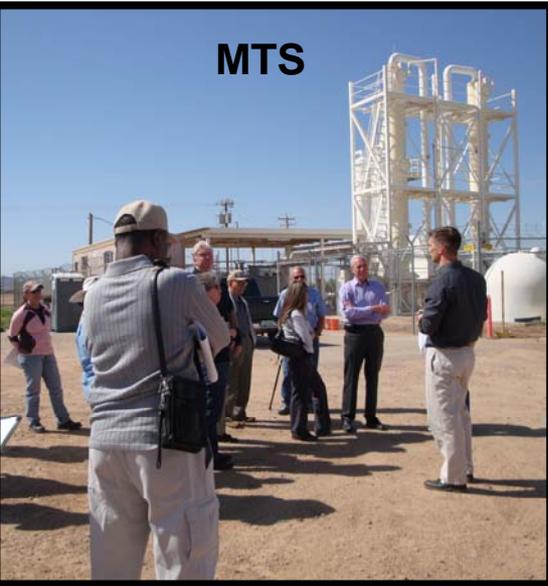
Groundwater Treatment Systems

EA-06

- Operating Since Jan. 2008
- 1 Ext Well, clean water to RID Canal
- 550 GPM
- Volume of Water Treated
 - ~ 220 Million Gallons
- Mass Contaminant removed
 - ~ 168 pounds

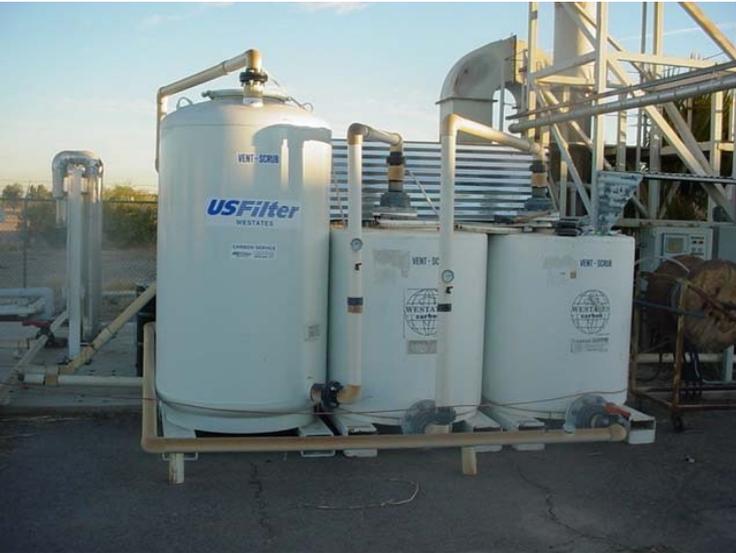
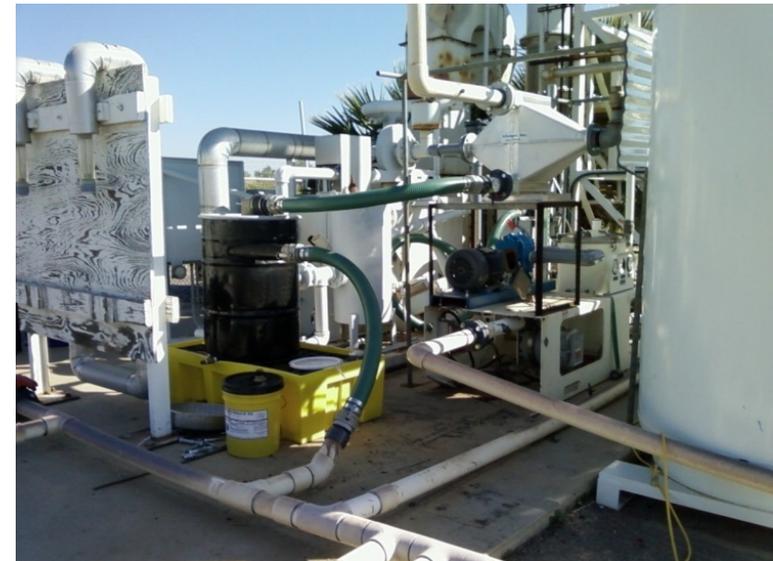
Soil Vapor Extraction

- Extraction and treatment of volatile organic compounds from the on-site soils
- Originally installed in 1996 Restarted in 2004
- Results of upcoming Soil Gas Investigation
- May result in modifications to increase capacity

- Carbon filters for vapor treatment
- 9 - Vapor Extraction wells
- 15 - Vapor Monitor wells
- >12,000 lbs of contaminants removed

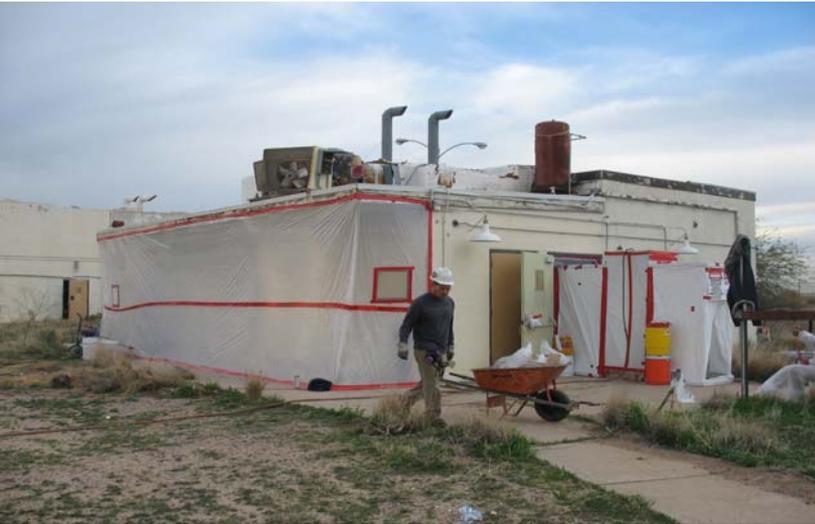
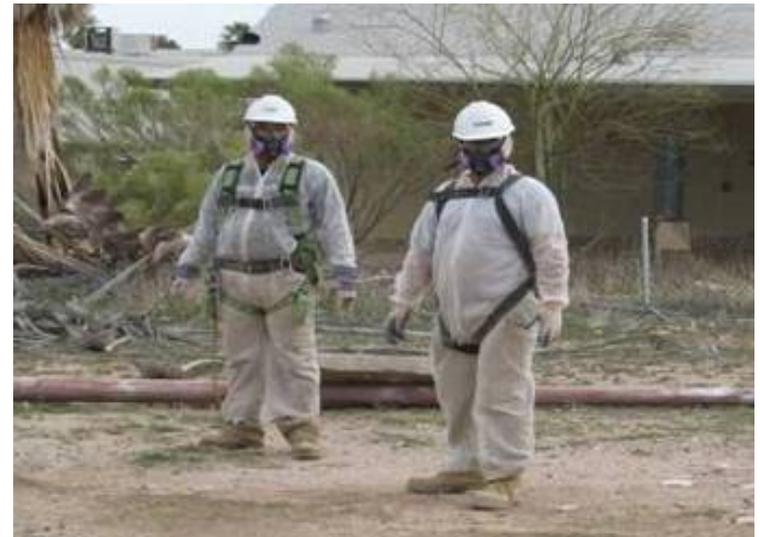
Demolition Asbestos Abatement

Abatement in progress under negative pressure.

Indoor air released to the atmosphere after treating using HEPA filter.

Viewing window is provided to observed on-going activities.

Protective gear includes hard hat, steel toe boots, respirator, and safety harness if working on the roof

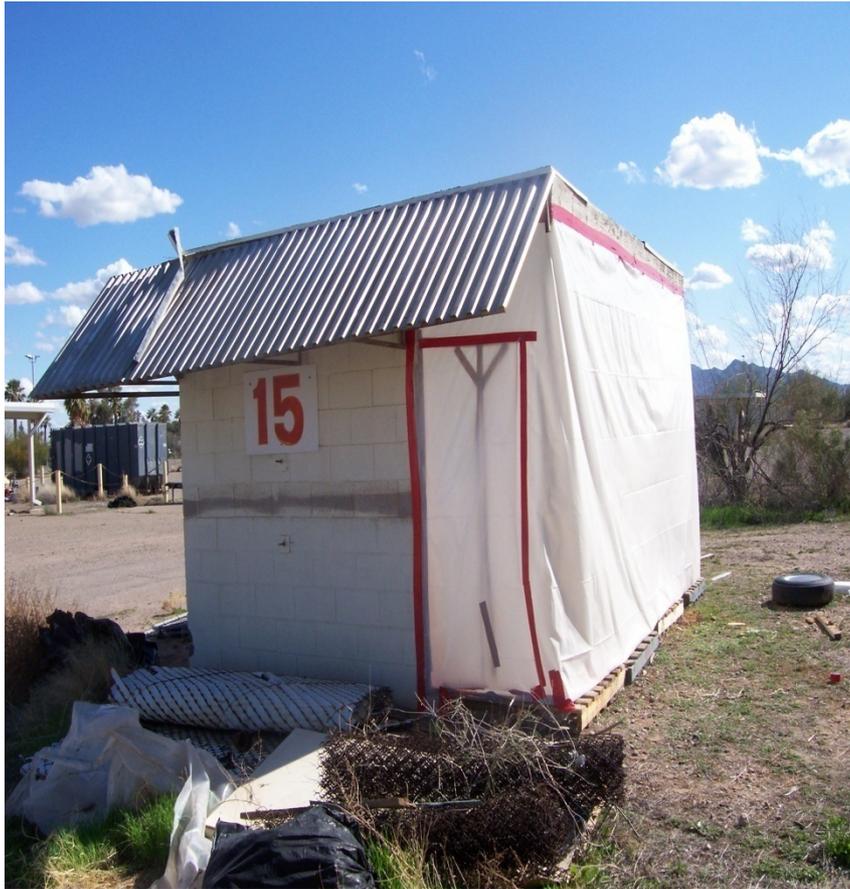
Before Abatement

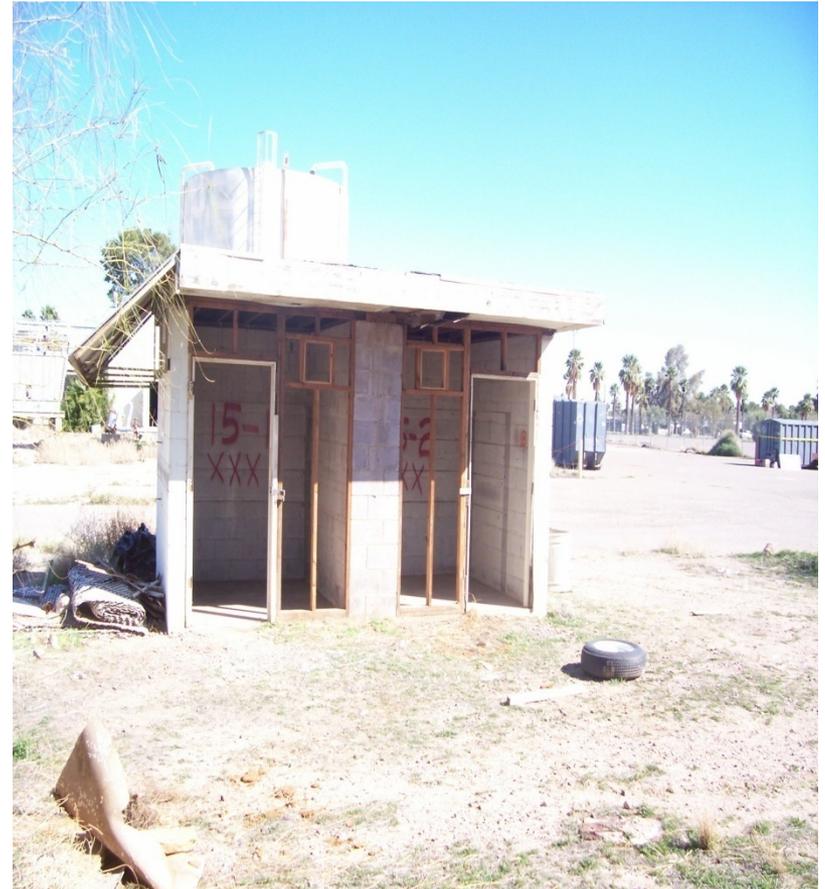
After Abatement

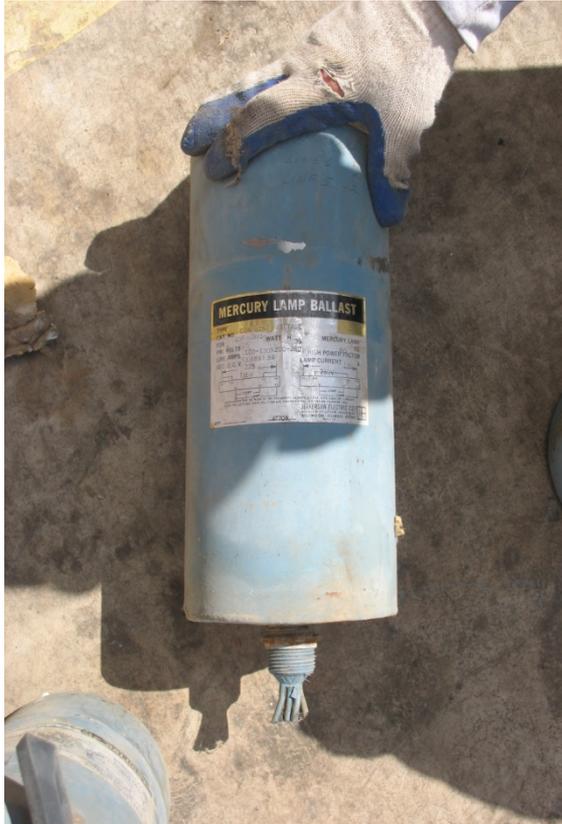
Ballast containing
Mercury

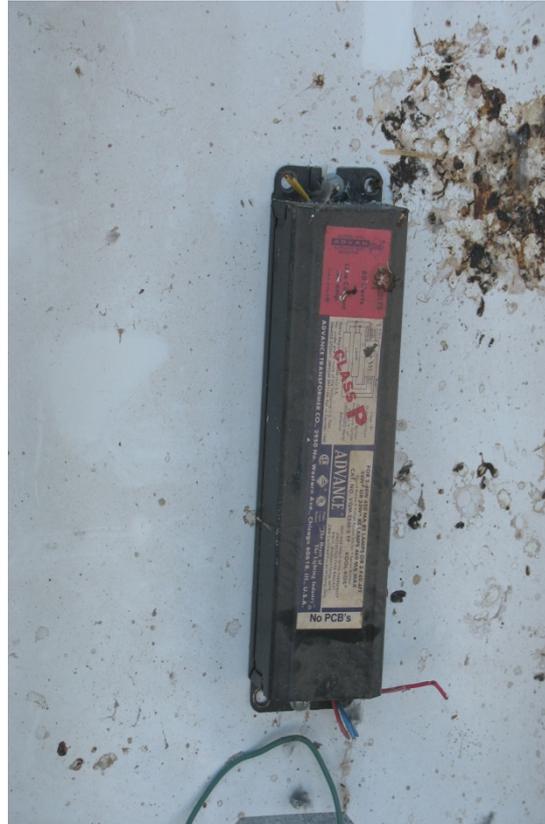
Ballast potentially
containing PCBs

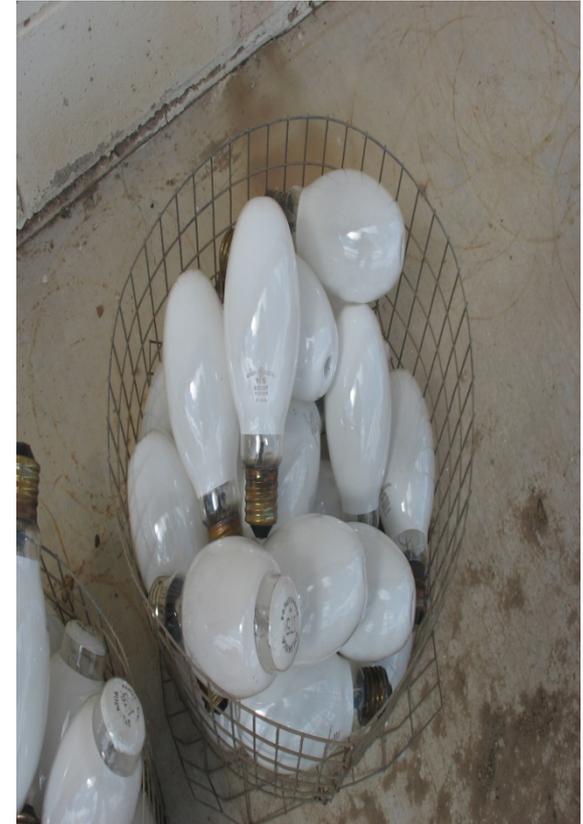
Lamps containing
Mercury

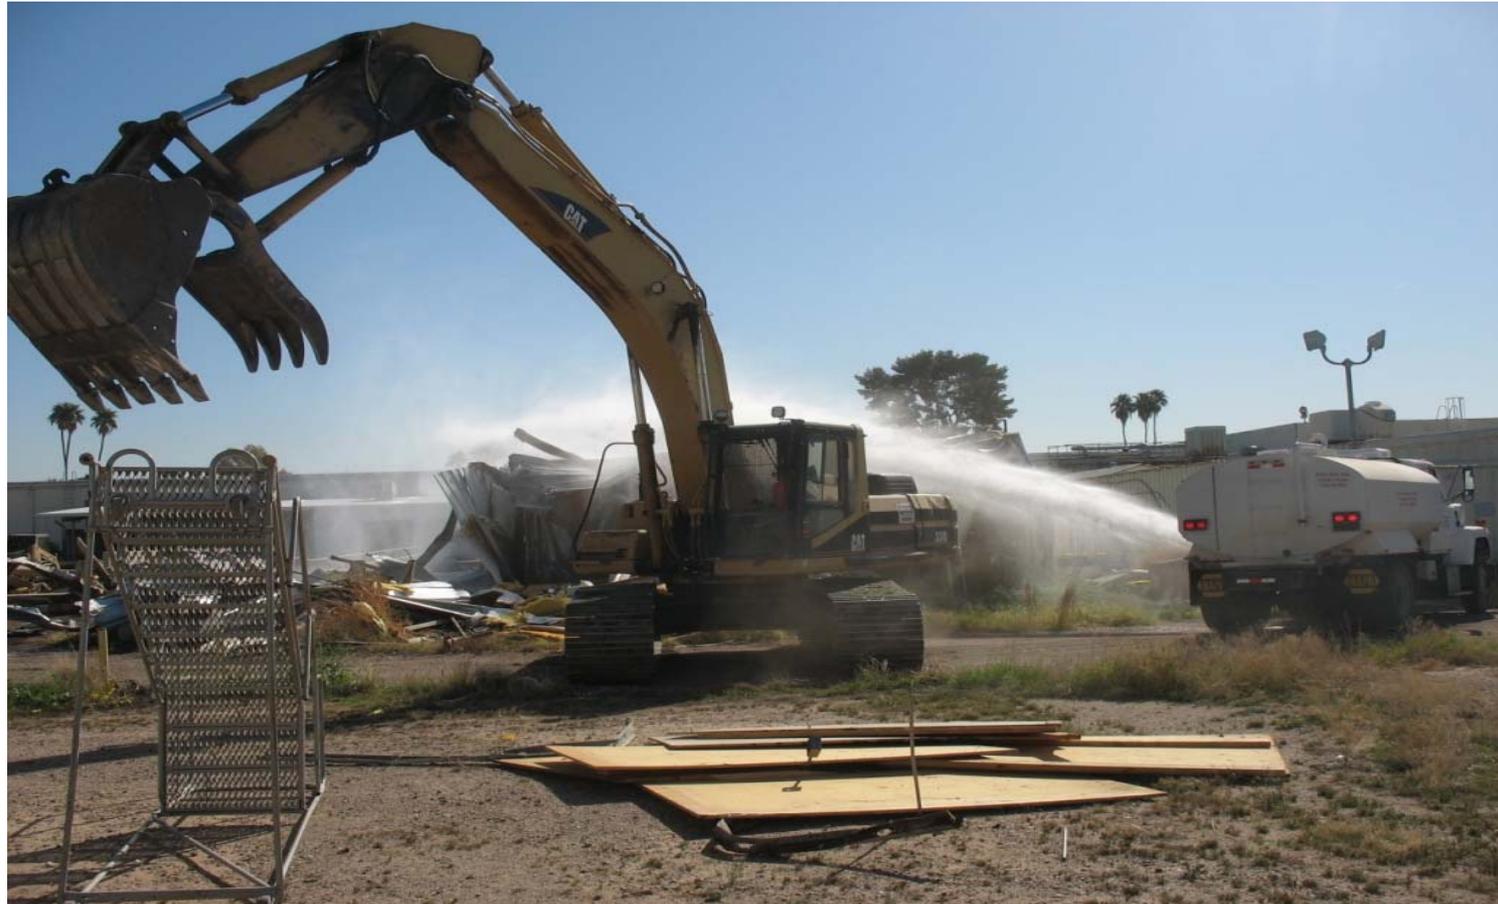
On-going Demolition with Dust Control Measures In Place

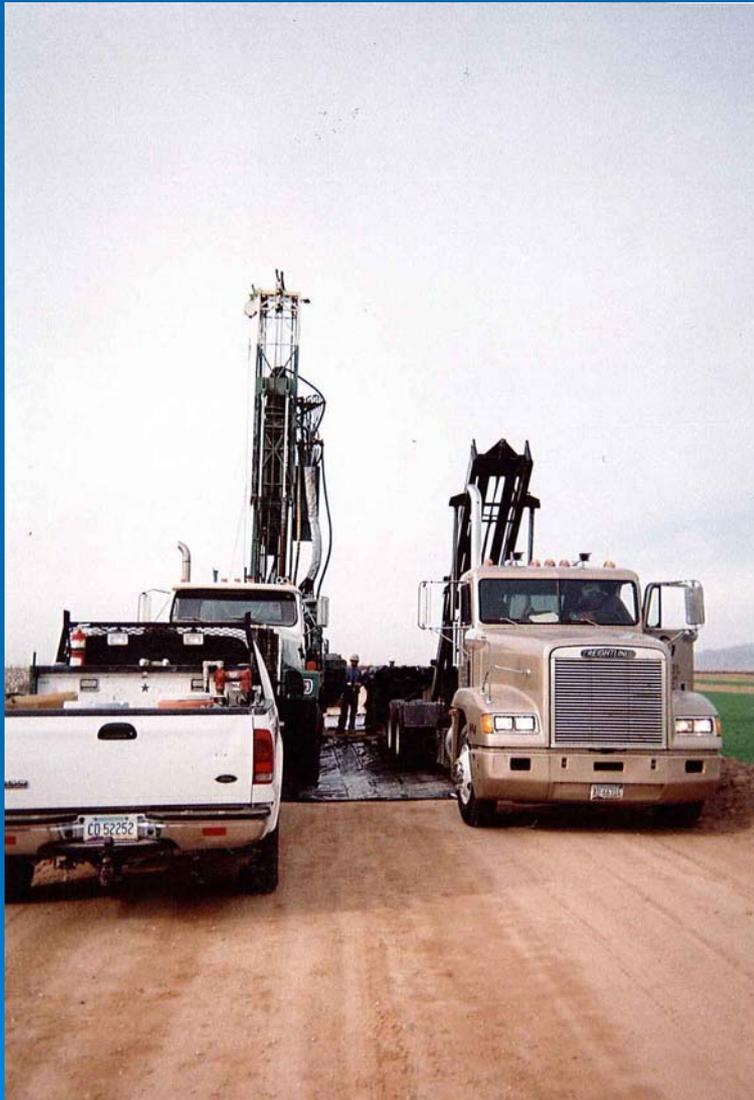
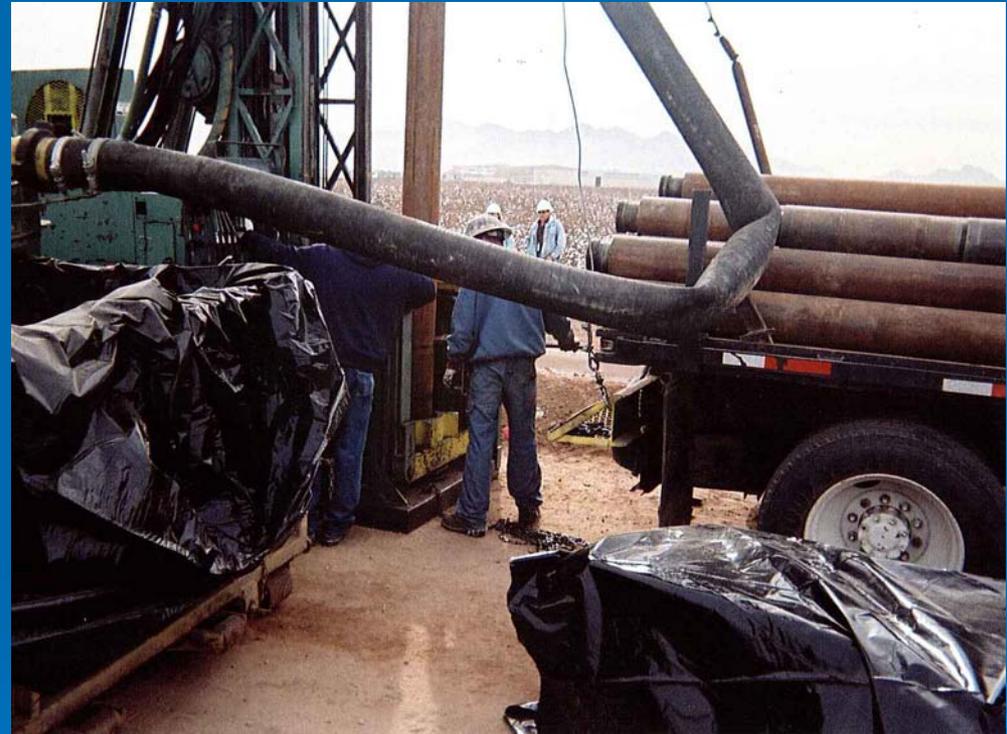
GMW-20 Installation Photos

**Morning of Dec. 4, 2008
Setup on GMW-20LC**

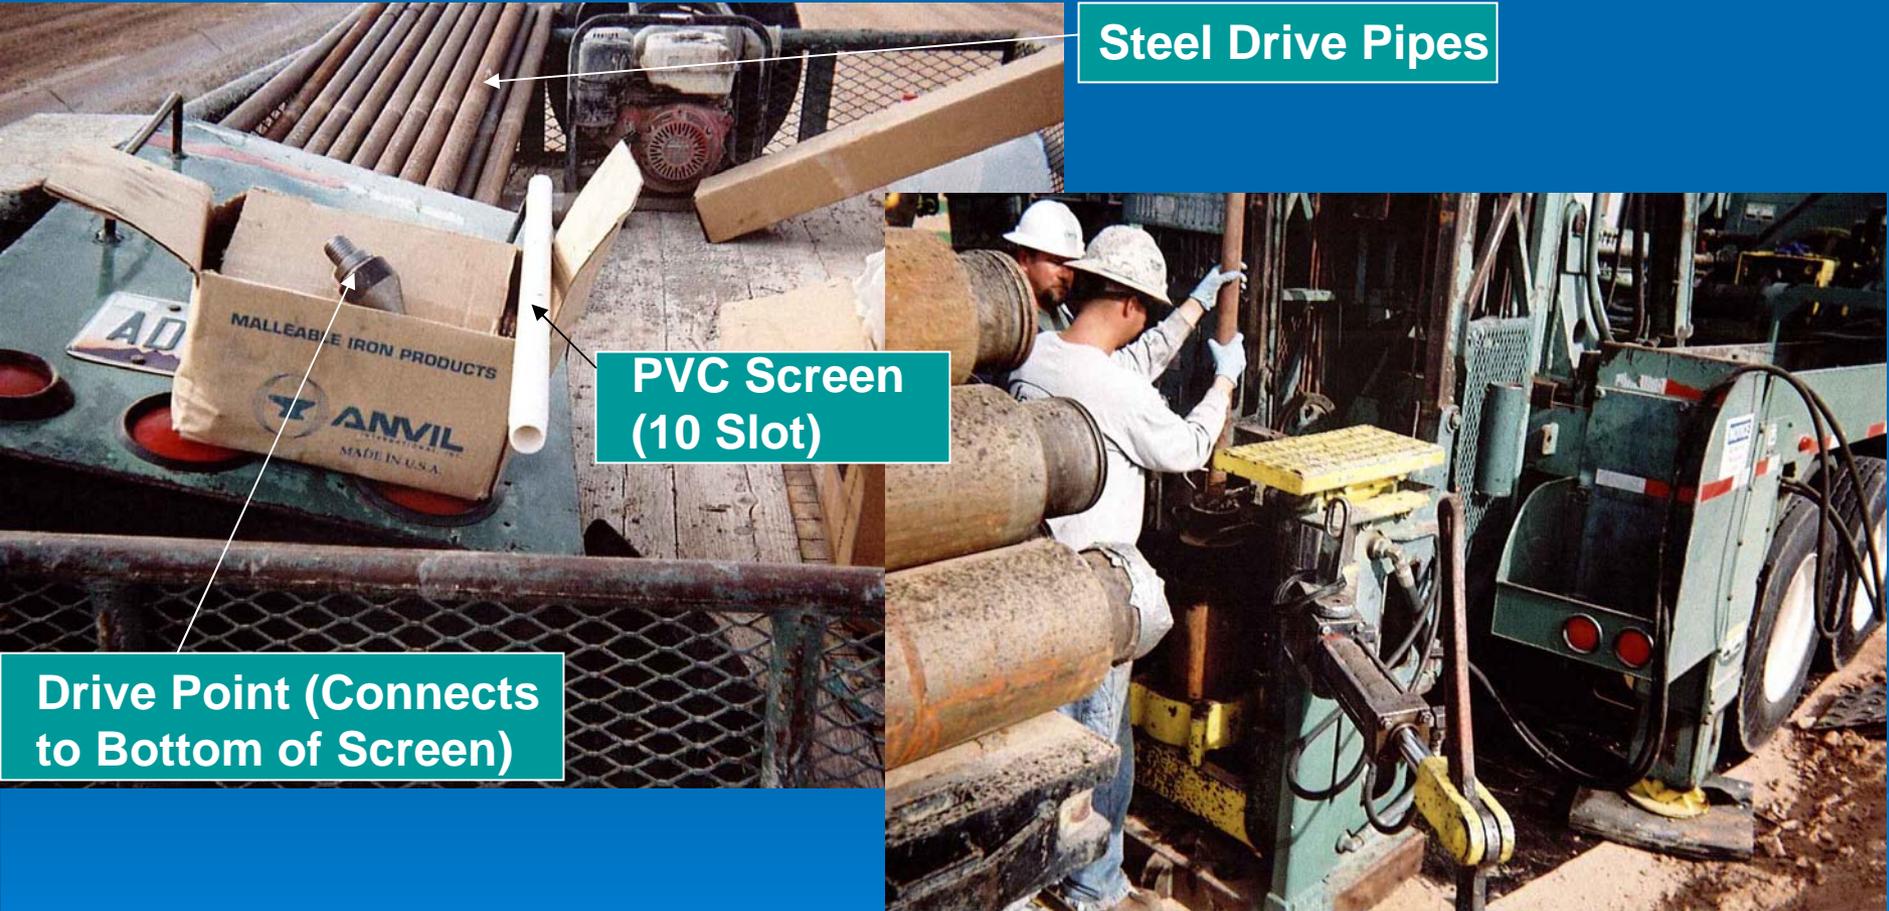
GMW-20 Installation Photos

Steel Drive Pipes

PVC Screen
(10 Slot)

Drive Point (Connects
to Bottom of Screen)

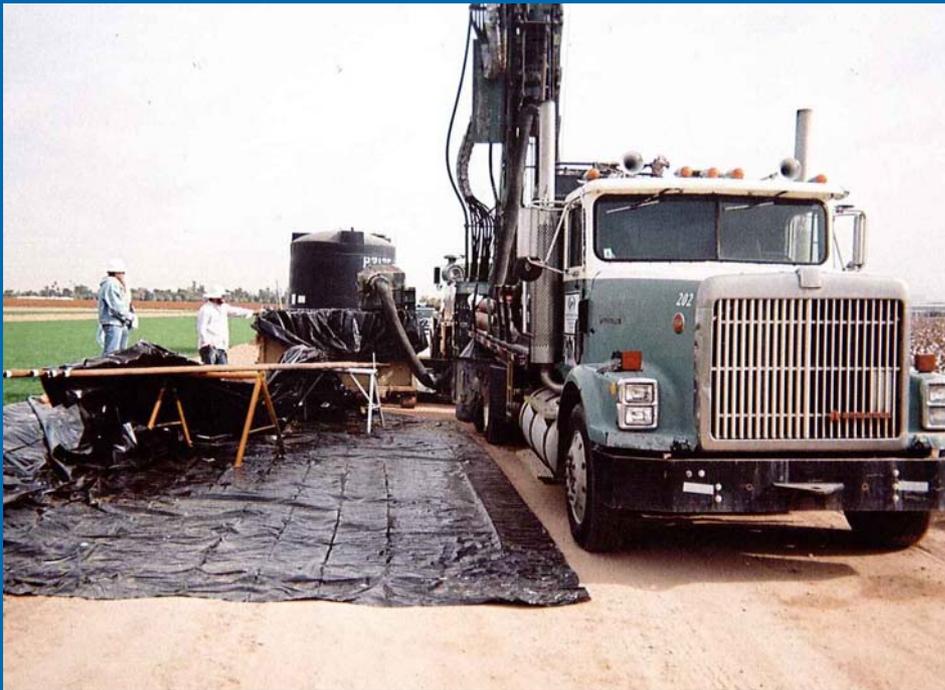
Afternoon of Dec. 4, 2008. Final setup on GMW-20LC

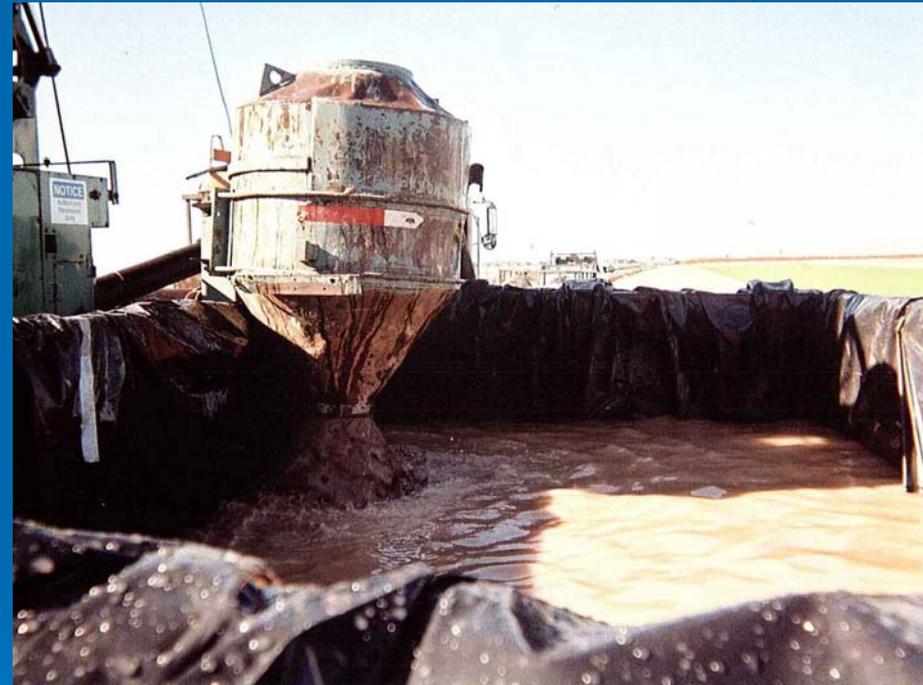
Contained drill cuttings and produced water

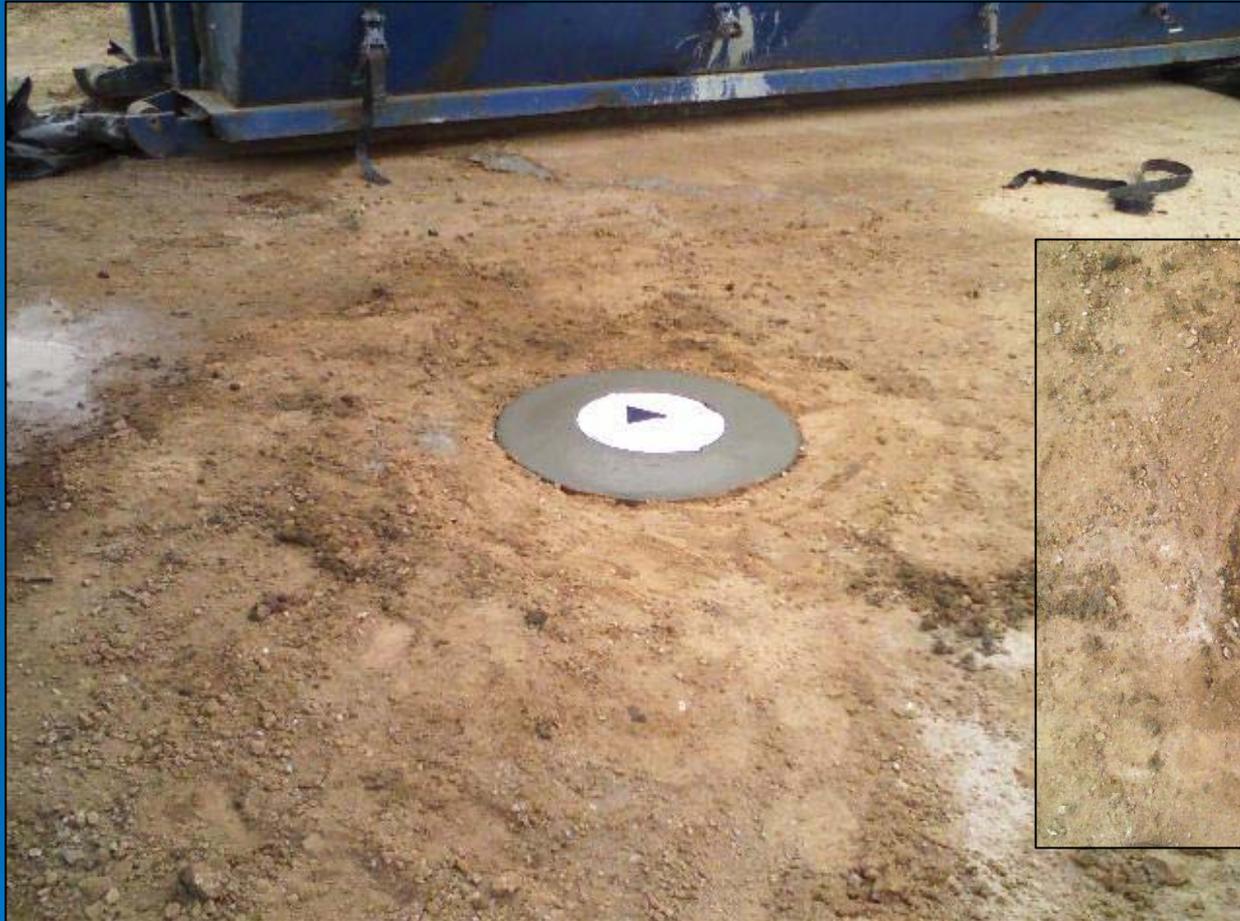
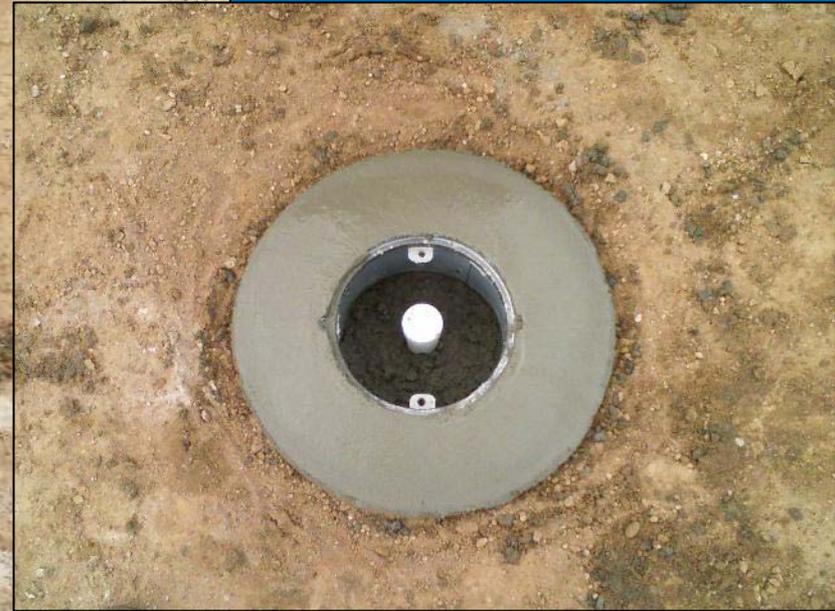
GMW-20 Installation Photos

Finished Well

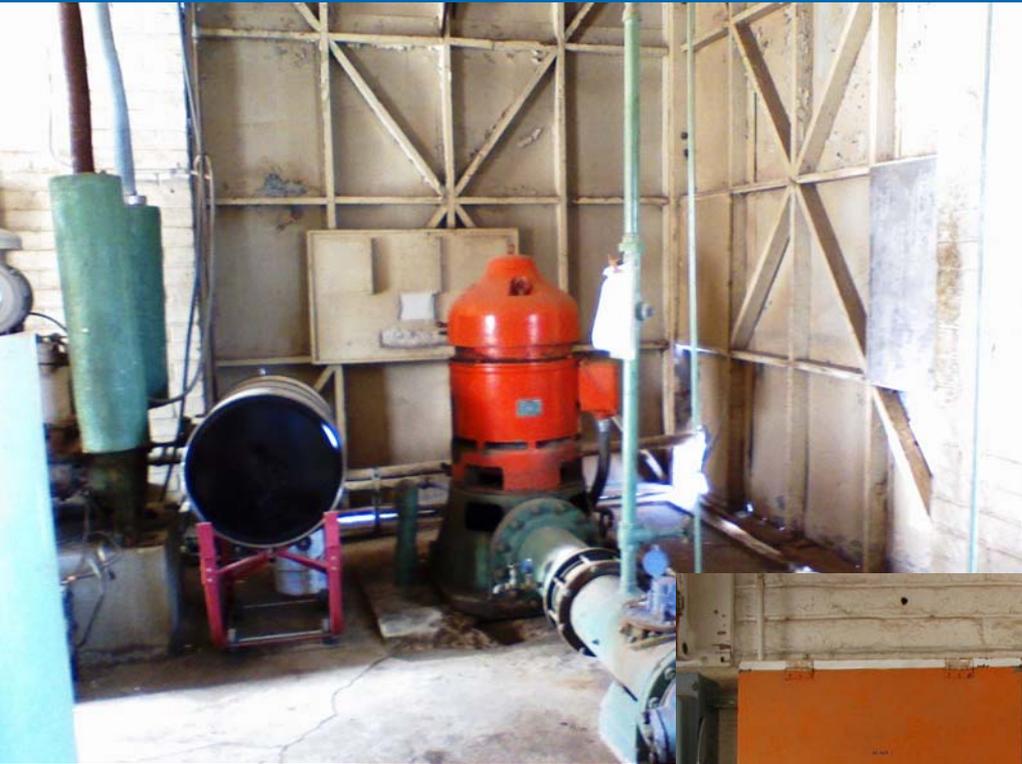
**GAC-04 Well Head
with Motor above**

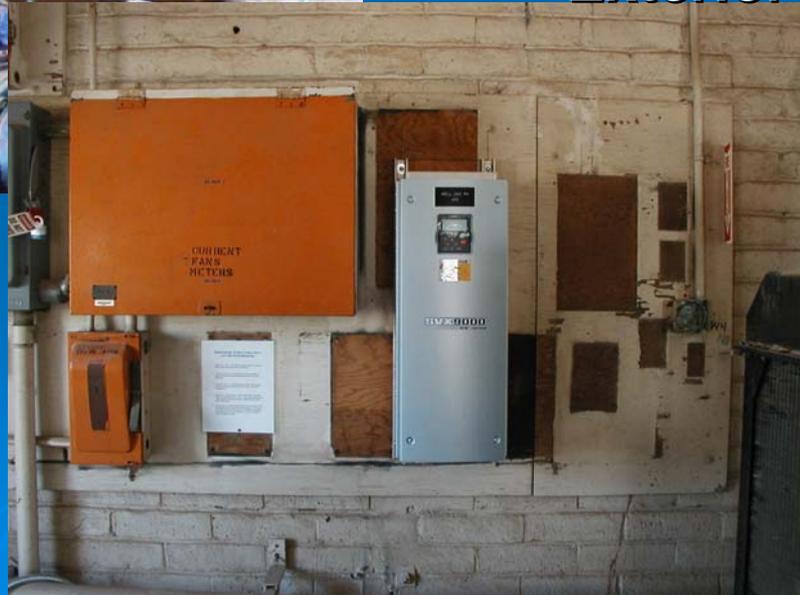
**New
Controls**

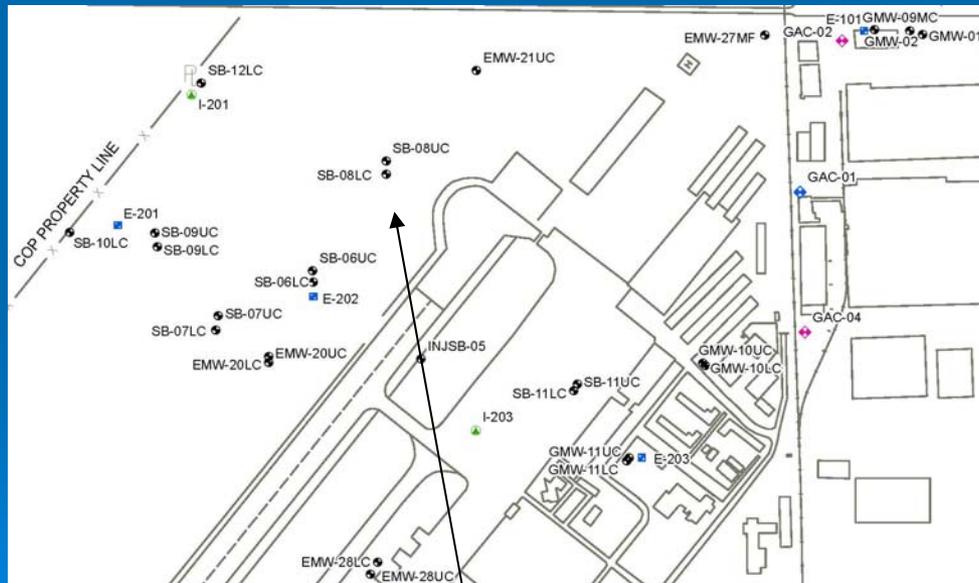
2009 TCE

Well SB-08UC contained TCE at 4.3 ug/L 2/09

Subunit	Max TCE ($\mu\text{g/L}$) 1990	Max TCE ($\mu\text{g/L}$) 02/09
Subunit A	2600	130 (E-12)
Southern Subunit C	150	4.3 (SB-08UC)
Northern Subunit C	180	60 (GMW-13UC)
