Camp Navajo  
Stakeholder Advisory Group

Thursday, June 10, 2010  
6:00 – 8:00 PM  
Camp Navajo Training Site  
Bellemont, AZ

# Five-Year Review for NAAD Sites 11B, 14D, 14G, 40, and 43 Camp Navajo, Arizona

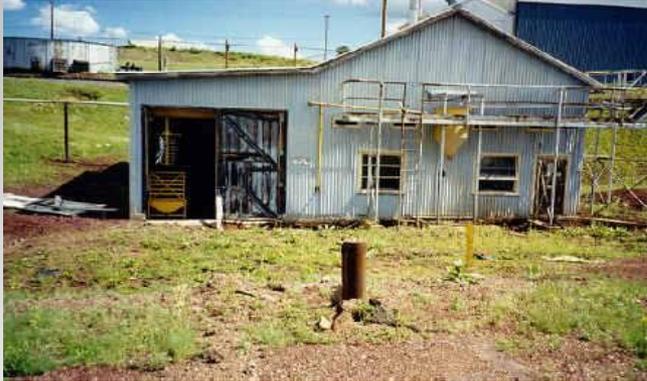
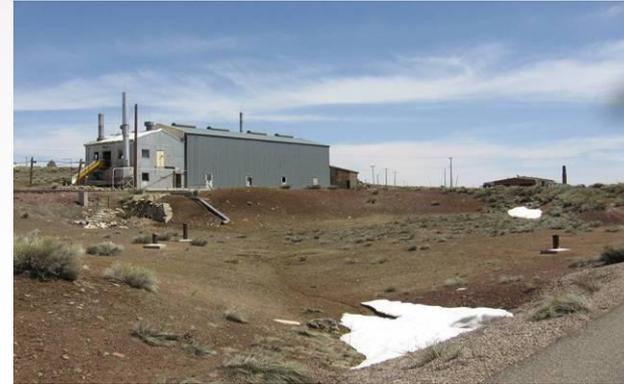
**NAAD 11B – Land and Resource Use**

Building 318/319 housed the former trinitrotoluene (TNT) washout and recovery operations. Activities Conducted at Building 318/319 included:

- Cleaning of explosives from ordnance and processing recaptured material for reuse;
- Discharging of wastewater generated during cleaning processes to surface impoundments, then to a closed system for transportation to other portions of the site.

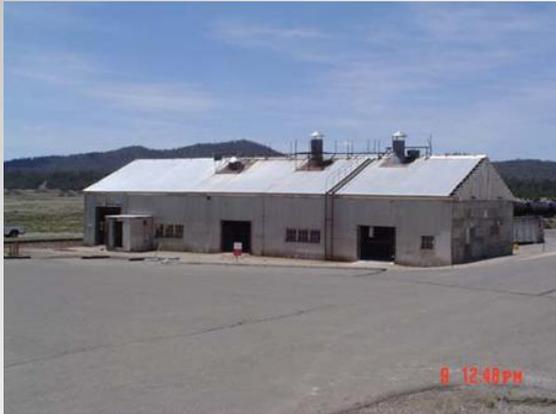
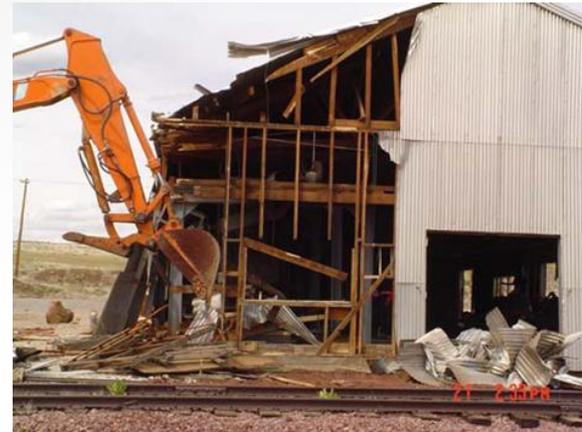
**NAAD 14D – Land and Resource Use**

- Building 322 was a 4,840 square foot facility used for degreasing, cleaning, and spray painting ammunition in the Ammunition Workshop Area.
- Building 322 contained two paint booths and four acid stripping tanks.
- Release mechanisms included spills, washout from daily operations, and discharge piping.
- Approximately 20 percent of the northern end of the building was removed in 1998 to accommodate road construction and widening of the access area into Building 375.

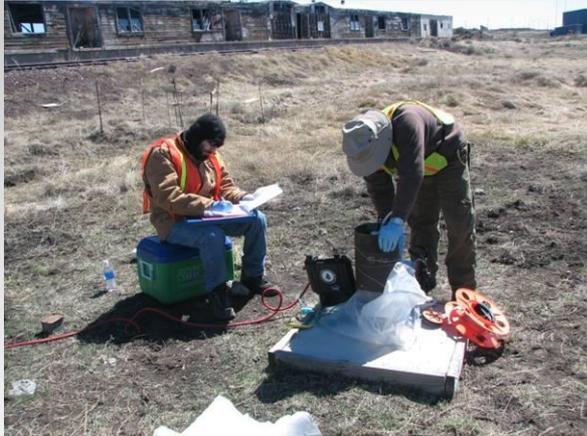
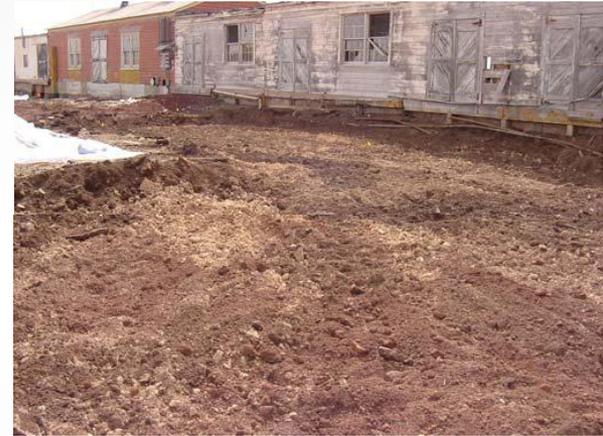
**NAAD 14G – Land and Resource Use**

- Building 327 was used for ammunition repair and disposal. Specific tasks included repacking shells, disassembling boosters, spray painting, and small arms ammunition disposal.
- Release mechanisms included activities associated with ammunition repair and disposal conducted in building 327.
- Extensive soil, groundwater, and surface water investigations were conducted at this site.

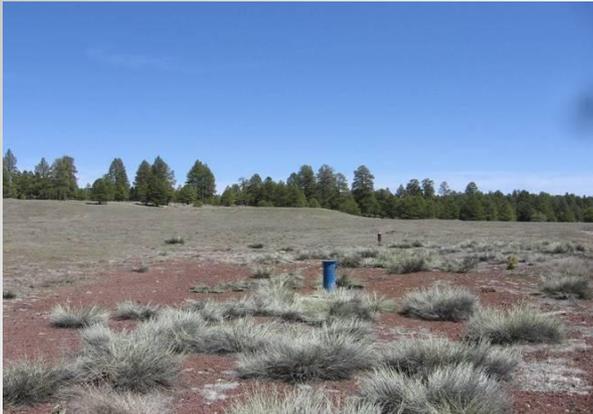
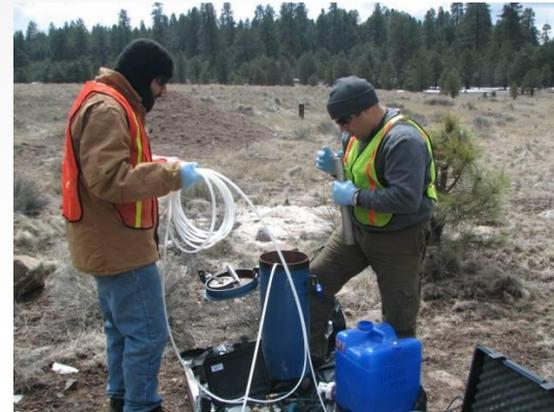
**NAAD 40 – Land and Resource Use**

- The Former Sanitary landfill (FSL) NAAD 40 covers approximately six acres and is located in a shallow alluvial valley in the eastern standard magazine area of Camp Navajo.
- The FSL was in operation from the 1940s until 1966, receiving primarily household waste. The site received dried sewage sludge between 1966 and 1981 and has been inactive since 1981.
- The FSL was capped in 2001.
- ADEQ considers the status of this site to be “No Further Action (NFA)”. ADEQ also recommends groundwater monitoring and annual inspections.

- Maintenance on the NAAD 40 landfill cap was performed in Fall 2008 and the annual inspection was moved to Spring 2009 to assess the condition of the landfill repairs. The results of the Spring 2009 site inspection indicated that the landfill cap is providing adequate protection to the landfill contents.

- The biennial survey of the landfill elevation points indicate that little settling of landfill contents is occurring.
- The landfill cap at NAAD 40 is in good condition and is functioning as designed. LUCs (including fencing, gates and signs) are in place and prevent unauthorized access and intrusive activities.

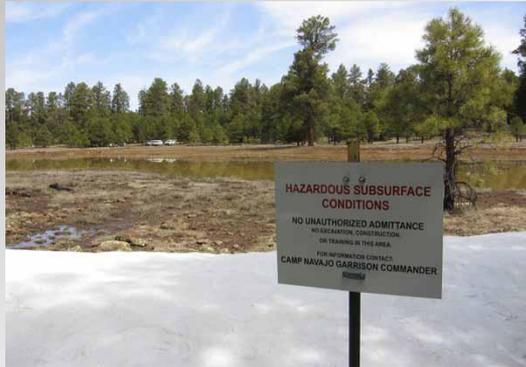
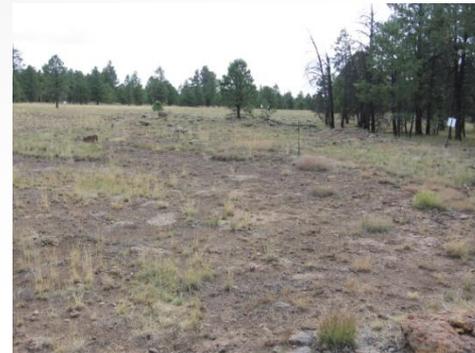
**NAAD 43 – Land and Resource Use**

- NAAD 43 was also known as former construction debris landfill #5 (FDCL#5) and is approximately four acres in size.
- Wood, concrete, bricks, metal, glass, asphalt, roofing material, and ceramic tile from the destruction of “Indian Village” were placed in FCDL #5.
- The debris and contaminated soil were removed from this landfill and disposed at an appropriate waste management facility in 1998 and 2001.
- ADEQ has designated this site for Construction Complete, No Further Remedial Action. ADEQ also recommended LUCs, annual site inspections and maintenance, and preparation of an operation and maintenance (O&M) Plan.

- MKM conducted semiannual inspections of the NAAD 43 landfill in 2007, 2008, and 2009. The Fall 2007 inspection identified several areas of erosion, and maintenance activities were conducted to repair the NAAD 43 landfill in Spring 2008.

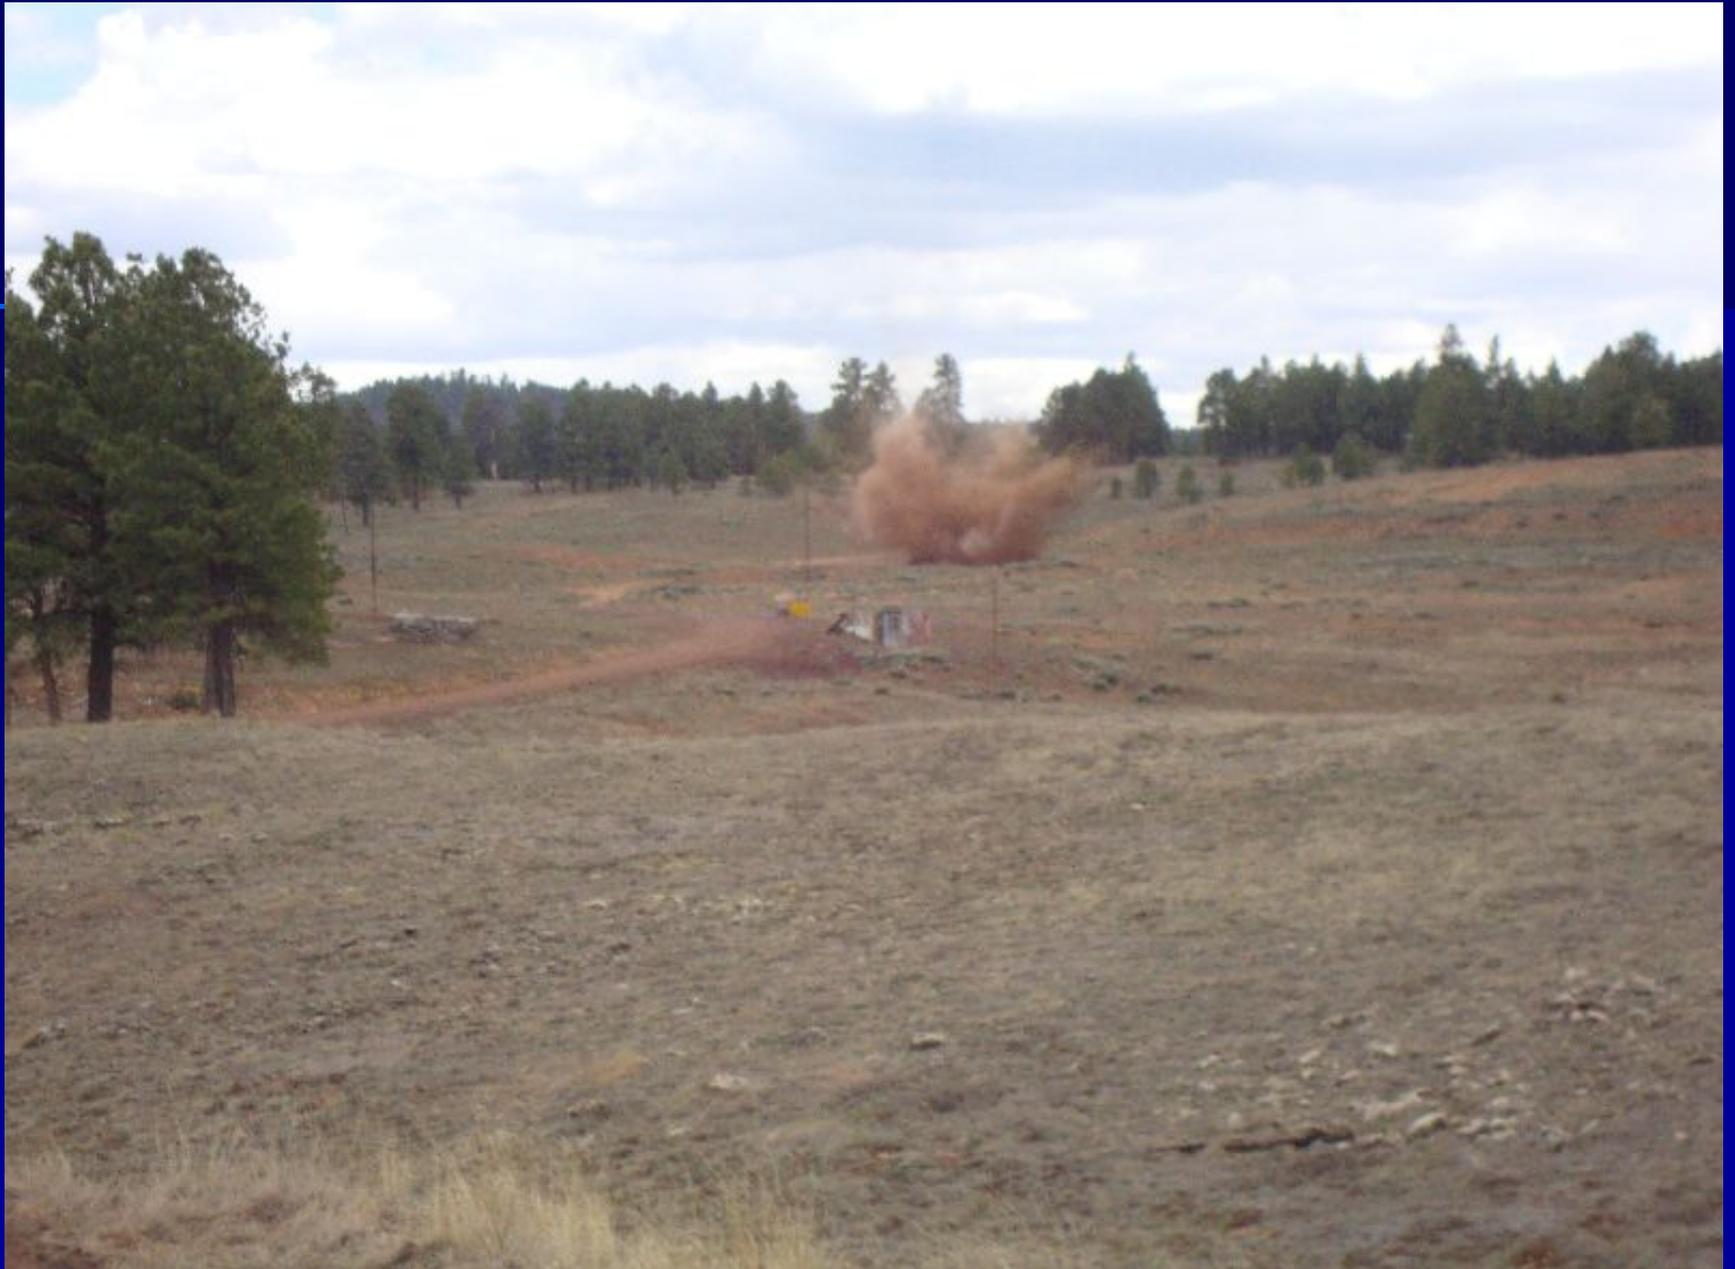
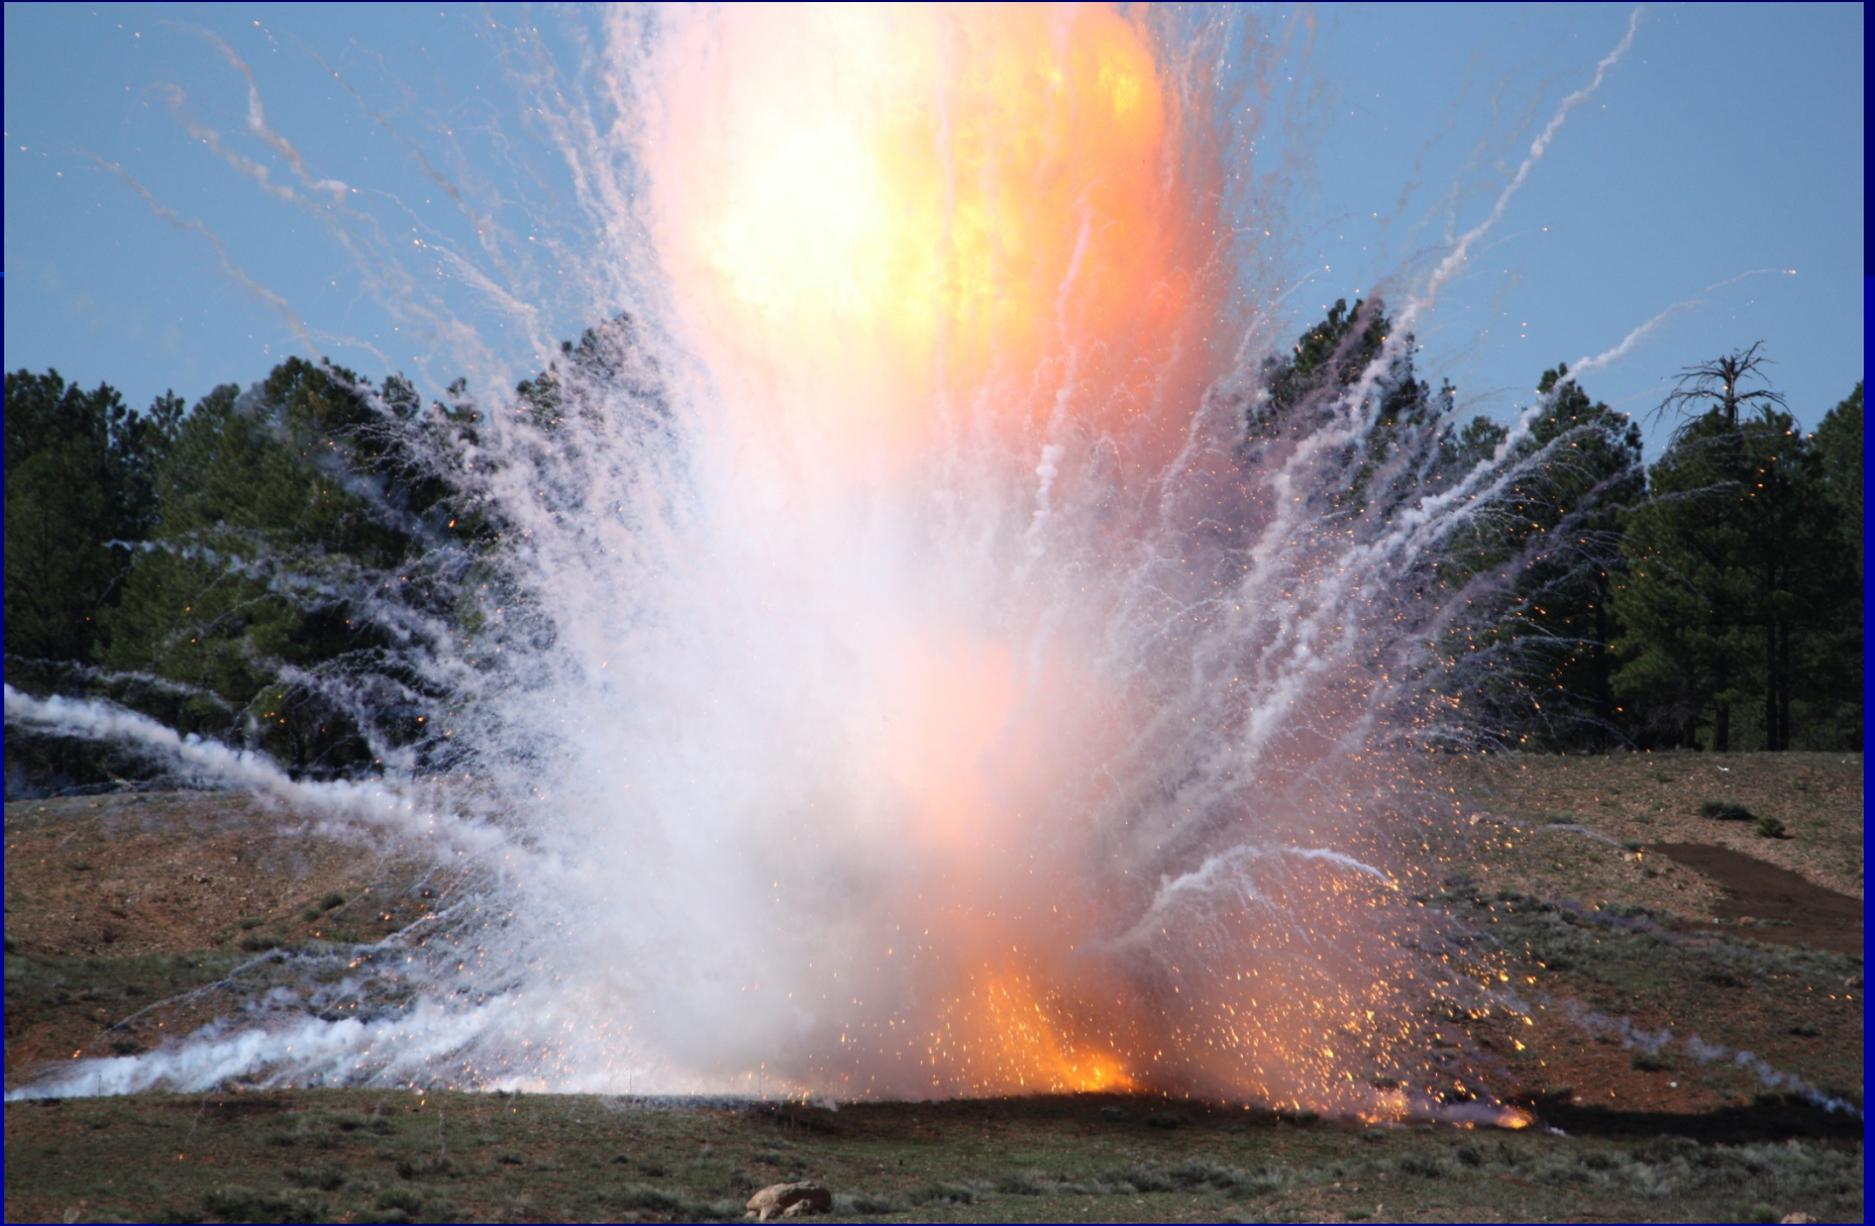
# Open Detonation Disposal of MEC

- Public notifications mailed on 4/27; hand-out brochures ready on 4/30.
- Daily notifications to Security and Fire Department
- Modified work practices to complete OD activity in wind speeds > 10 mph
  - Tamped HE and HC MEC with soil
  - Conducted WP detonations on less windy days
  - Use of water truck to dampen surrounding vegetation
  - Fire Department on stand-by during WP detonations
- Detection of MSO pair!

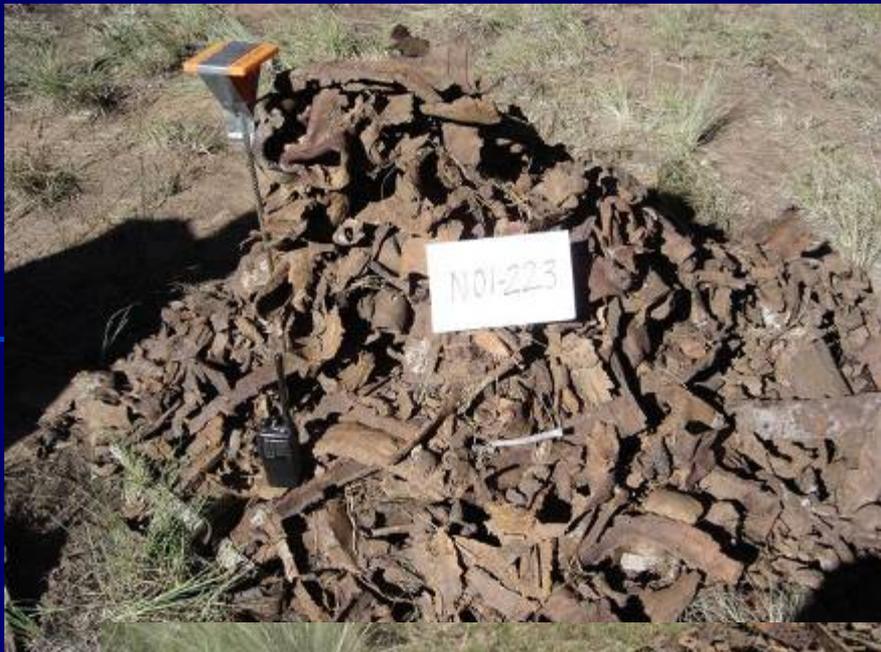
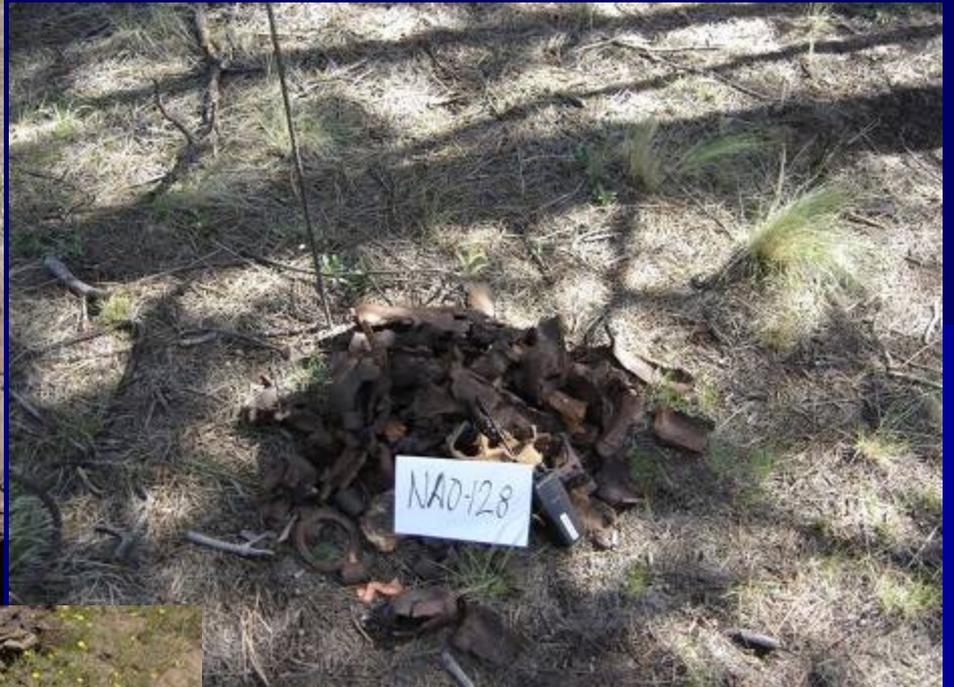
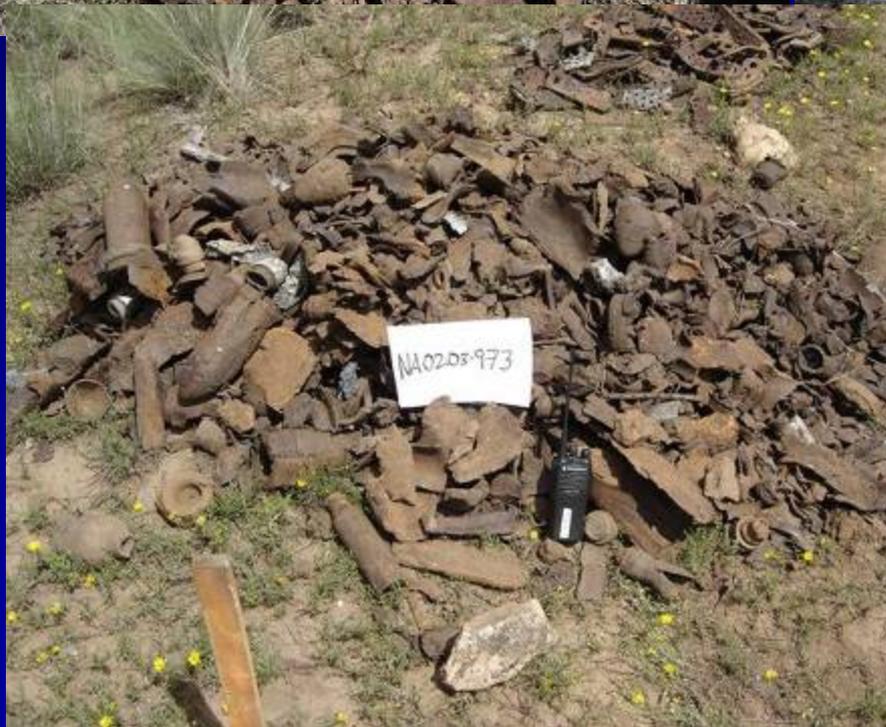
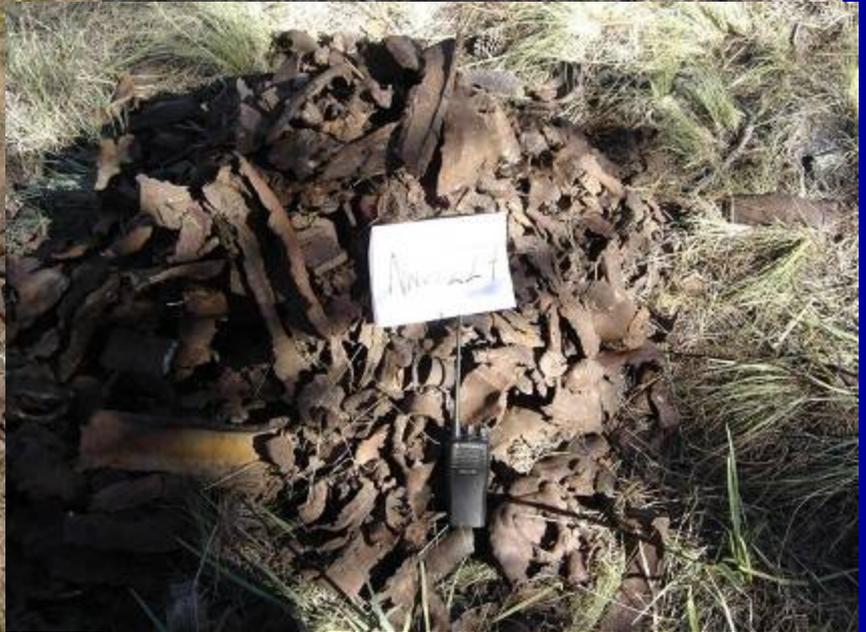
# MD Management Project

Collection, segregation, inspection, re-inspection, verification and recycling of Munitions Debris which has been consolidated throughout OB/OD Area work areas:

- Grid cells investigated or cleared
- ODPs/PSAs investigated
- Removal action areas
- Geophysical prove-out areas
- Former QC seeds & miscellaneous areas

- Field Activities Nov 2 – Dec 22, 2009
- Suspended due to deep snow
- Resumed field activities on 5/24
  - To date, MD recovered from:
    - 1,257/1,279 grid cells (~228,000 lbs)
    - 24/24 ODP/PSAs (~53,980)
    - NAAD 07 Removal Action Area (~3,150 lbs)
    - NAAD 09C Removal Action Area (~442,170 lbs)
    - QC Seed Consolidation Area (~500 lbs)
    - 10/10 Misc Consolidation Areas (~18,000 lbs)
- Includes MD Management at NAAD 09C

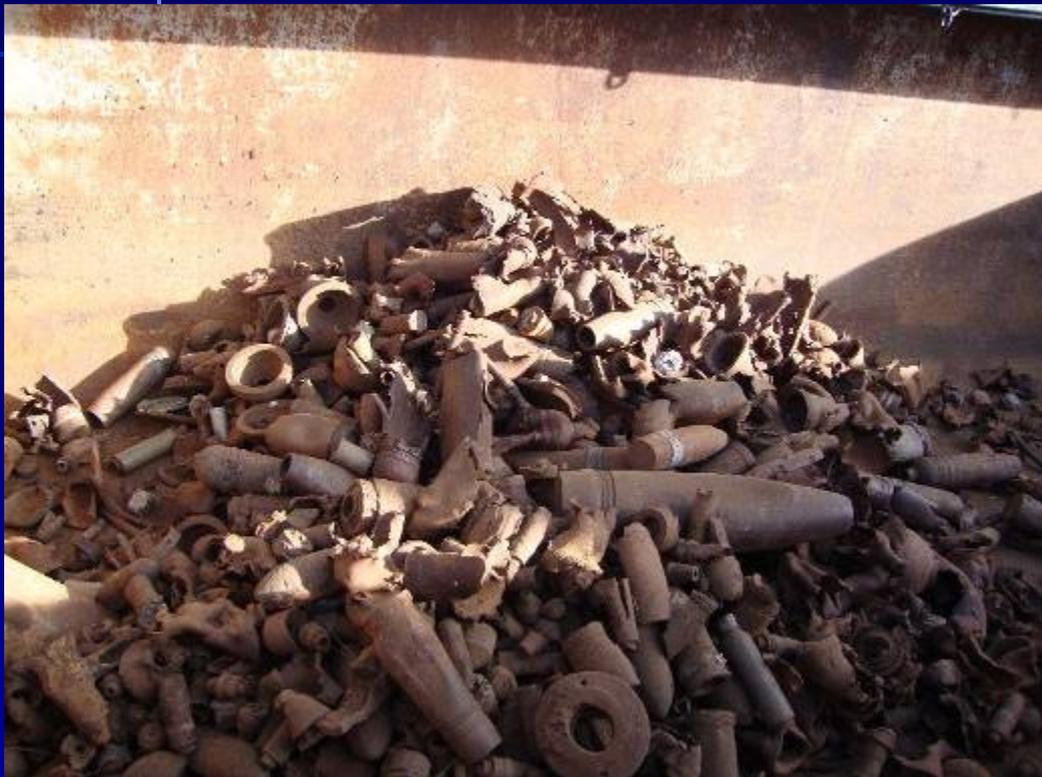
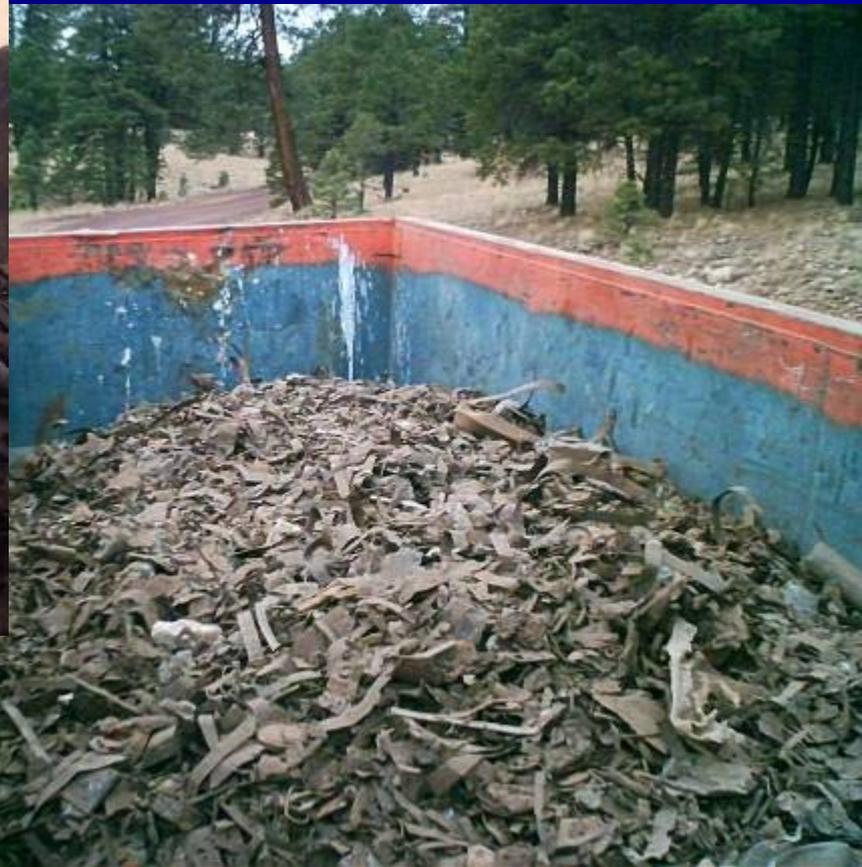
# MD Management

All segregated, inspected, certified and verified MD placed in secured and sealed bins

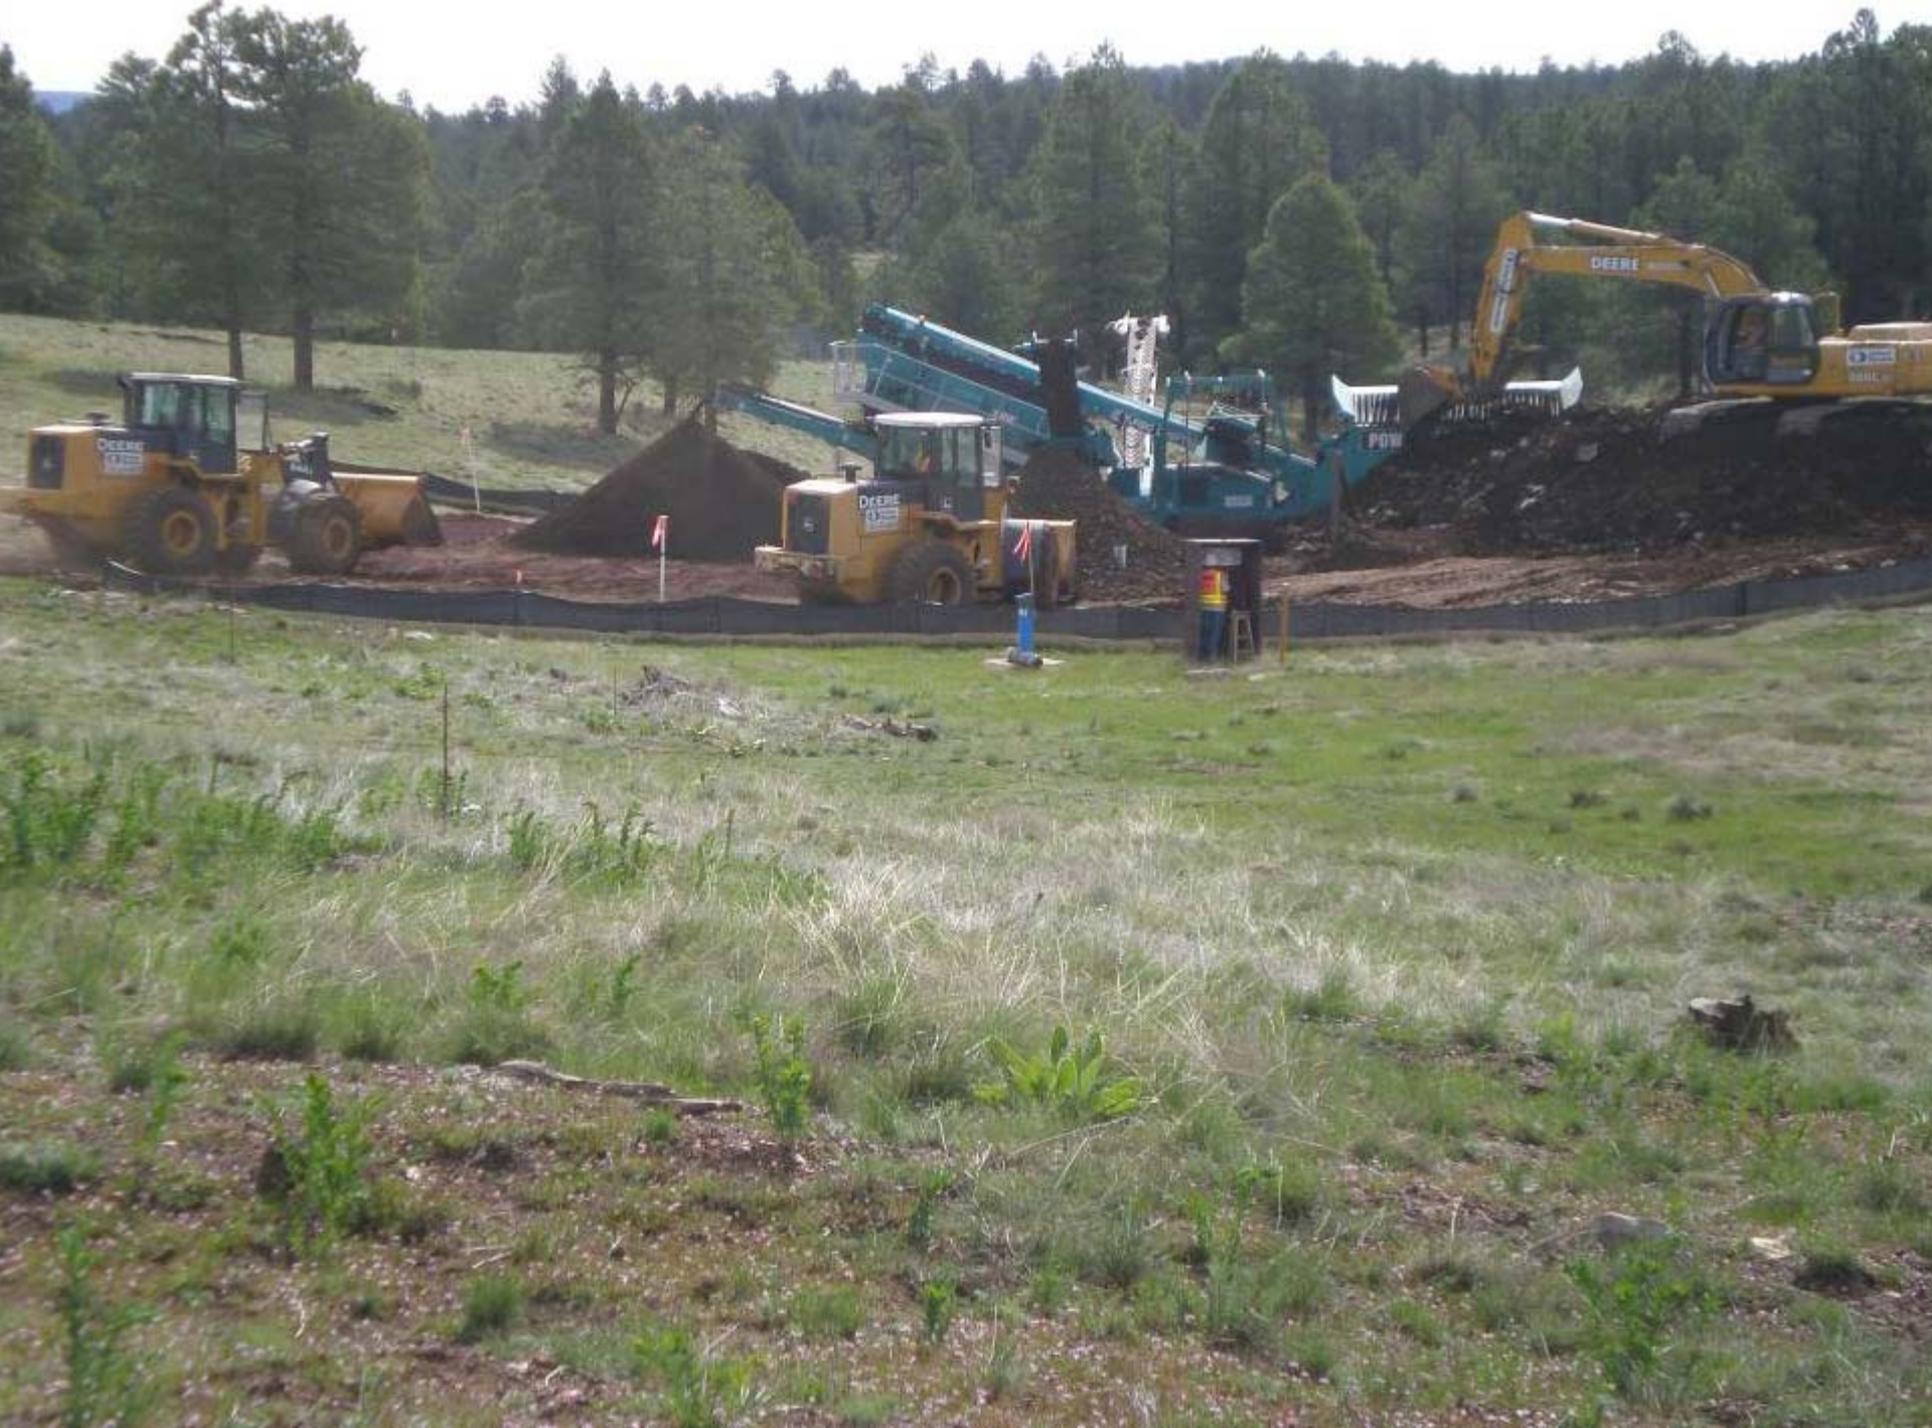
# Soil Stockpile Management

- NAAD 09C
  - ~10,000 cubic yards soil generated from 2005 removal action
- NAAD 02
  - ~2,300 cubic yards soil generated from 2007 removal action (transferred to NAAD 09C for processing)

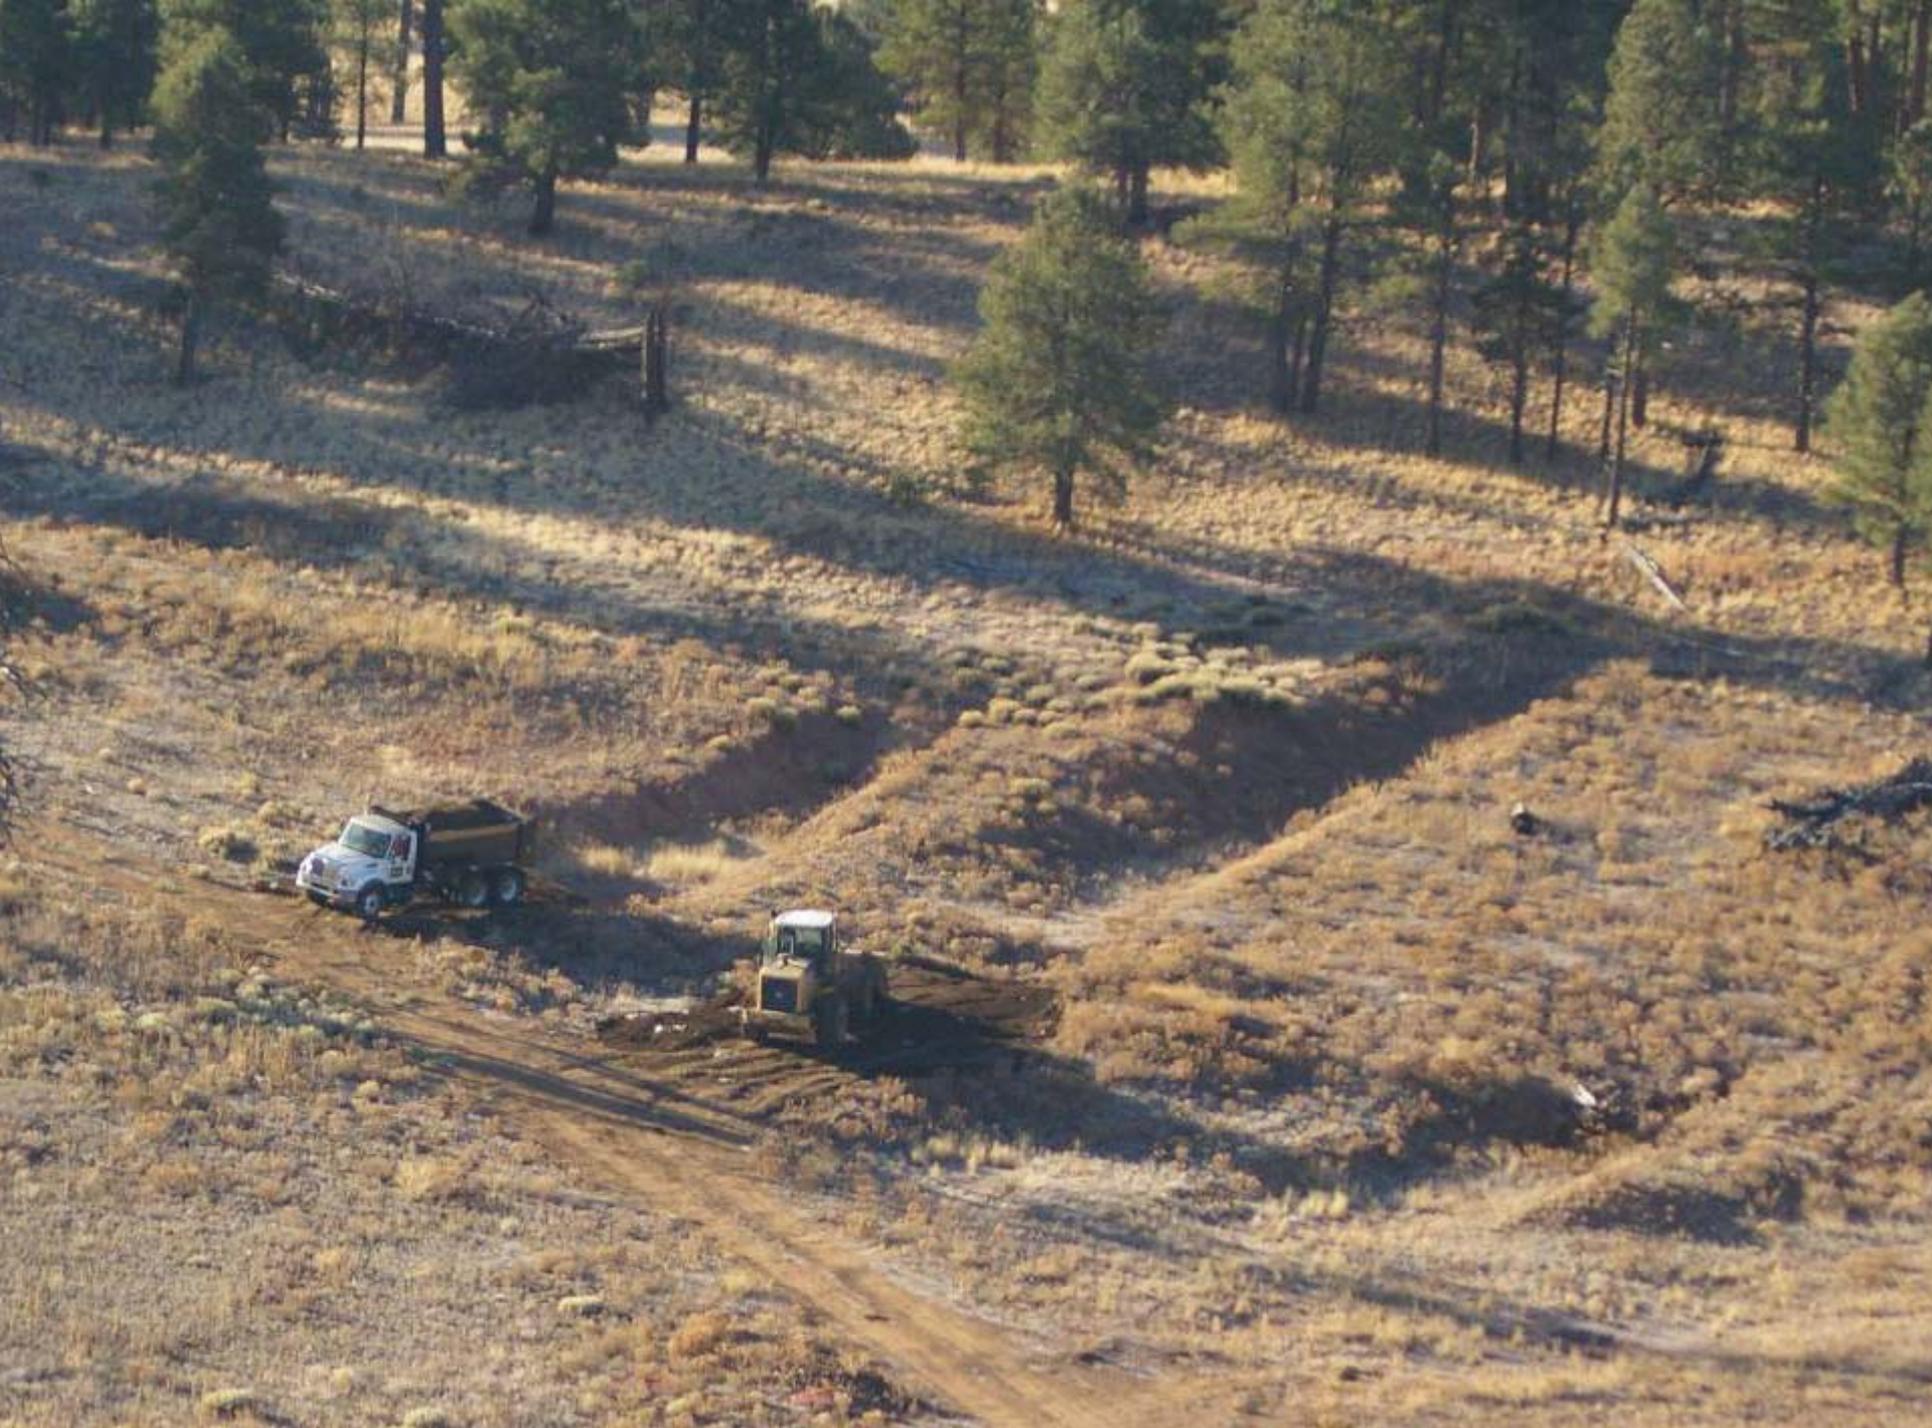
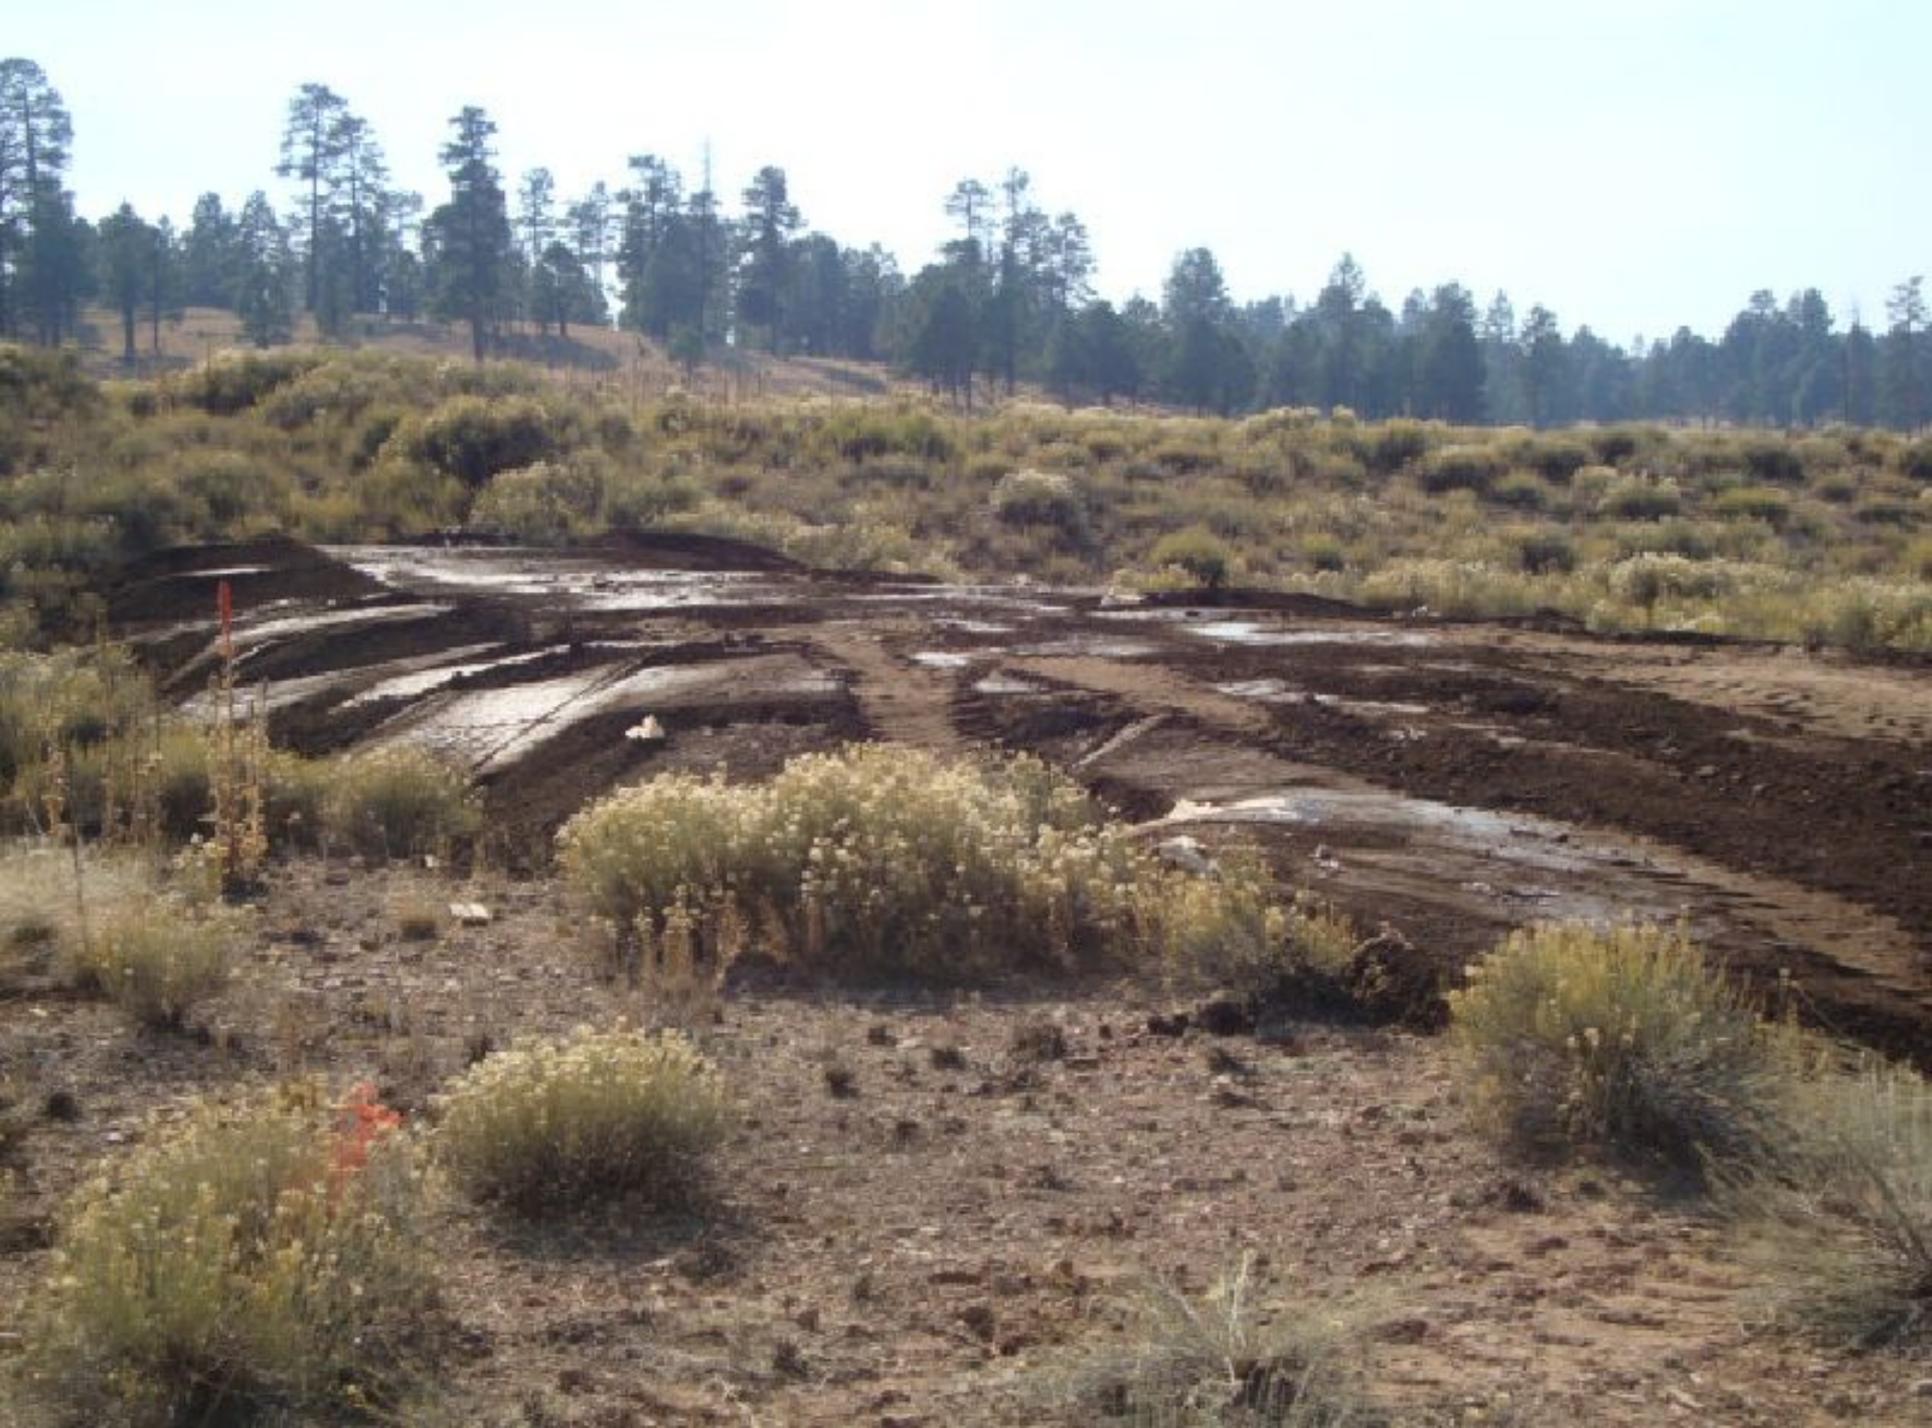
# Soil Stockpile Management

- Beneath original stockpile footprint
- Beneath former areas of soil sieving
- Beneath former soil batch staging areas
- Beneath metal segregation and consolidation areas

Samples will be analyzed for: TPH, VOCs, SVOCs, Pesticides, Explosives, Metals, Dioxins and Furans, PCBs, White Phosphorous, and Perchlorate.

- Analytical results from processed soil batches and samples taken from the soils beneath the former NAAD 02 stockpiles will be incorporated into the final NAAD 02 risk assessment.
- Risk assessment results will be used to support the NAAD 02 Decision Document for site-related chemical constituents.

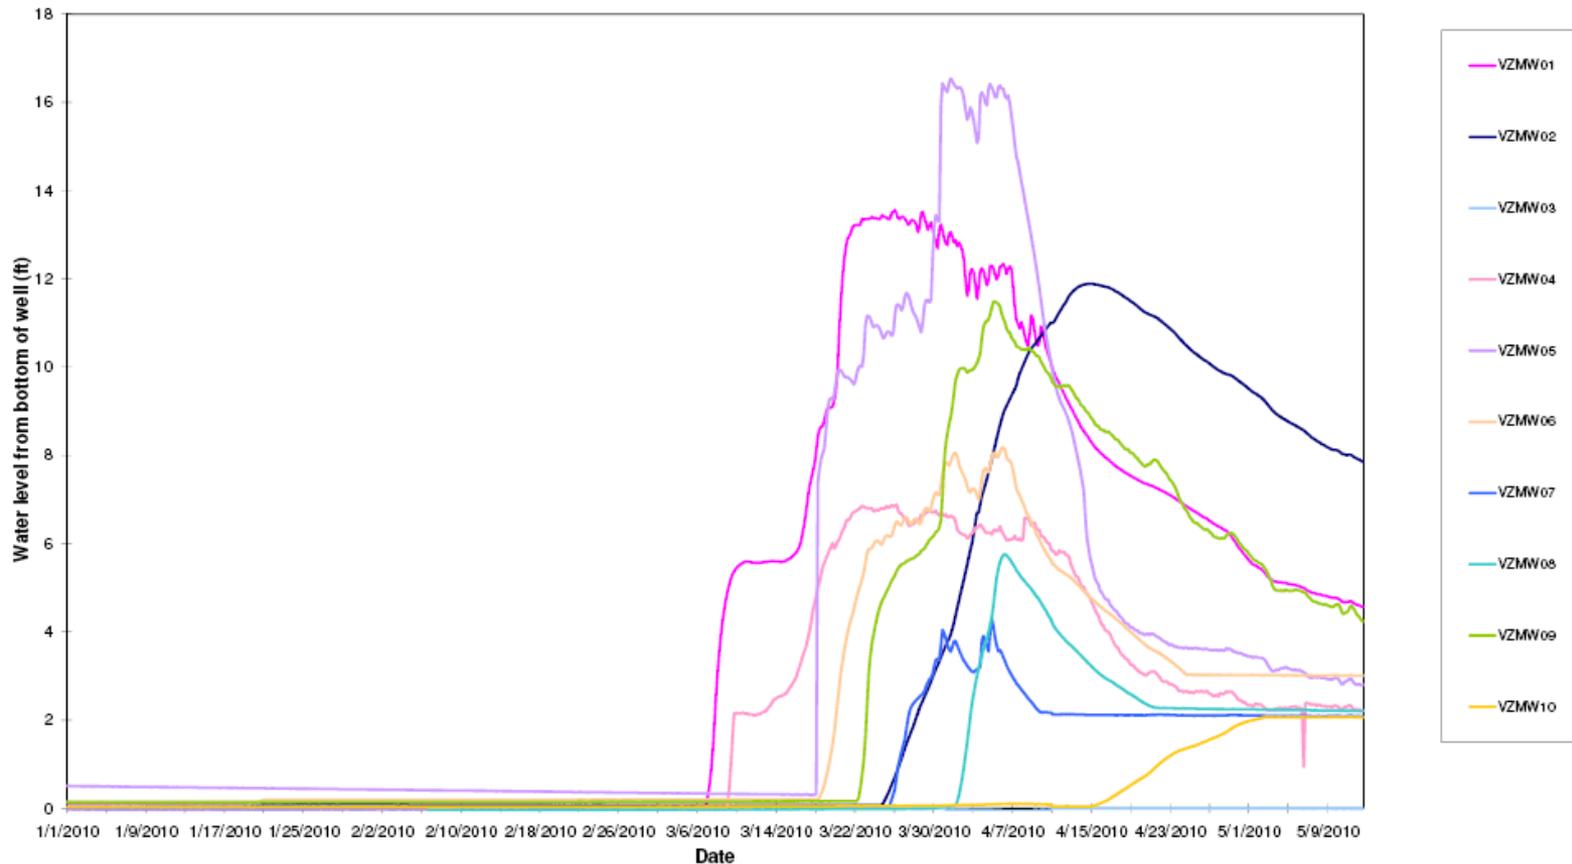
# Combined VZMW 1-10 Hydrographs January-May, 2010

Water Levels in feet, Camp Navajo OB/OD Vadose Zone Monitoring Wells  
(January 1st- May 12th, 2010)
