In the northeast portion of the VRGB, the watercourse flows through the Virgin River Gorge, an area of spectacular geology admired by motorists traveling through Arizona on Interstate 15. The gorge separates the Paiute and Beaver Dam Mountains wilderness areas that are found in the basin. Southwest of the gorge is the broad Virgin Valley which contains small communities historically based upon irrigated agriculture. The valley has experienced recent residential growth that often consists of retirees drawn to the area by a mild climate and amenities offered by the nearby Nevada casino resorts.

In contrast, the relatively low parameter levels characteristic of the VRB aquifer are likely the result of high-quality, mountain-front recharge from the Virgin Mountains. The relatively high parameter levels characteristic of the LTL aquifer appear to be influenced from contact with limestone known as the *Littlefield formation* (2). This horizontal limestone unit is overlain by alluvial fan deposits and is the likely cause of the saline, *very hard* groundwater found in the LTL aquifer.

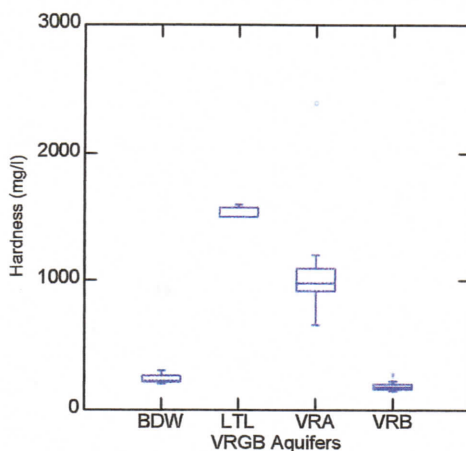
Figure 5. Boxplot comparing hardness levels among four VRGB aquifers.

These differences in aquifer water quality are illustrated by graphically comparing hardness levels (Figure 5). The highest hardness levels are found in the LTL aquifer, its *very hard* water in evidence by the calcium carbonate precipitation on plumbing fixtures (Figure 6). Water in the VRA aquifer is also *very hard* but is significantly lower than water in the LTL aquifer. Although both have *hard* water, the BDW aquifer had significantly higher hardness levels than the VRB aquifer. Twelve (12) parameters generally followed this pattern: bicarbonate, boron, calcium, chloride, hardness, magnesium, potassium, sodium, SC, sulfate, total alkalinity, and TDS.

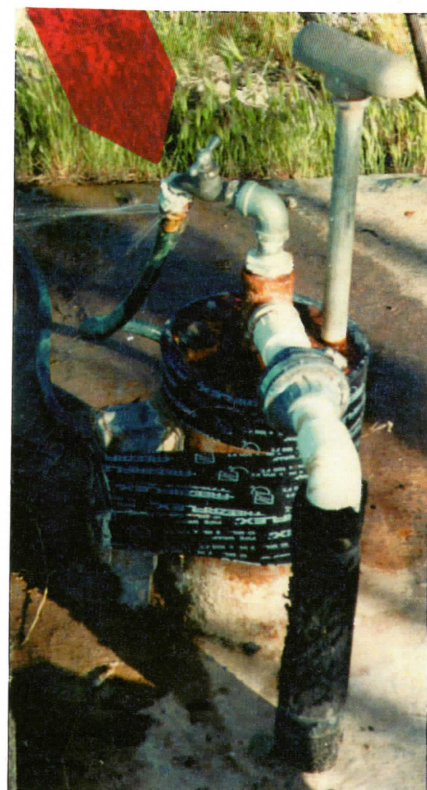
Figure 6. The red arrow points out the precipitation of calcium carbonate on a spigot as a result of *very hard* water pumped by a well tapping the LTL aquifer.

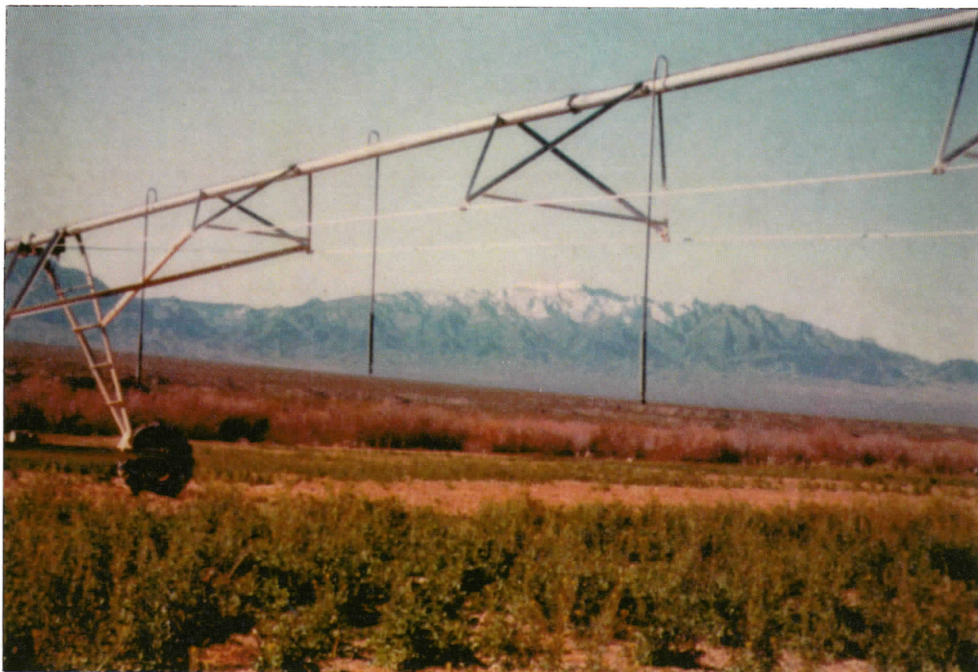
Figure 8. Situated in the Virgin River floodplain, a center-pivot irrigation unit tapping the VRA aquifer frames dormant riparian vegetation and the snow-capped Virgin Mountains.

percent) met aesthetics-based, water quality standards. Secondary MCL exceedances generally occurred at sites in the LTL aquifer and the VRA aquifer (**Figure 8**) while sites in the BDW aquifer and the VRB aquifer typically met Secondary MCL standards.
