Coyote Creek Watershed Improvement and Education Project

DRAFT Watershed Improvement Plan

Natural Channel Design, Inc.
206 South Elden Street
Flagstaff, AZ 86001

April, 2011

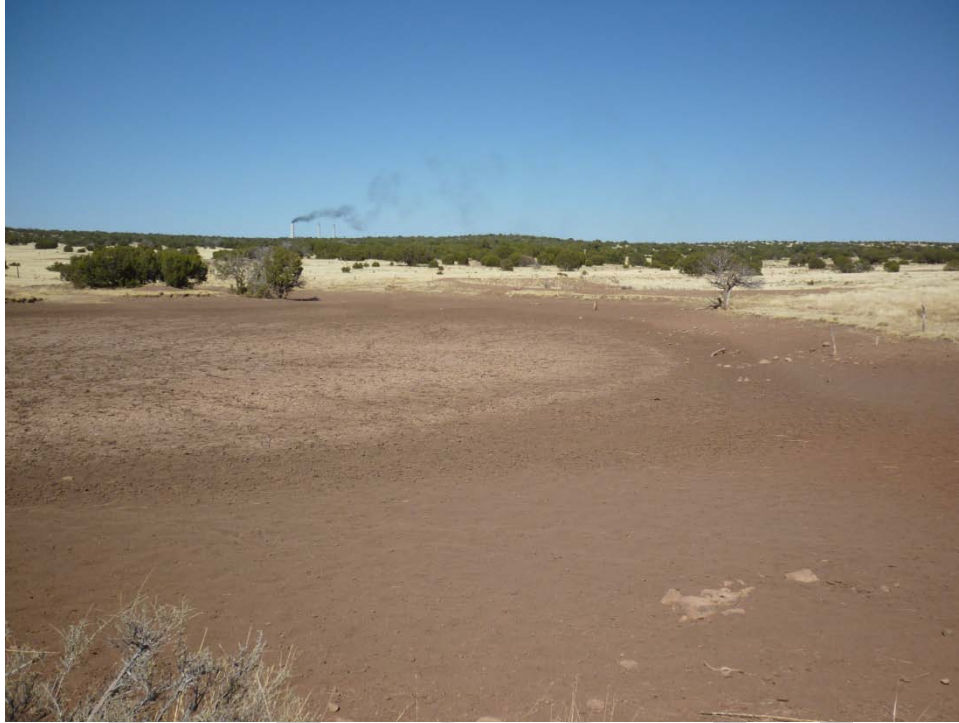
A typical sediment basin found on this ranch. This one in particular has been in service for over 20 years and is still functioning, though it needs some rehabilitation to restore its historic capacity.

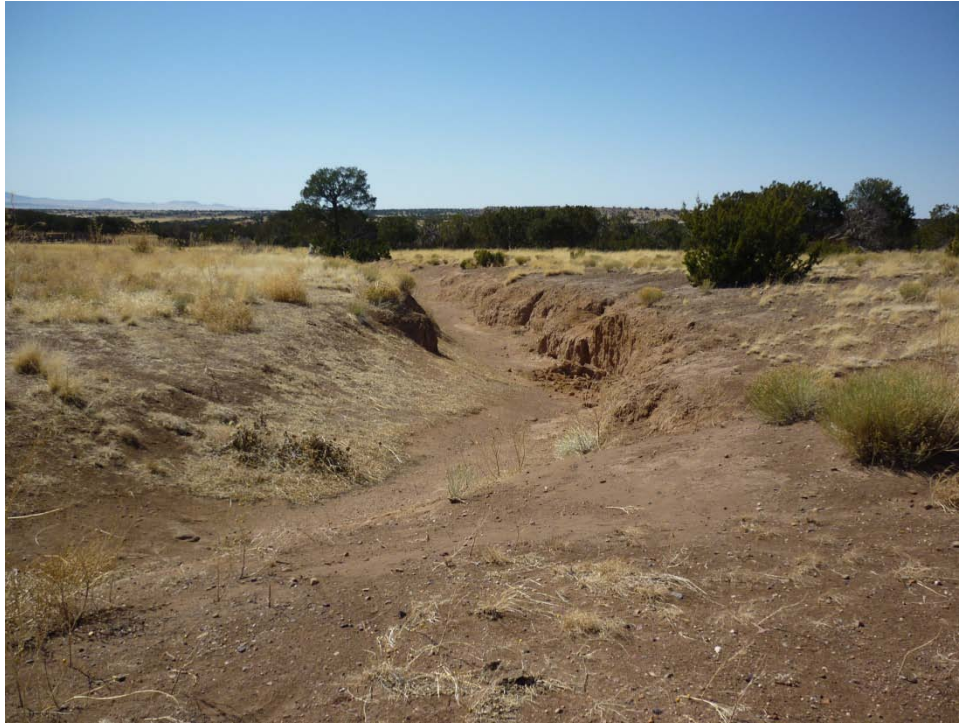
An active gully where Mr. Johnson would like to install a dike and V-mesh spreaders.

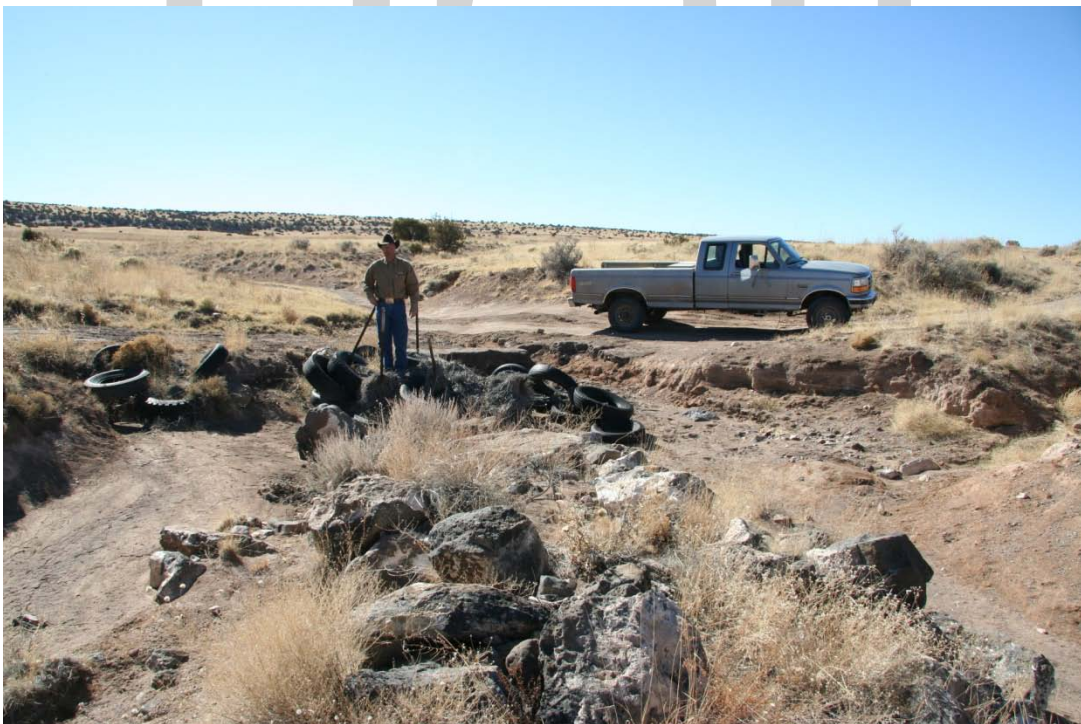
View of a failed grade-control structure made of T-posts and tires.

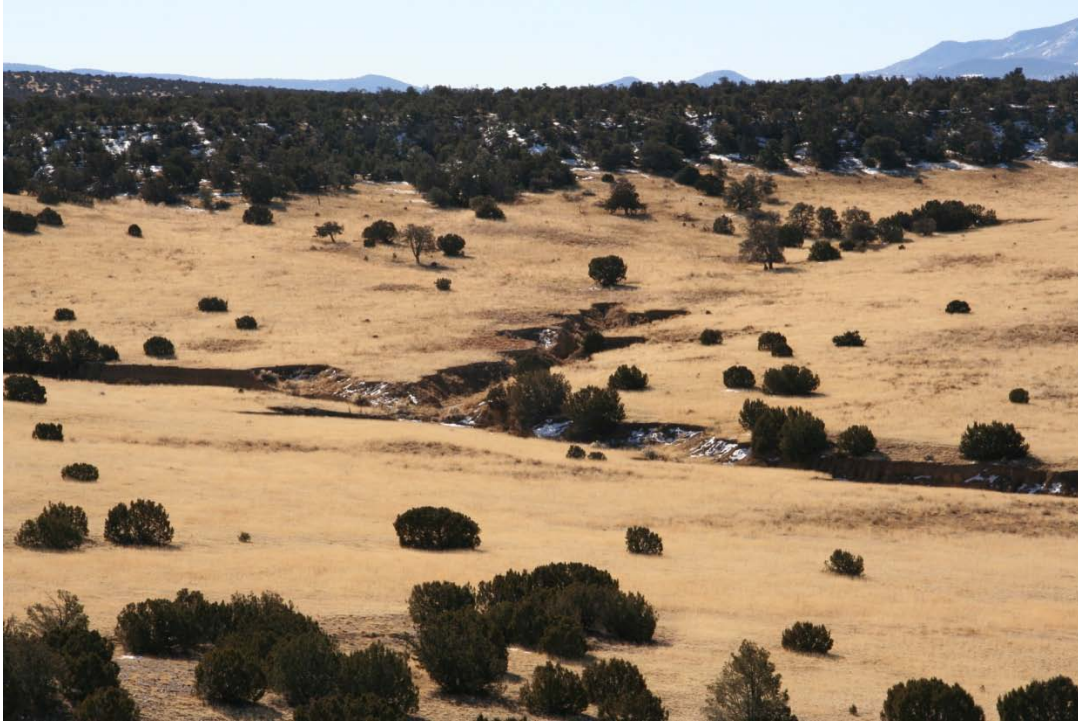
Shows actively eroding headcuts.

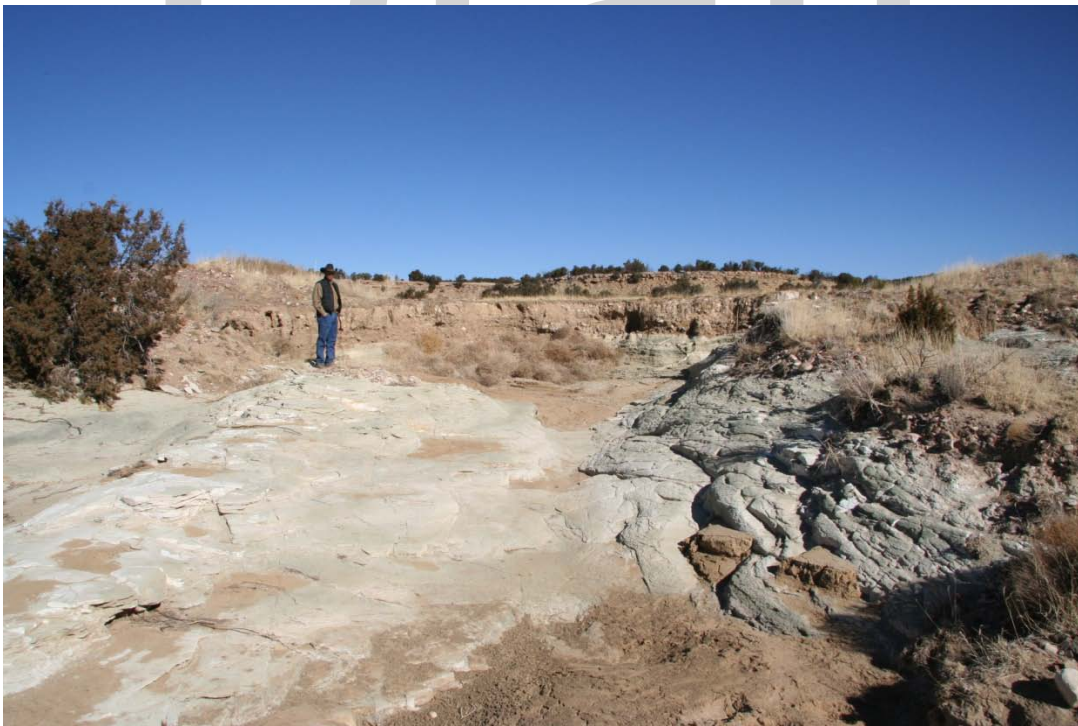
Shows an area of an actively eroding headcut.

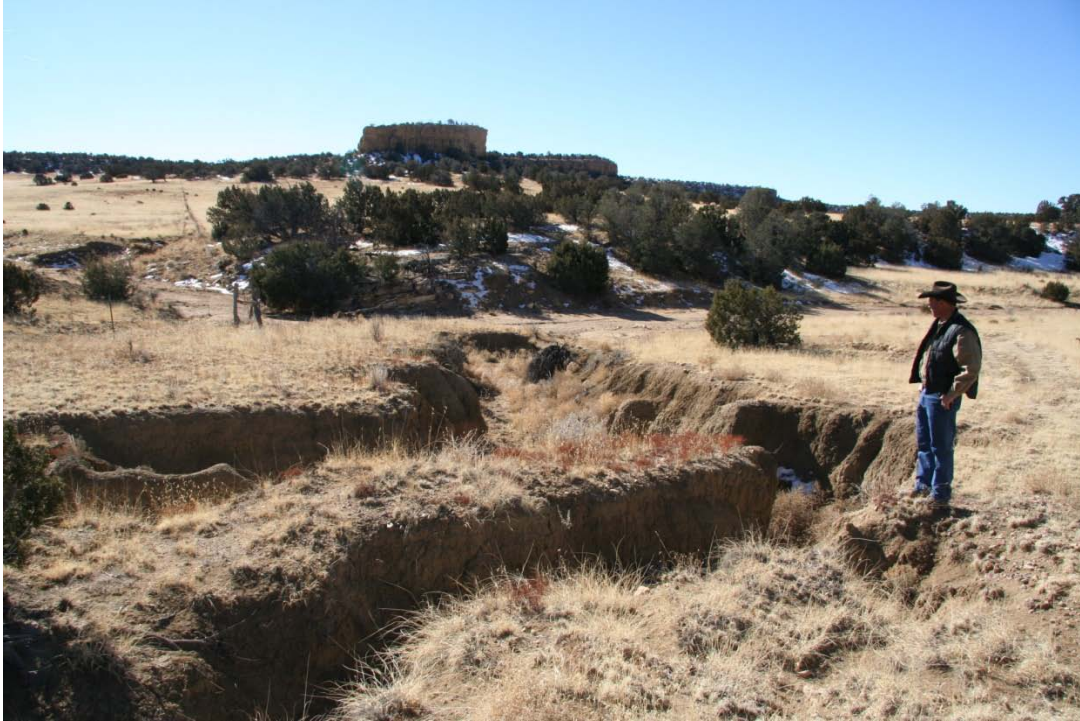
Shows another actively eroding headcut.

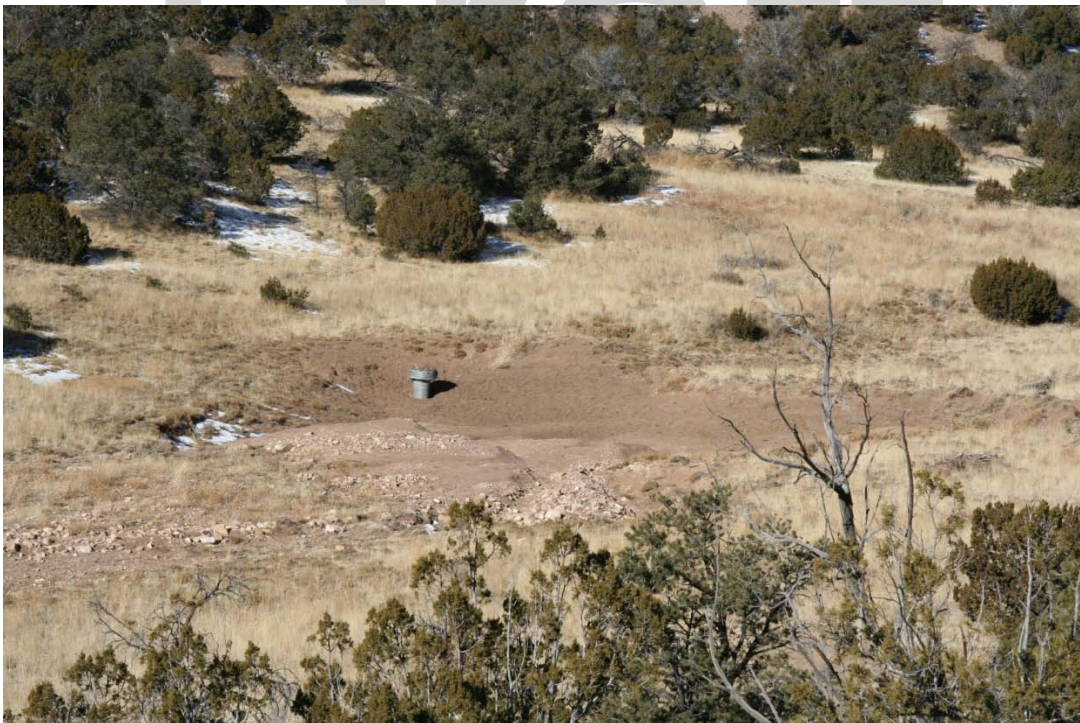
Shows a failed WASCOB that has reached the end of its service life and is potentially built in a location that has too large of a contributing watershed.

There are several breached or nearly breached sediment basins and WASCOBs on this ranch. Rehabilitation of the sediment basins would restore the historic capacity and function could be an effective solution for sediment reduction. The design standard for a WASCOB states that they must be built on watersheds with less than 1 square mile of drainage area. Many of these WASCOBs exceed this standard and rehabilitation is not recommended.

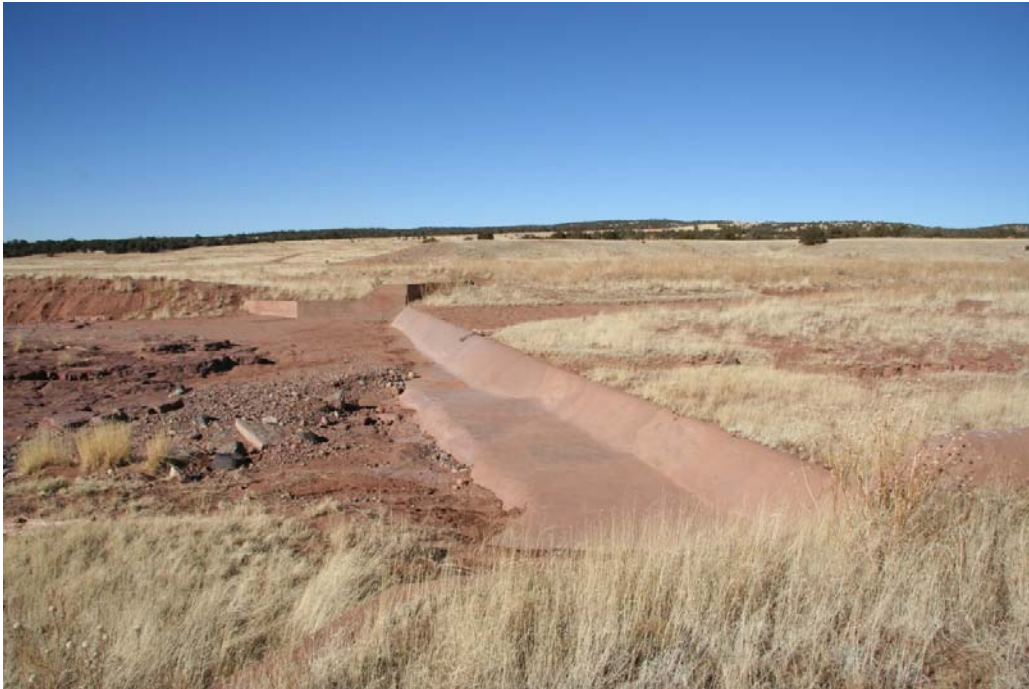
Grade-control sill has effectively controlled the course of Coyote Creek and maintained the local grade.

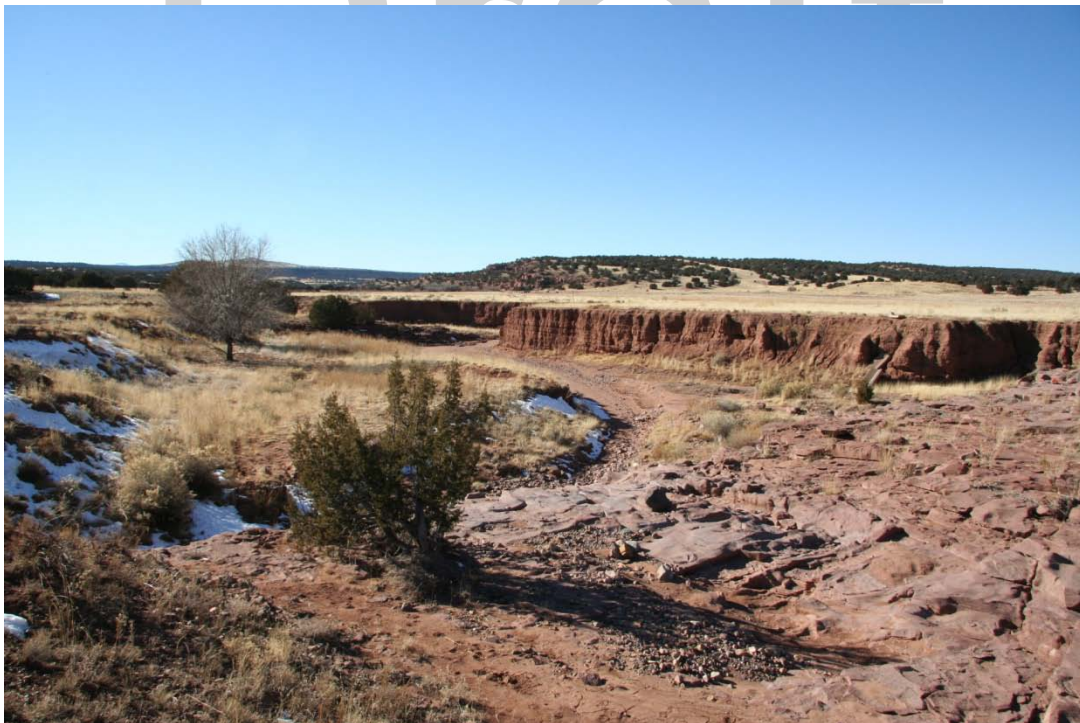
Vertical banks of Coyote Creek, downstream of the grade-control sill. The grade-control sill has been constructed upon the natural bedrock rock seen in the foreground.

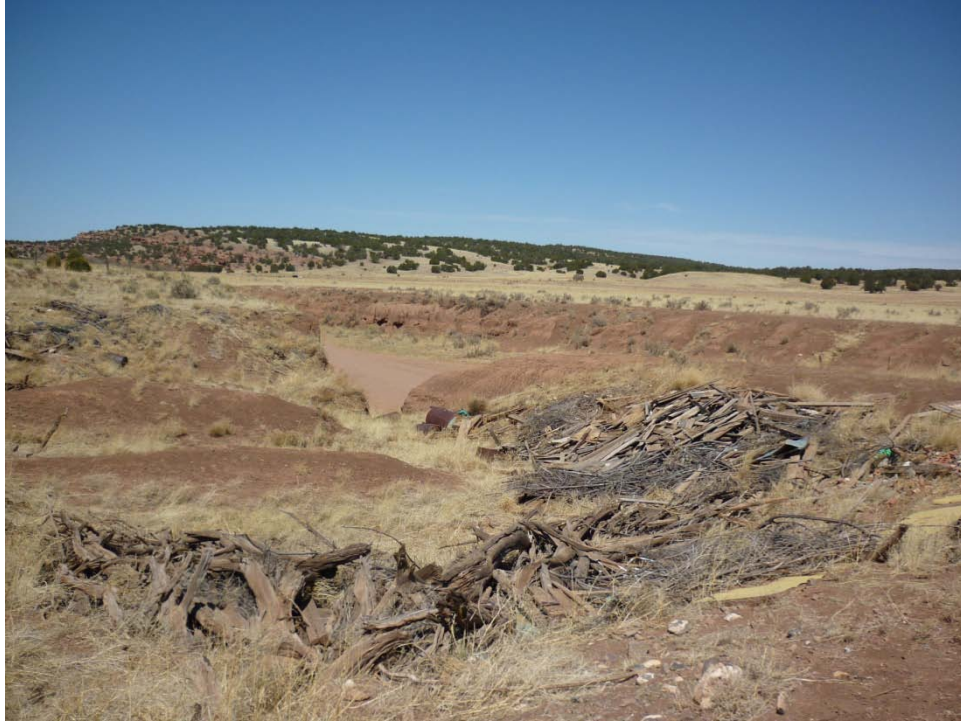
Gully migrating out of Coyote Creek with unsuccessful mitigation in the form of brush.

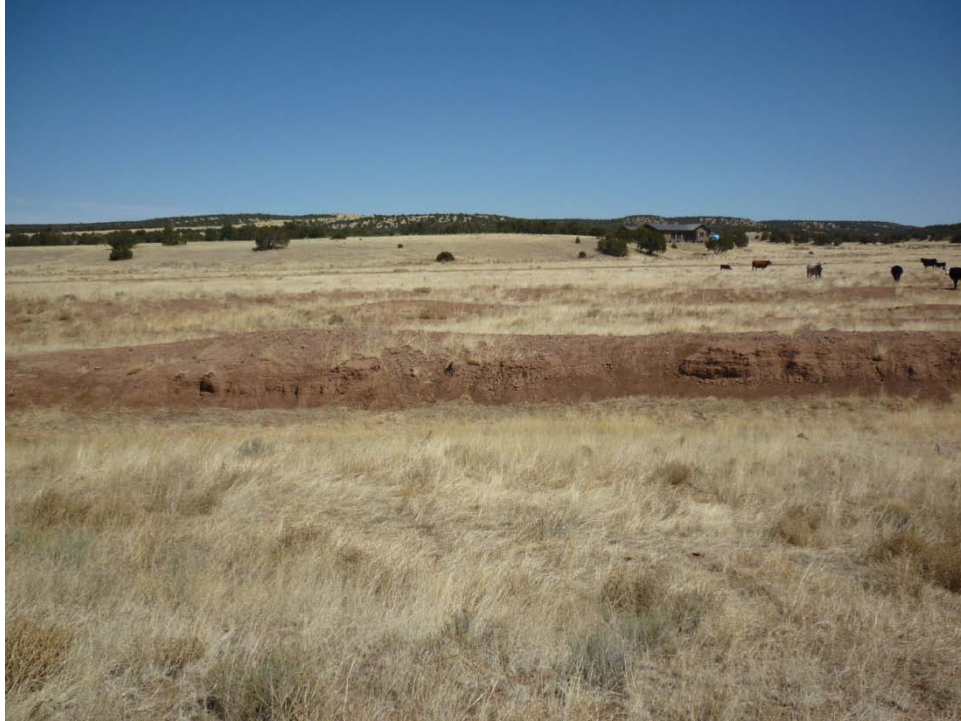
The lower reach of Becker Draw is actively eroding. This reach is evolving toward a stable condition and is a good candidate for bank stabilization.

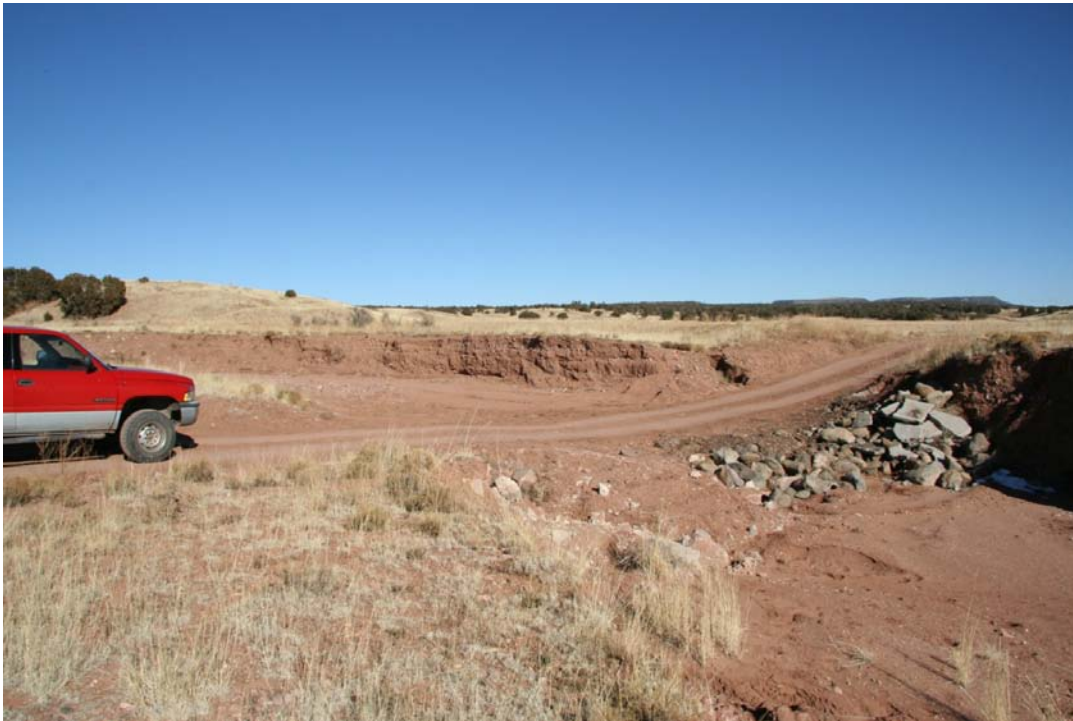
A failing grade-control structure at a road crossing on a tributary to Coyote Creek.

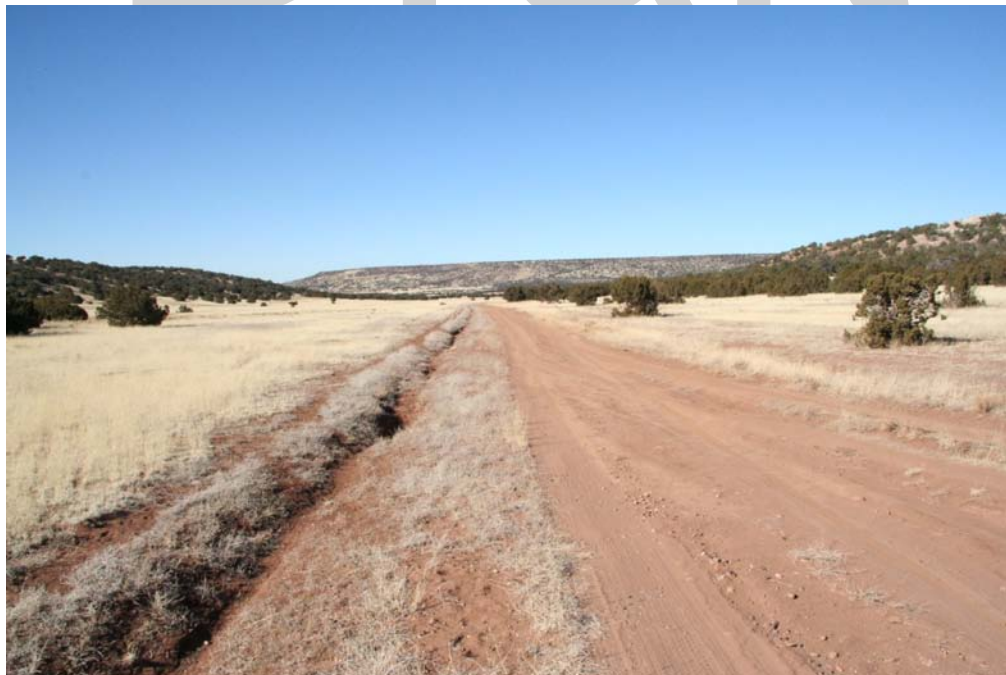
A typical road on this ranch with an actively eroding parallel gully.

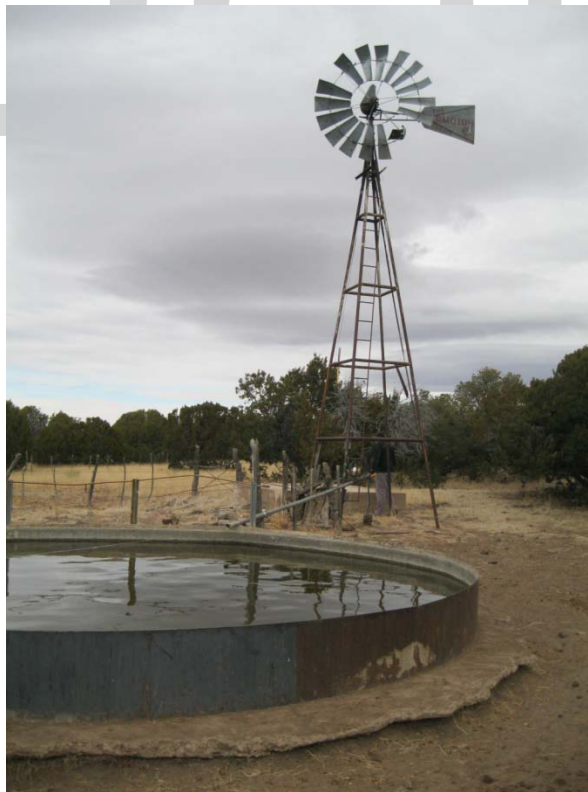
Picture of a damaged windmill and well in need of rehabilitation.
