Ambient Groundwater Quality of the Dripping Springs Wash Basin: A 2004-2005 Baseline Study – June 2011

INTRODUCTION

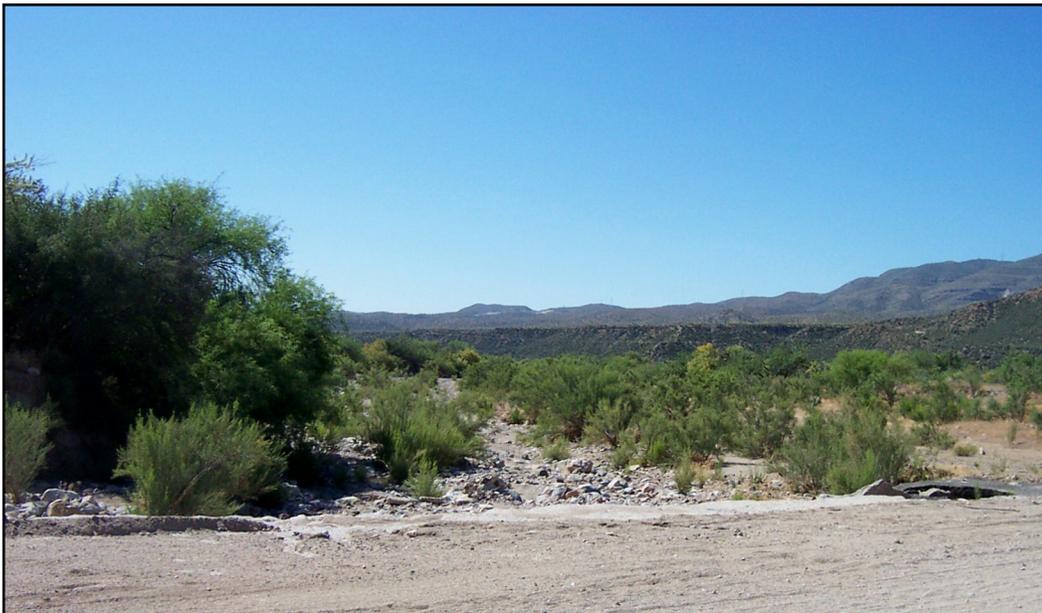
Figure 2. The Dripping Springs Wash, shown at the Dripping Springs Road crossing, is an ephemeral waterway. Most wells in the basin draw water from the alluvium associated with the wash..

The basin is located in a mountainous area that contains small, sediment-filled valleys which store only minor amounts of groundwater.² The largest of the valleys is drained by the Dripping Springs Wash (Figure 2) which is a tributary to the Gila River. The Gila River enters the basin from the east just down gradient of Coolidge Dam and splits the basin roughly in half, flowing from the northeast to southwest. This perennial stream is controlled by releases from Coolidge Dam to meet downstream legal obligations.

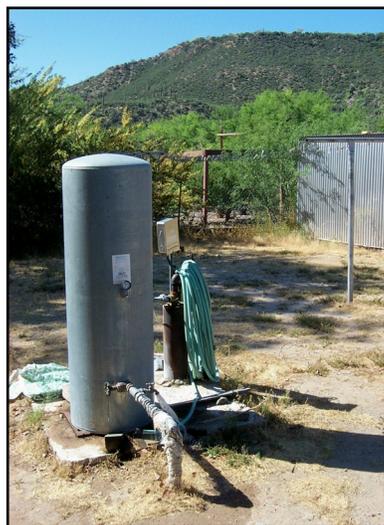
Figure 3 – Most wells sampled for the study are shallow wells tapping the younger alluvium of the Dripping Springs Wash.

(or older alluvium) and consolidated rocks.² The major water producing unit is the younger alluvium that consists of mostly sand, silt and a small amount of gravel to a depth of around 150 feet below land surface. The younger alluvium has been tapped by wells that are used mainly for domestic and stock purposes (Figure 3). The older alluvium consists of stream deposits containing gravel and sand as well as lake deposits consisting of clay, silt, tuff and gypsum. The consolidated rocks, which make up the surrounding mountains, contain only minor amounts of groundwater and issue less than two gallons per minute to springs in the basin (Figure 4).²
