Ambient Groundwater Quality of the Tiger Wash Basin: A 2014 Baseline Study – October 2014

A baseline groundwater quality study of the Tiger Wash basin located 75 miles northwest of Phoenix was conducted in 2014 by the Arizona Department of Environmental Quality (ADEQ) Ambient Groundwater Monitoring Program. ADEQ carried out this task pursuant to Arizona Revised Statutes §49-225 that mandates monitoring of waters of the state, including its aquifers. The fact sheet is a synopsis of the ADEQ Open File Report 14-07.¹

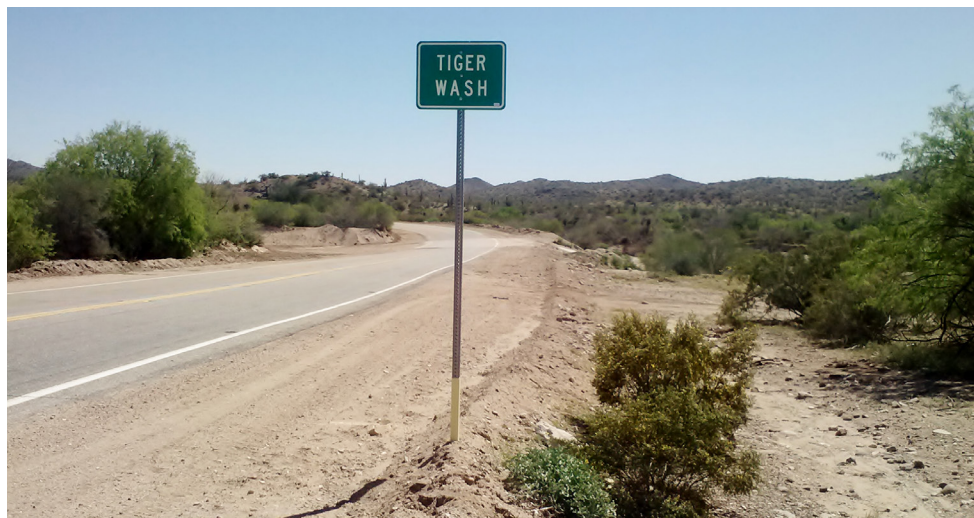
Figure 1 – The basin is drained by Tiger Wash, an ephemeral waterway that flows only in response to major precipitation events. The wash is shown here crossing Eagle Eye Road.

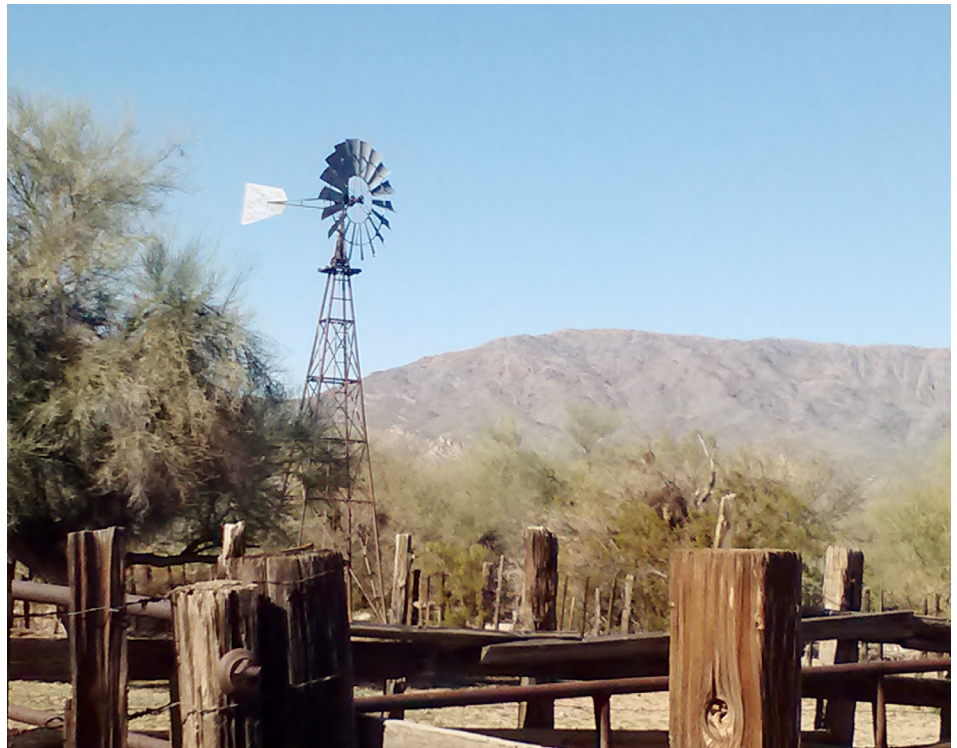
Figure 2 – Tiger well is photographed from the associated corral with the Harquahala Mountains in the background. The sample collected from the windmill met all water quality standards except for arsenic.

Limited time trend analysis involving two wells had inconclusive results. Historic sampling results from Tiger well (TIG-4) suggested generally steady constituent concentrations including arsenic levels which exceeded the Primary MCL. Previous sample results from Headquarters well (TIG-3), however, indicated decreasing concentrations of many constituents. Emblematic are nitrate concentrations which were measured at 16 mg/L in 1984 and declined below the 10.0 Primary MCL to 5.9 mg/L by 2014. Possible explanations for decreasing constituent concentrations at Headquarters well include less input from onsite septic systems.

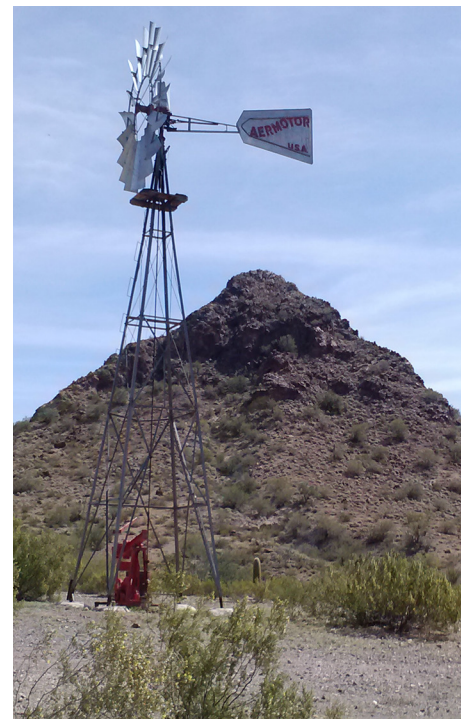
Figure 3 – Little Horn windmill, named after a nearby rock outcrop, was one of five wells sampled for the Tiger Wash basin study. The small, remote basin located west of Phoenix in the Lower Sonoran desert is used almost exclusively for livestock grazing and recreation.

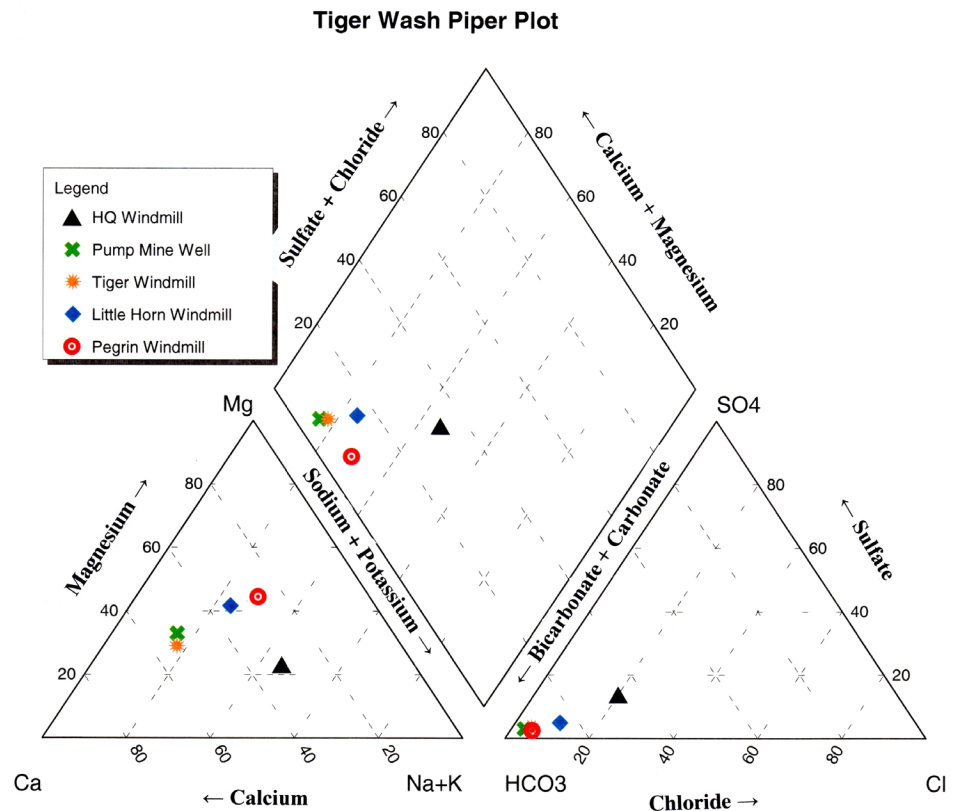
Figure 5 – Samples collected in the Tiger Wash basin are of calcium/magnesium-bicarbonate chemistry, which is reflective of recently recharged groundwater.⁸

Groundwater chemistry in the basin is a combination of calcium/magnesium/mixed-bicarbonate (Figure 5). Other groundwater characteristics are summarized in Table 1.
