Ambient Groundwater Quality of the Hualapai Valley Basin: A 2000 Baseline Study – March 2007

INTRODUCTION

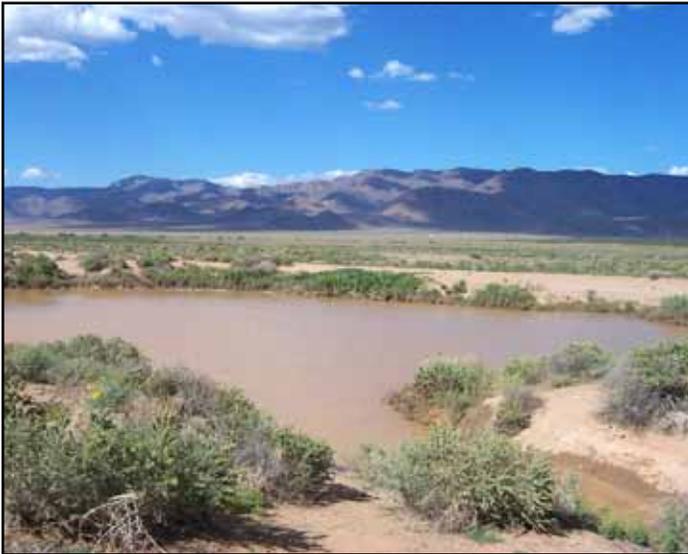
Figure 1 - Monsoon rains fill this stock tank that were diverted from Truxton Wash, below which the channel becomes braided before flowing into Red Lake, a large playa located in the center of the Hualapai Valley basin.

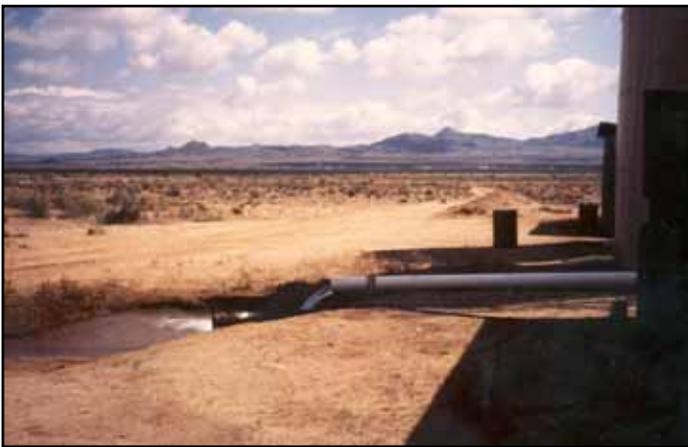
Figure 3 - Wells in the Hualapai Valley basin are capable of producing upwards of 1,000 gallons per minute, including this 1,059 feet deep irrigation well off Route 66 between Kingman and Hackberry. The sample from this well met all health-based water quality standards.
