# Ambient Groundwater Quality of the Tiger Wash Basin

A 2014 Baseline Study  
By Douglas Towne

Arizona Department of Environmental Quality  
Water Quality Division  
Surface Water Section, Monitoring Unit  
1110 West Washington Street  
Phoenix, AZ 85007-2935  
Publication Number: OFR-14-07

## **Arizona Department of Environmental Quality Open File Report 14-07**

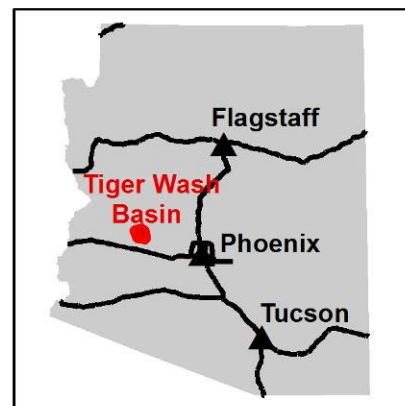
# Map 1 - Tiger Wash Basin

The Tiger Wash groundwater basin comprises approximately 74 square miles within Maricopa County in the west central portion of Arizona (Map 1).<sup>5</sup> The Tiger Wash basin, which is the smallest officially designated groundwater basin in the state, is located about 75 miles northwest of Phoenix. There are no incorporated towns in the rural basin, which had an estimated population of less than 10 people in 2000.<sup>5</sup> The basin is a small, shallow alluvium-filled valley bordered by mountain ranges. Groundwater is used for stock and domestic uses.

The basin is bounded on the north by the Harquahala Mountains and the Little Horn Mountains on the south. Elevations range from a maximum of approximately 2,724 feet above mean sea level (amsl) at Little Horn Mountain to a low of approximately 1,950 feet amsl where Tiger Wash exits into the Harquahala basin.

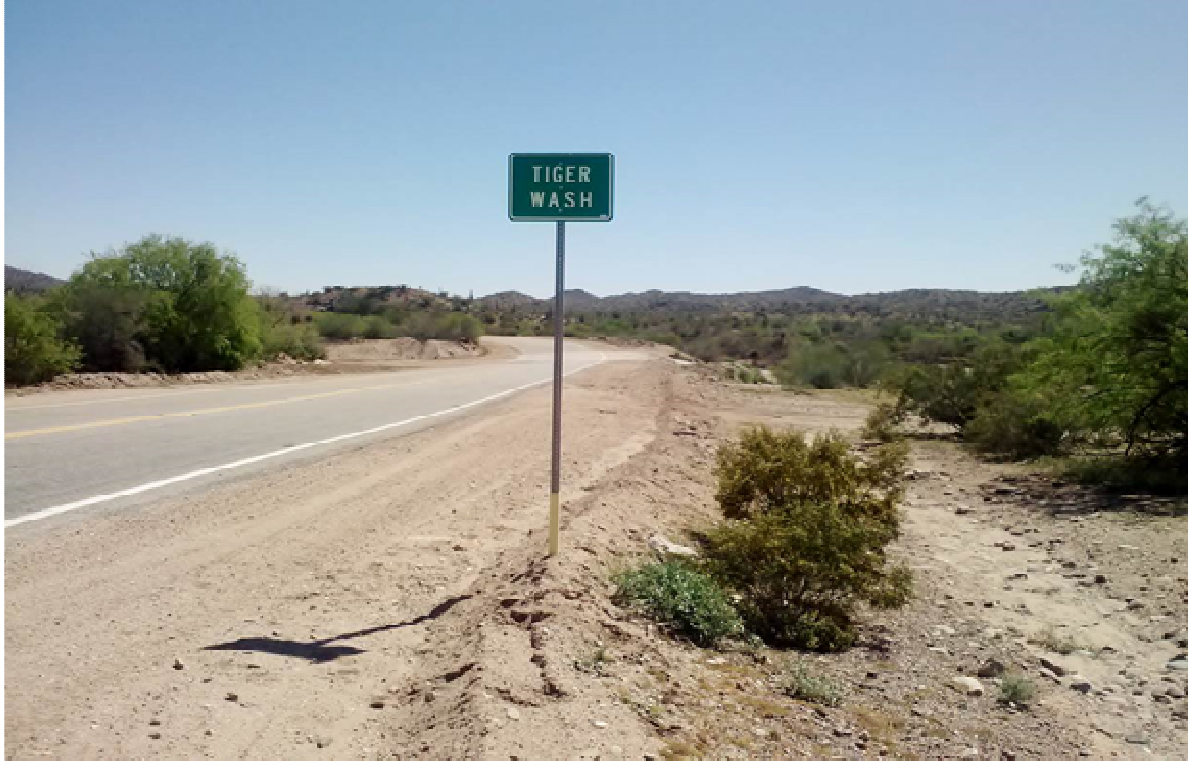
**Figure 1** –The basin is drained by Tiger Wash, an ephemeral waterway that flows only in response to major precipitation events. The wash is shown here crossing Eagle Eye Road.

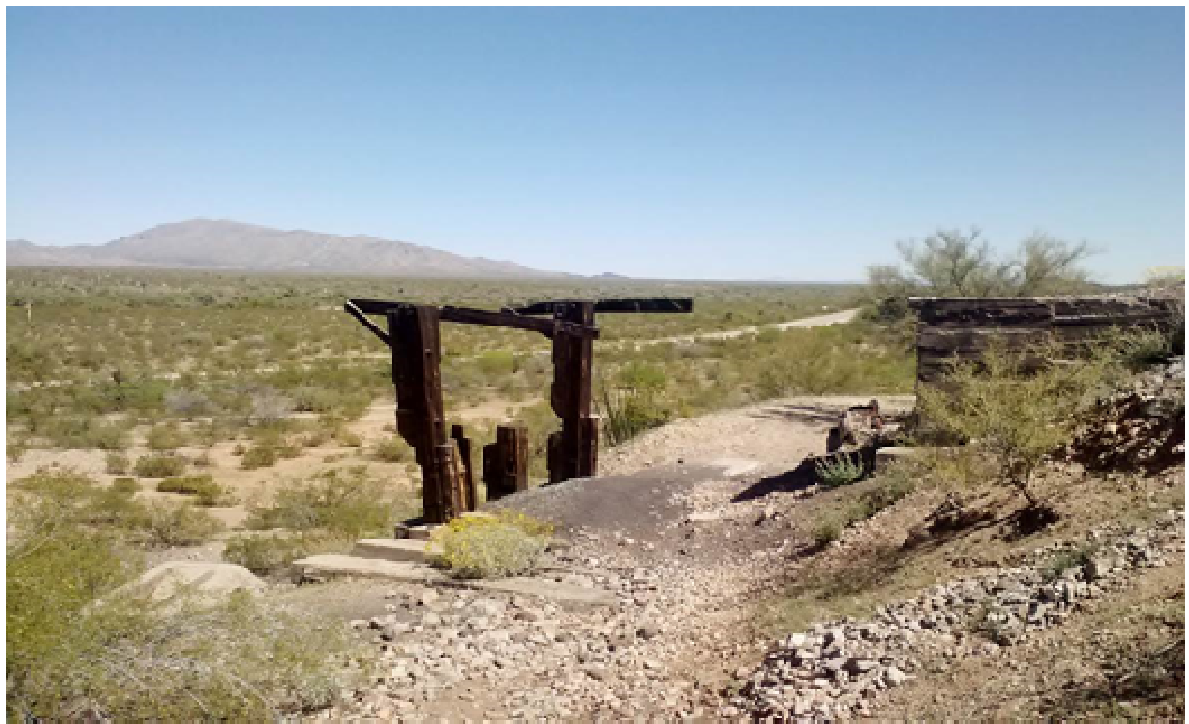
**Figure 2** – Looking north along Eagle Eye Road from a former loading site for ore from the nearby Black Nugget and Black Queen mines. More than 97 percent of the basin consists of federally owned land managed by the Bureau of Land Management that is used for low intensity livestock grazing and recreation.<sup>5</sup>

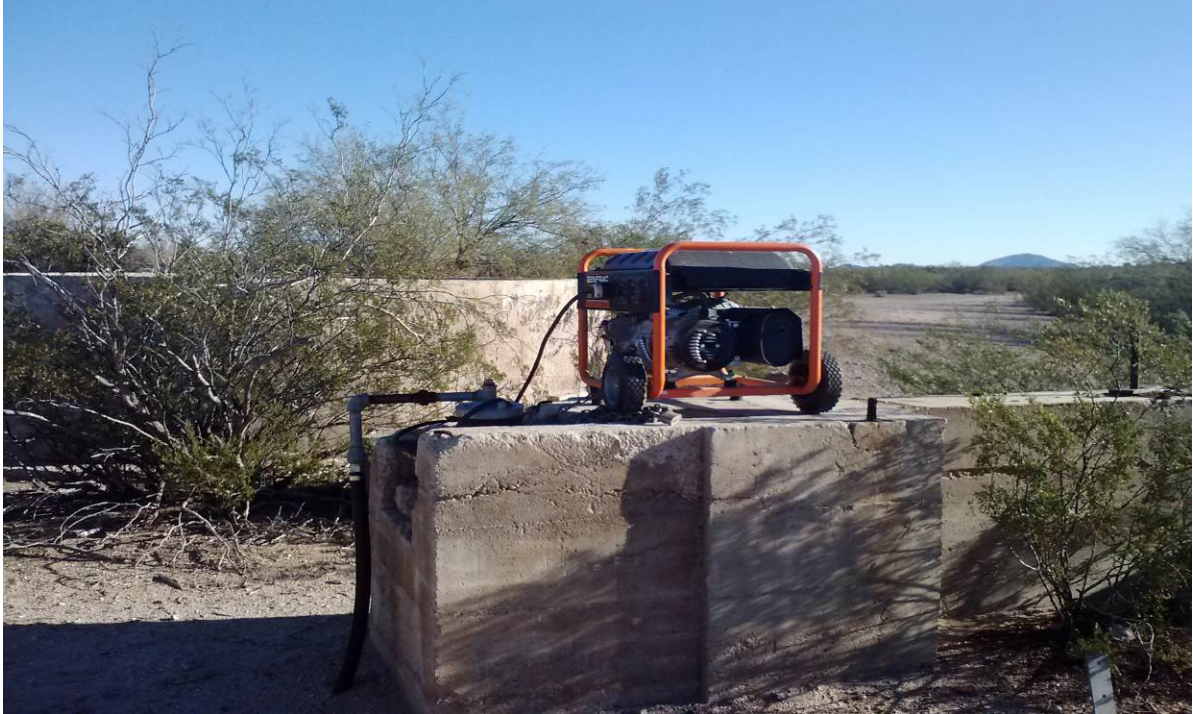
**Figure 3** – A generator powers the submersible pump in Mine Pump well. Water from the well is piped to a nearby water tank and distributed to troughs for livestock and wildlife use. A split sample (TIG-1/2) was collected from the well.

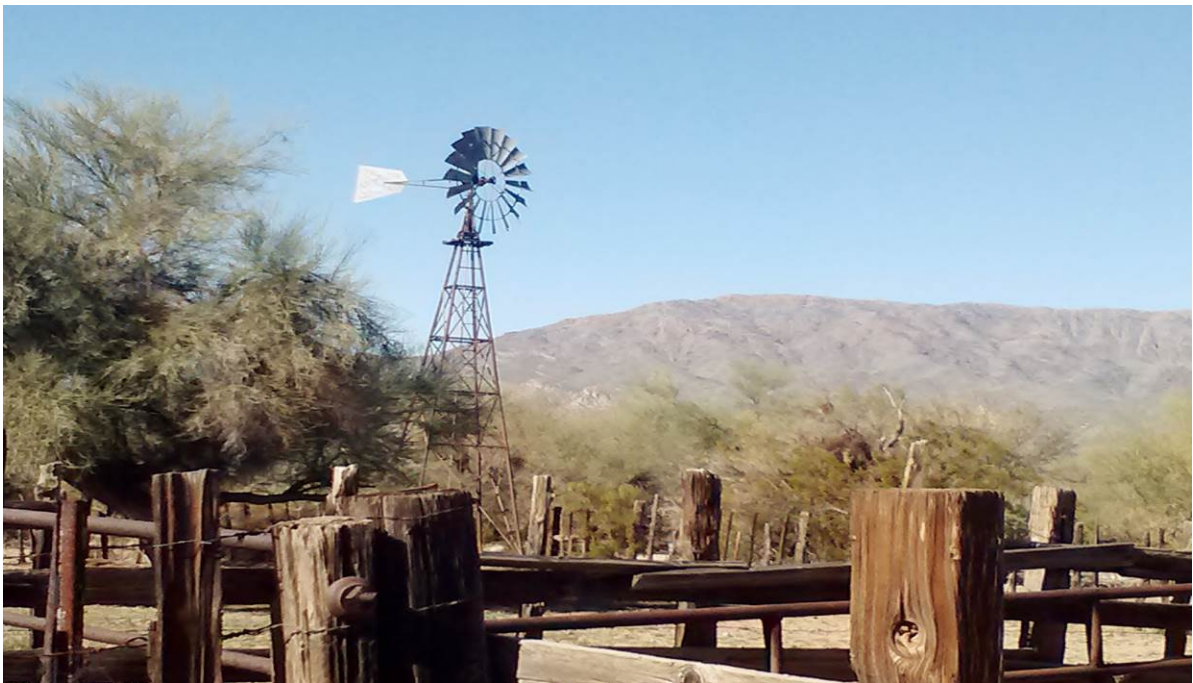
**Figure 4** –Tiger well is photographed from the nearby corral, in the background are the Harquahala Mountains. The sample collected from the windmill met all water quality standards except for arsenic.

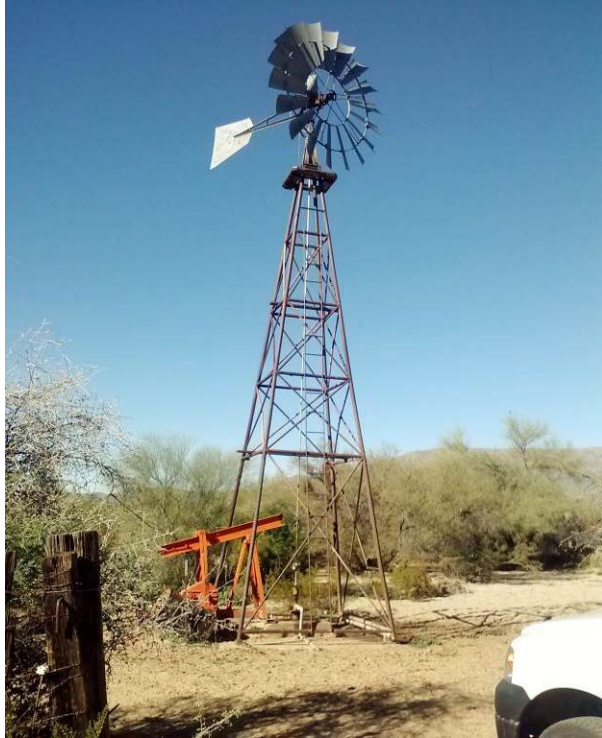
**Figure 5** – Headquarters well is located on a small enclave of private land in the basin. Formerly powered by a pump jack, the sample (TIG-3) collected from the windmill met all water quality standards.

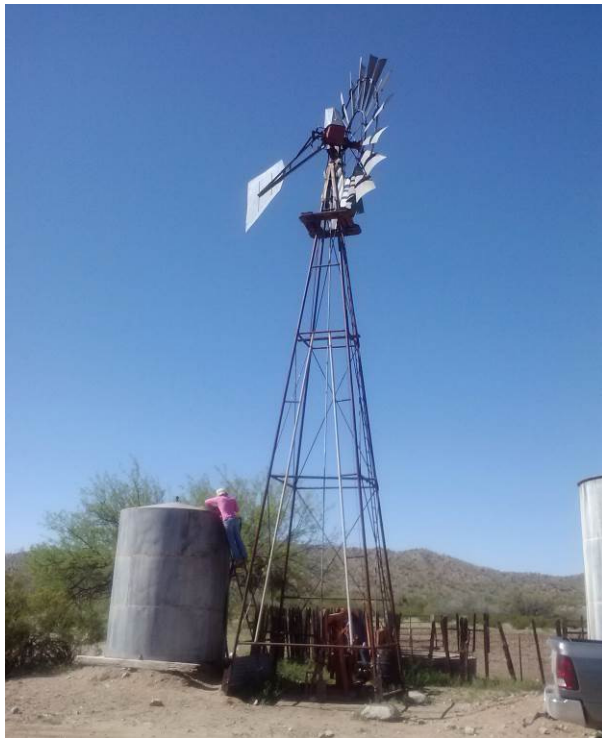
**Figure 6** – ADEQ’s Elizabeth Boettcher collects a sample (TIG-6) from Pegrin well. The well was temporarily powered by a pump jack to keep up with livestock water demands because of calm winter winds.

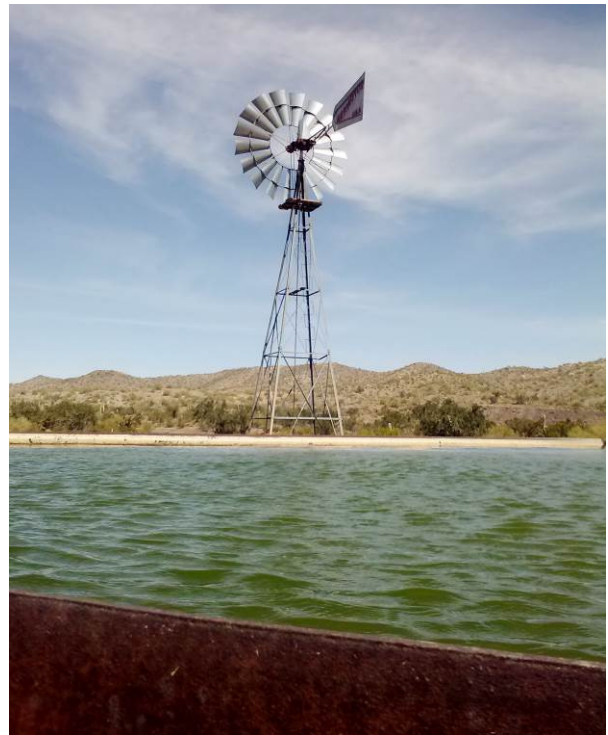
**Figure 8** – The water tank supplied by Little Horn well was full when a sample (TIG-5) was collected in February 2014. Overflow from the windmill supports a small riparian area adjacent to the tank.

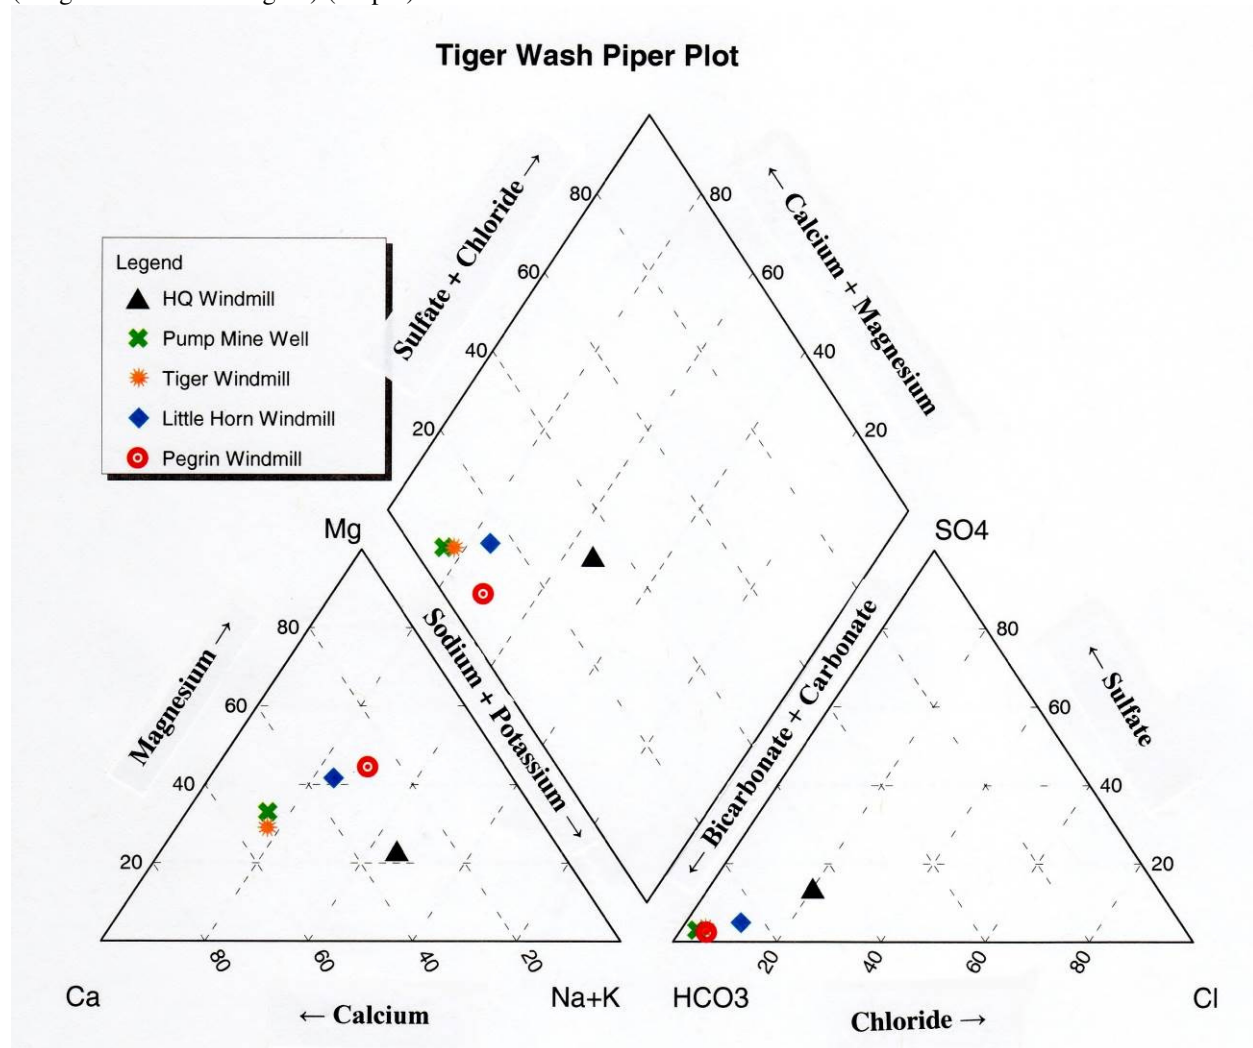
**Diagram 1** – Samples collected in the Tiger Wash basin are predominantly of calcium/magnesium-bicarbonate chemistry which is reflective of recently recharged groundwater.<sup>19</sup>

The water chemistry at the five sample sites in the Tiger Wash basin are all calcium-bicarbonate (Diagram 1 – middle figure) (Map 4). The dominant

cation was calcium at two sites, magnesium at two sites, and one site was mixed (Diagram 1 – left figure). The dominant anion was bicarbonate at five sites (Diagram 1 – right figure).

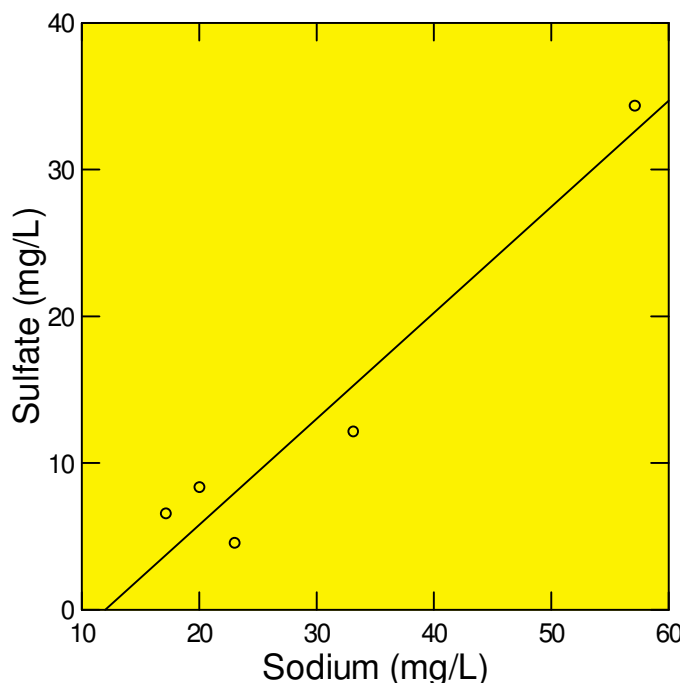
**Diagram 2** – The cation and anion that best predict TDS concentrations, sodium and sulfate, are significantly positively correlated (regression analysis,  $p \leq 0.01$ ). This relationship is described by the regression equation:  $y = 1.3x + 13.2$  ( $r = 0.97$ ).

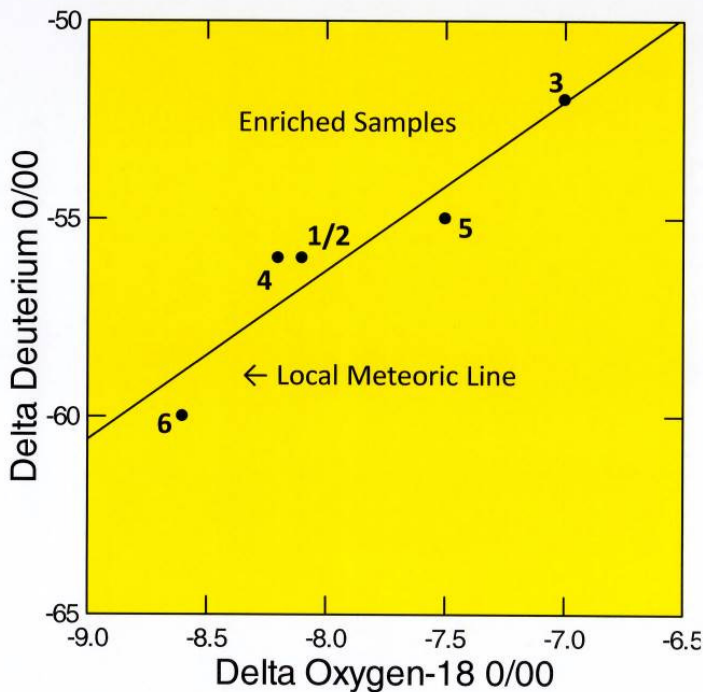
**Diagram 3** – The five isotope samples are plotted according to their oxygen-18 and deuterium values and form the Local Meteoric Water Line. The samples all consist of enriched samples that contain younger water recharged from lower-elevation precipitation that has undergone the most evaporation prior to sampling. This is in contrast to most of the isotope samples collected in nearby western Arizona groundwater basins such as Butler Valley, Harquahala, and Ranegras Plain. Samples from these basins were mostly depleted and consisted of older recharge that had undergone less evaporation prior to sampling and appeared to reflect groundwater recharged during cooler climatic conditions.<sup>11, 23, 24, 25</sup>

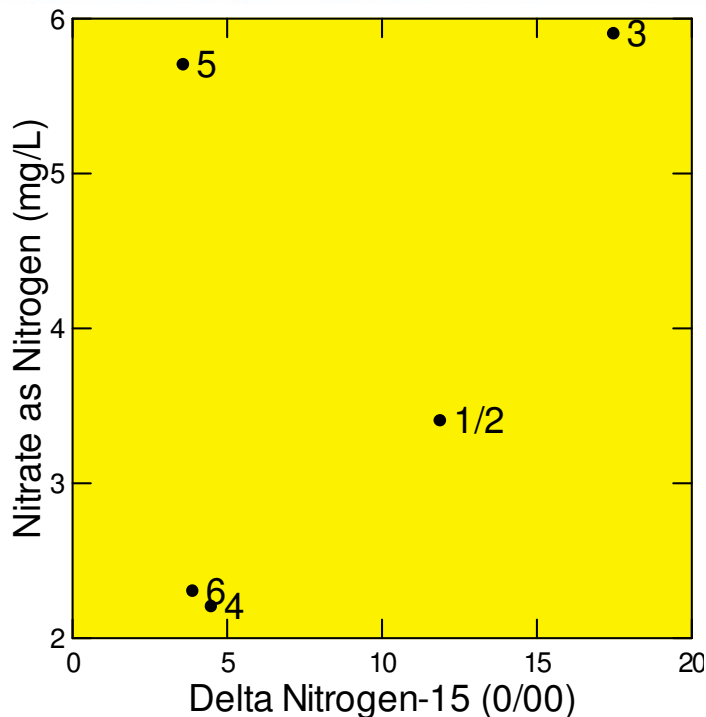
**Diagram 4** – The five nitrogen isotope samples are plotted along with their corresponding nitrate (as N) concentrations. Samples from three sites (TIG-4, TIG-5, and TIG-6) appear to stem from natural soil organic matter while nitrogen from animal waste may impact the remaining two sites (TIG-1/2 and TIG-3).<sup>20, 22</sup> However, these categories didn't appear to be accurate in the adjacent Harquahala basin where most  $\delta^{15}\text{N}$  values corresponded with naturally occurring soil organic matter yet there was a strong statistical correlation between nitrate concentrations and areas of irrigated agriculture.<sup>23</sup>

Based on these isotope results, it appears that the nitrogen source is natural soil organic matter for three samples in which  $\delta^{15}\text{N}$  values ranged from +3.6 to

+3.9 ‰.<sup>20, 22</sup> In two samples with  $\delta^{15}\text{N}$  values of 11.9 and 17.5 ‰, it appears that animal waste is the predominant contributor of nitrogen. The samples were collected respectively from Pump Mine Well and Tiger Well, both of which are frequently used by livestock for watering purposes.

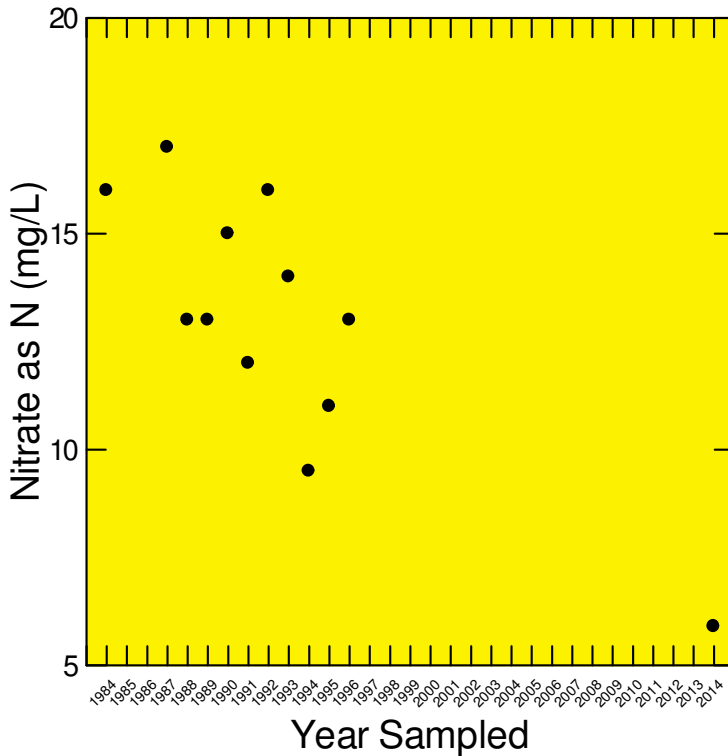
**Diagram 5** – Old Headquarters well (TIG-3) was sampled 12 times over a 30-year period from 1984 to 2014. The nitrate (as N) concentrations have declined 46 percent during this time period, with the majority of the decrease occurring 18-year time period between 1996 and 2014.
