ATTACHMENT D
PROCEDURES TO PREVENT HAZARDS

ATTACHMENT D (Application SECTION 4)

PROCEDURES TO PREVENT HAZARDS

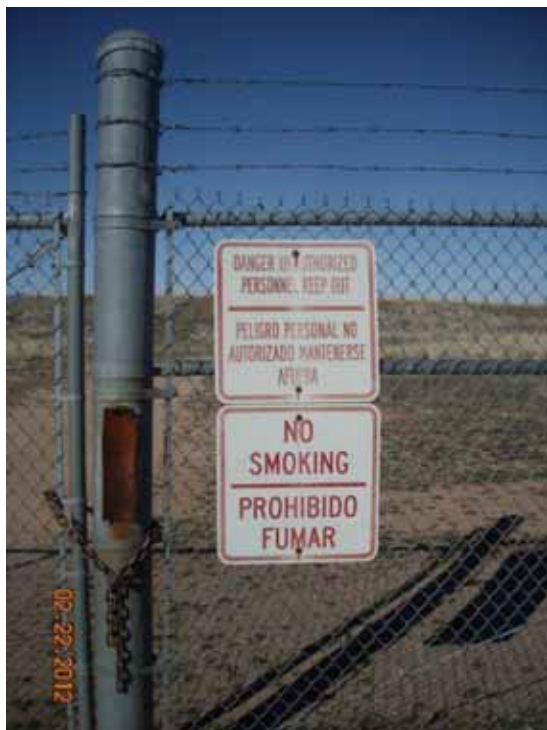
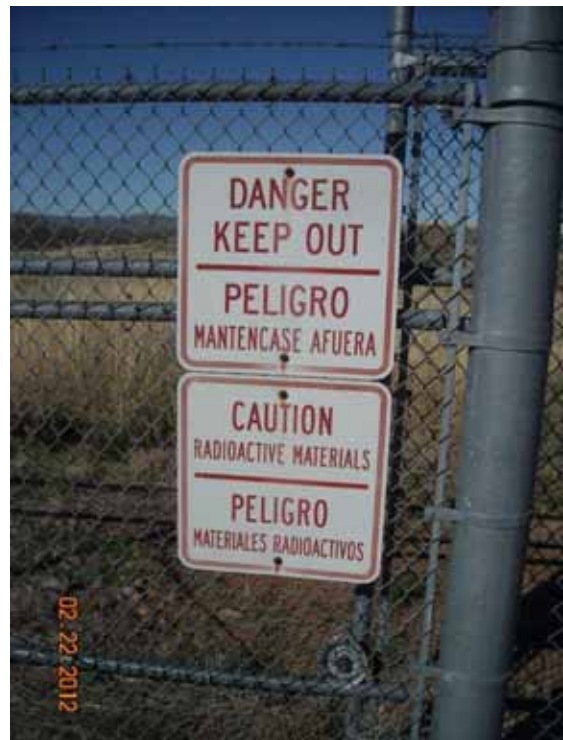
FIGURE D-1
TOPOGRAPHICAL MAP

The entire facility is enclosed by a 6-foot chain-link fence (with 45-degree barb wire on top), which surrounds both Units A and Unit B, all monitoring wells, and soil vapor extraction equipment. The fence posts are made of steel and are set in concrete (see Figure D-1).

The access to the facility is through three 24-foot rolling gates (two on the east boundary and one on the north boundary (see Figure D-1). The facility gates are kept locked at all times when UA personnel or their representatives are not at the facility.

Surface water drainage around the facility is generally to the west and southwest. The storm water run-on control system consists of storm water drainage channels and culverts (see Figure D-1). The storm water run-on from the surrounding area to the northeast and east is controlled by storm water channels, which, in turn, convey and dissipate the flows into the surrounding area. Inspection of drainage structures is described in Attachment B and Appendix B-1.

The final grading of the caps drains the surfaces to the perimeters of each unit: northeast and southwest at Unit A, and north and south at Unit B (see Figure D-1). Storm water then flows as sheet flow to the surrounding area.
