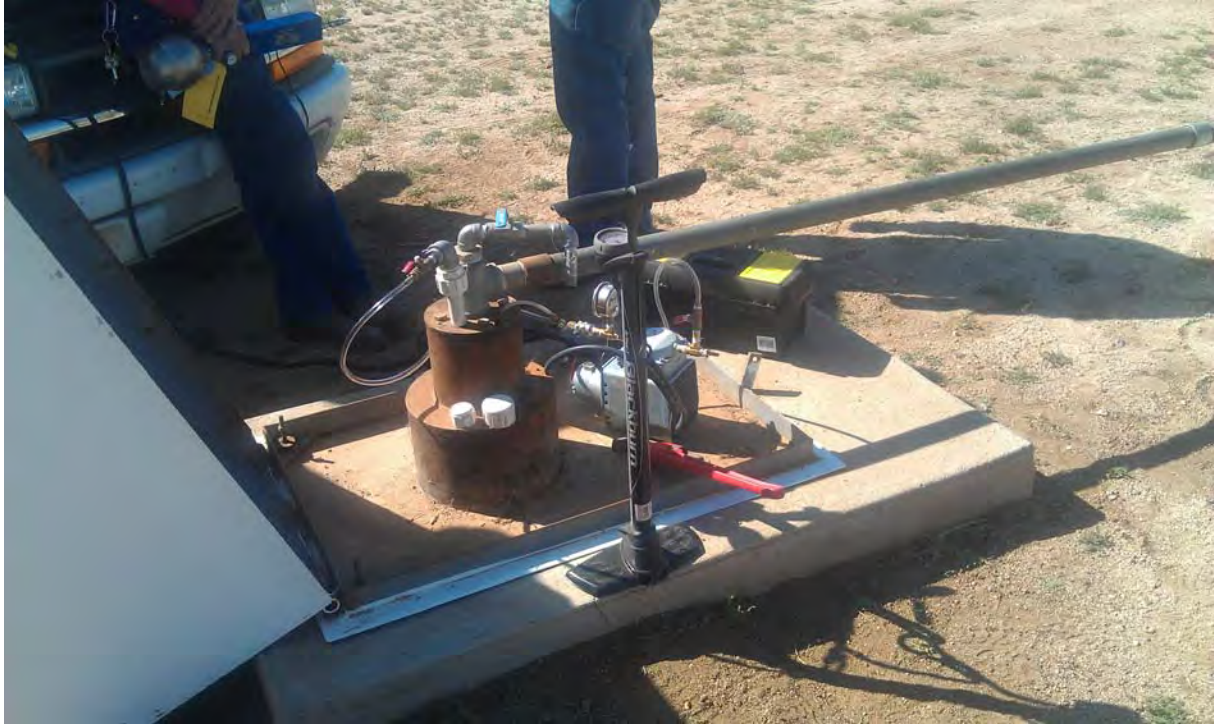
**Figure 4.** Photograph of retrofitted ground water monitoring well MW-2, while setting it up for soil vapor sampling.
