Project Name: Miracle Mile Remedial Investigation Report

Job No: 23444816.52000

Date: January 2007

Time-Series Graphs

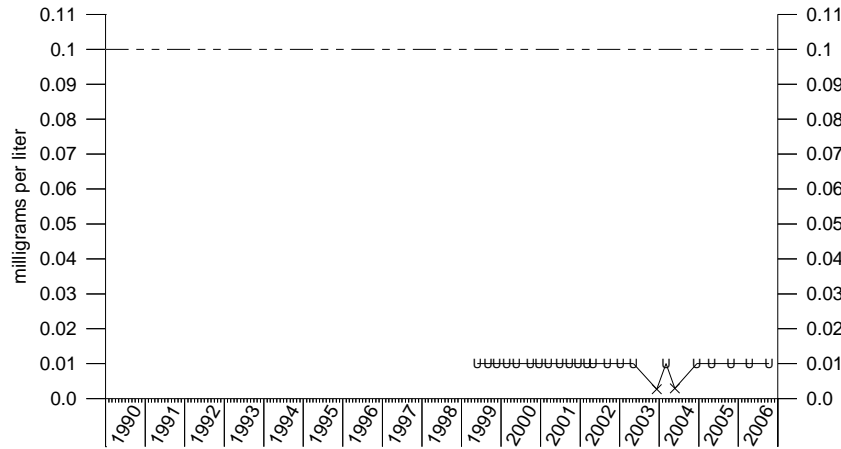
**Chromium
Crescent Manor**

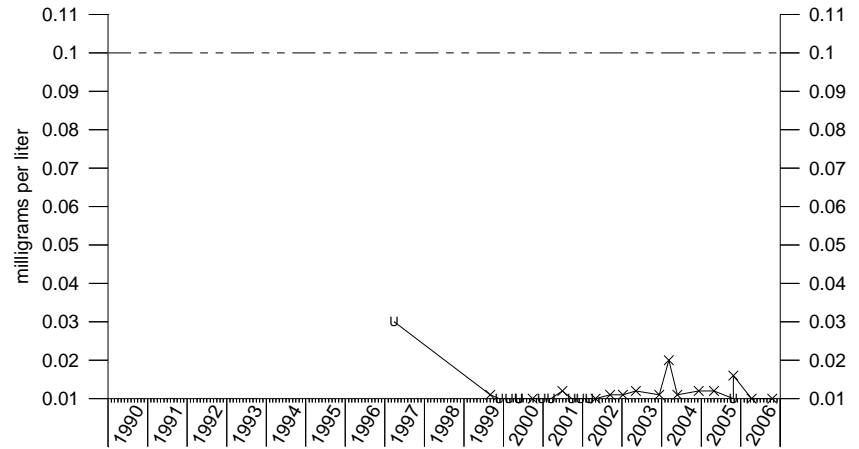
**Chromium
Douglas**

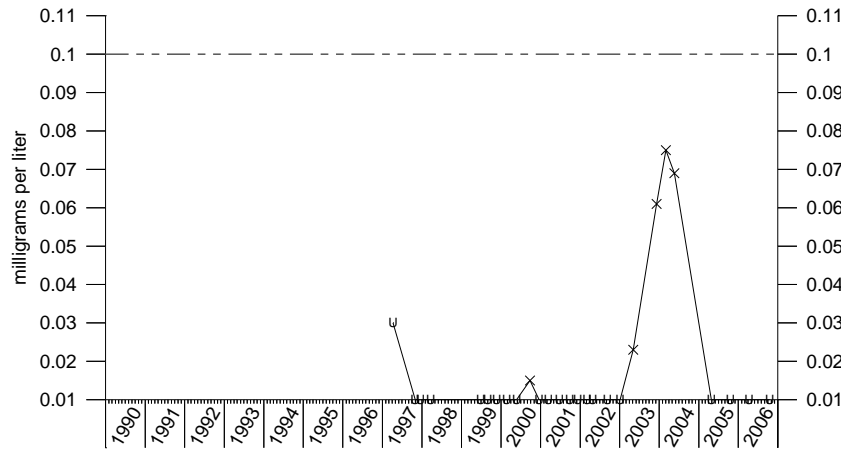
**Chromium
IRA-1**

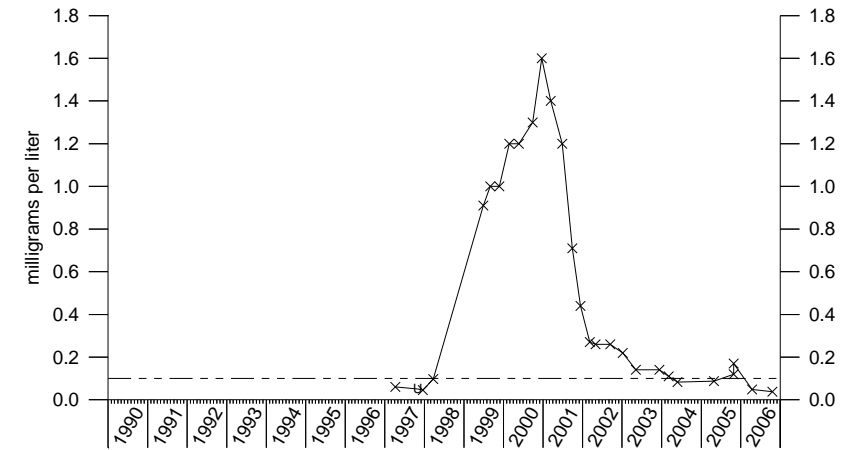
**Chromium
IRA-2**

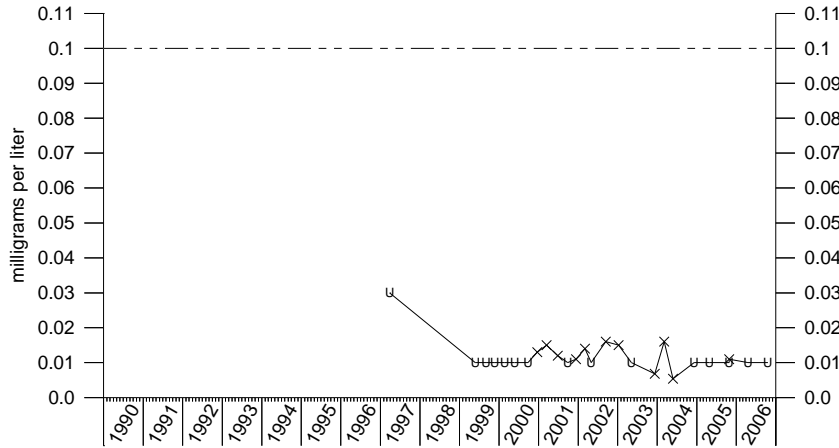
**Chromium
IRA-3**

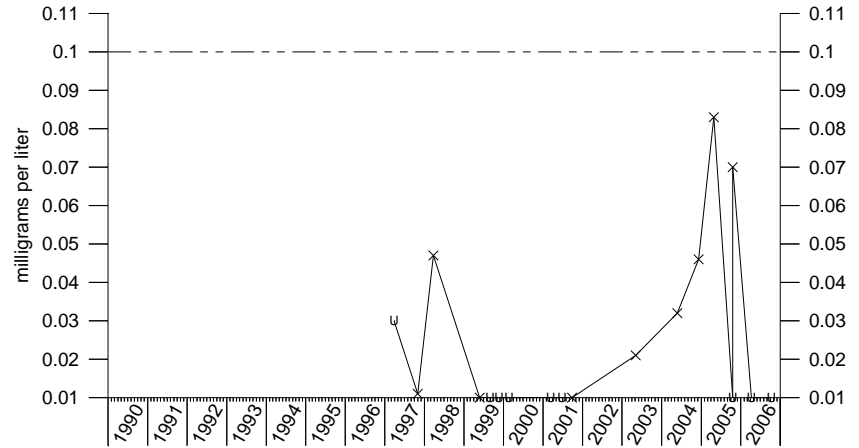
**Chromium
IRA-4**

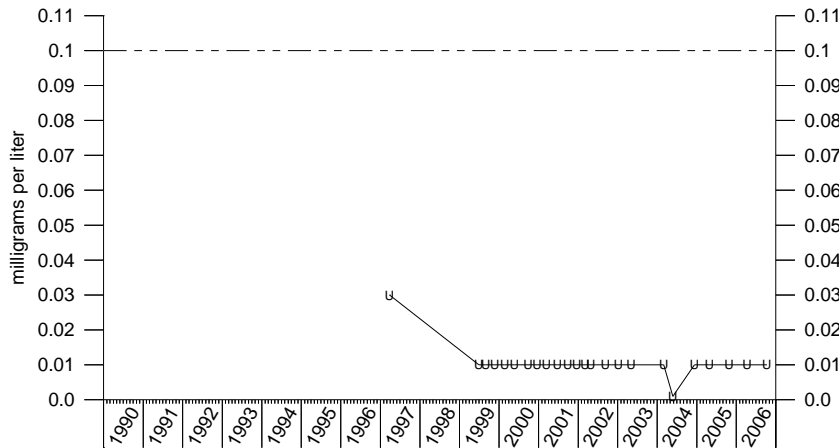
**Chromium
IRA-5**

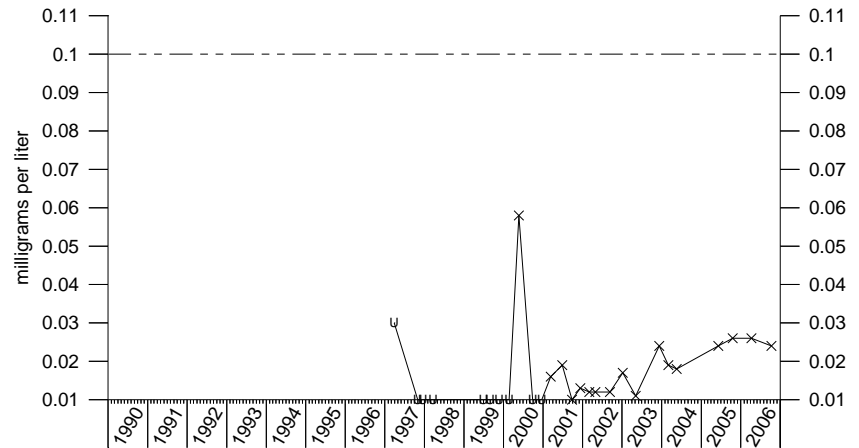
**Chromium
IRA-6**

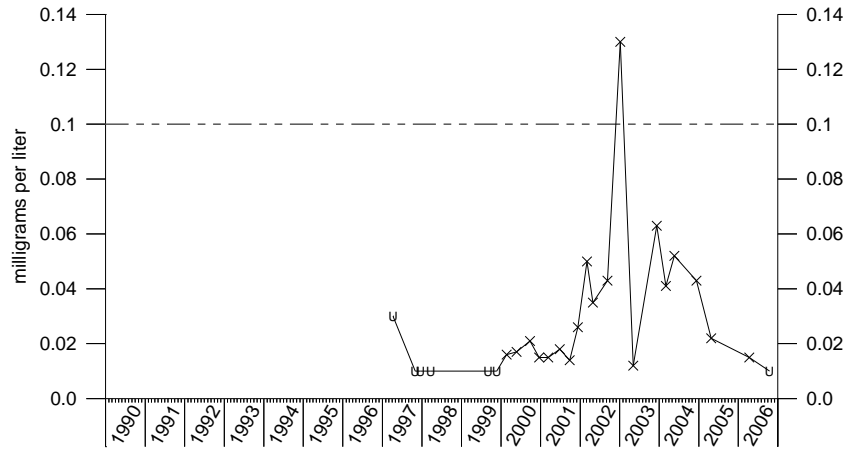
**Chromium
IRA-7**

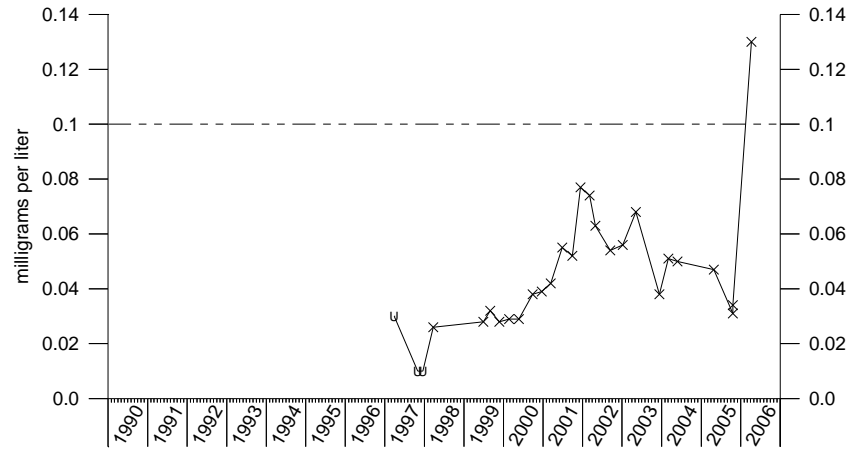
**Chromium
IRA-8**

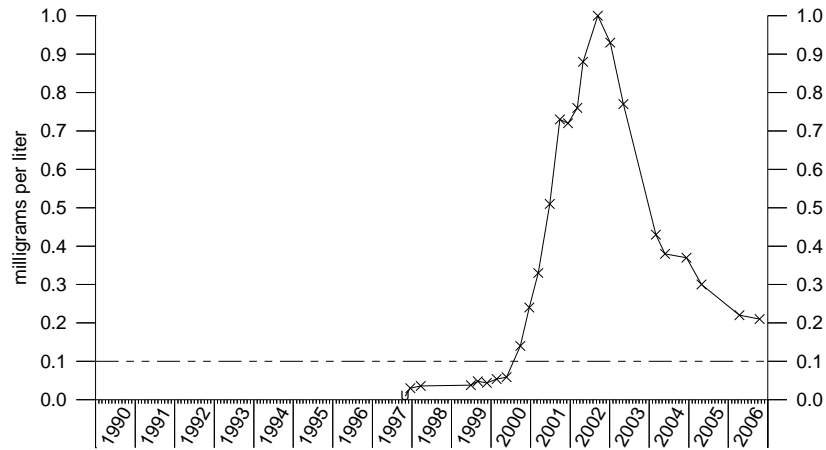
**Chromium
IRA-9**

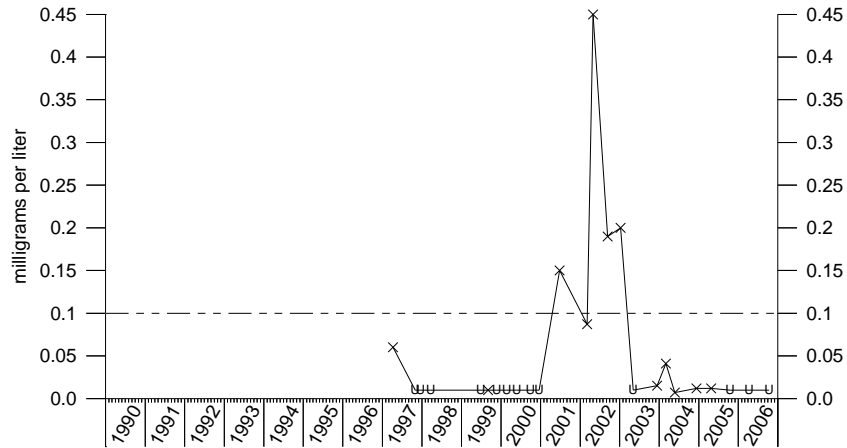
**Chromium
IRA-10-230**

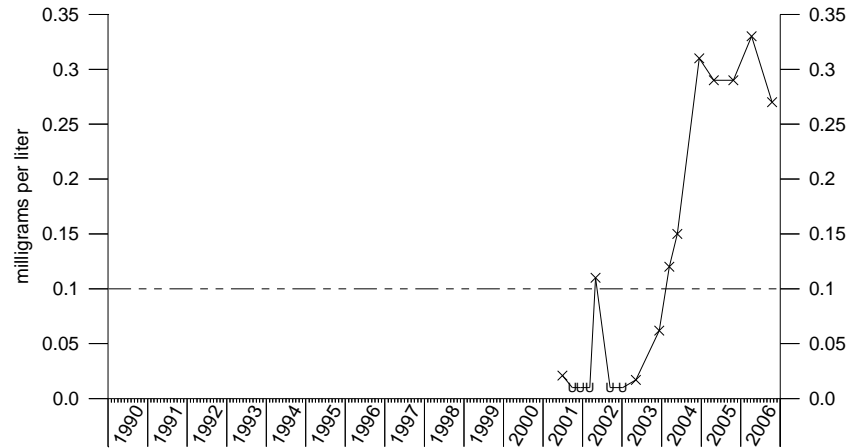
**Chromium
IRA-11-210**

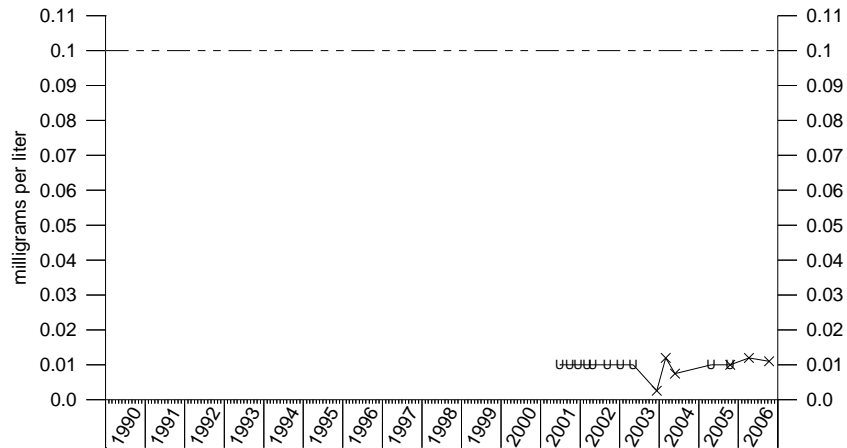
**Chromium
IRA-12-210**

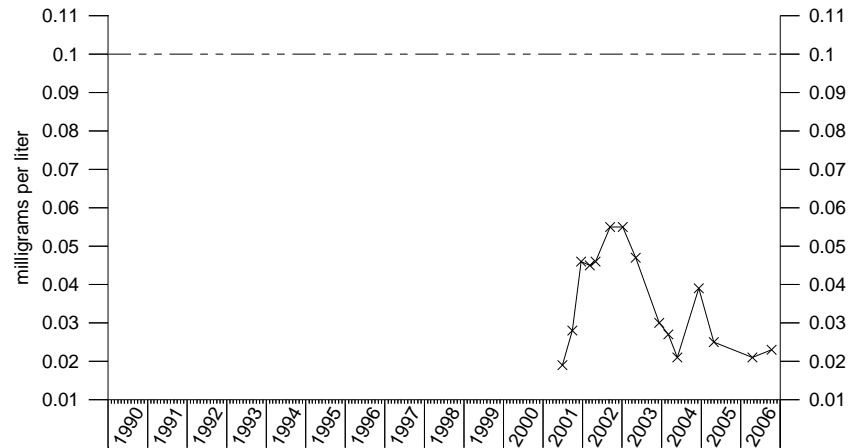
**Chromium
IRA-13-210**

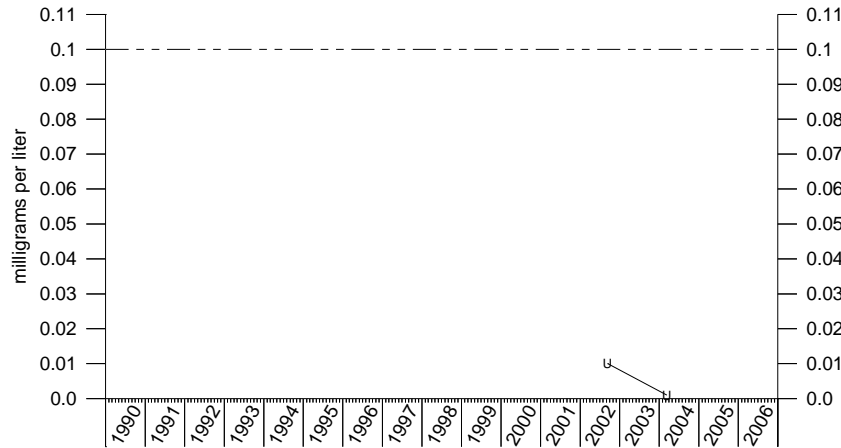
**Chromium
IRA-11-70**

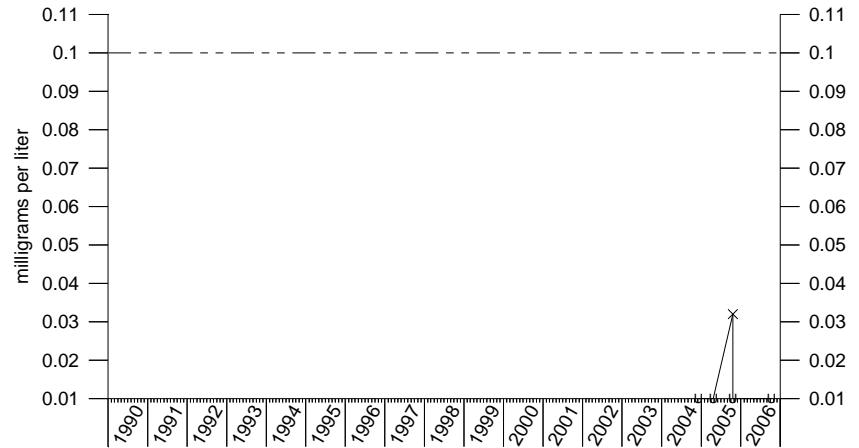
**Chromium
IRA-12-70**

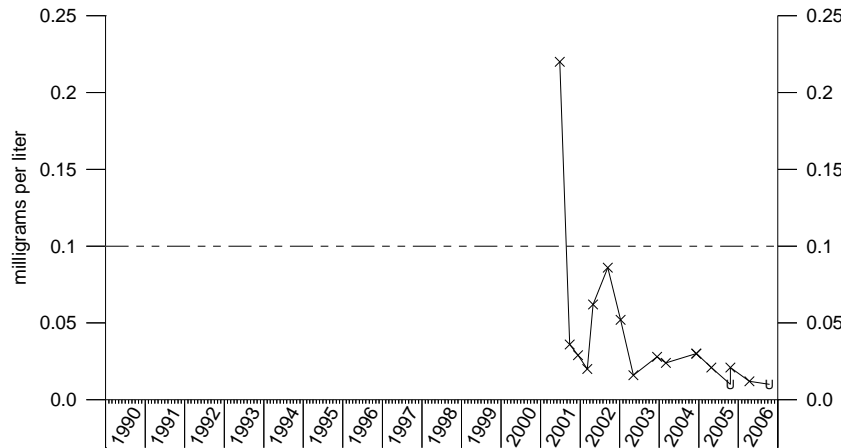
**Chromium
IRA-16**

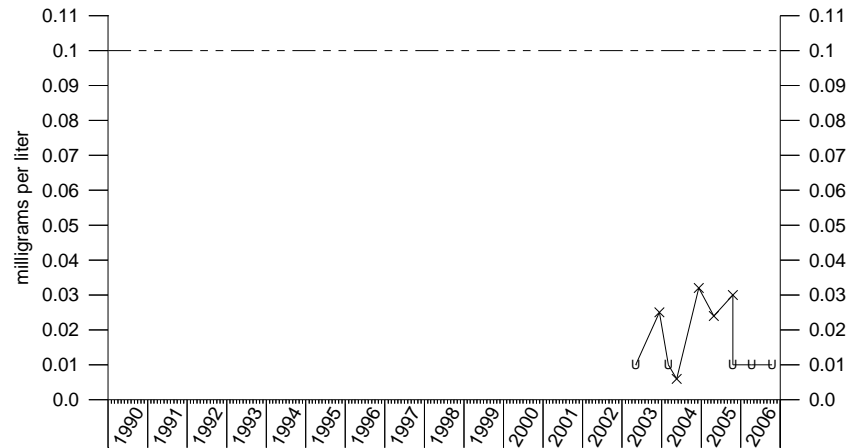
**Chromium
IRA-17**

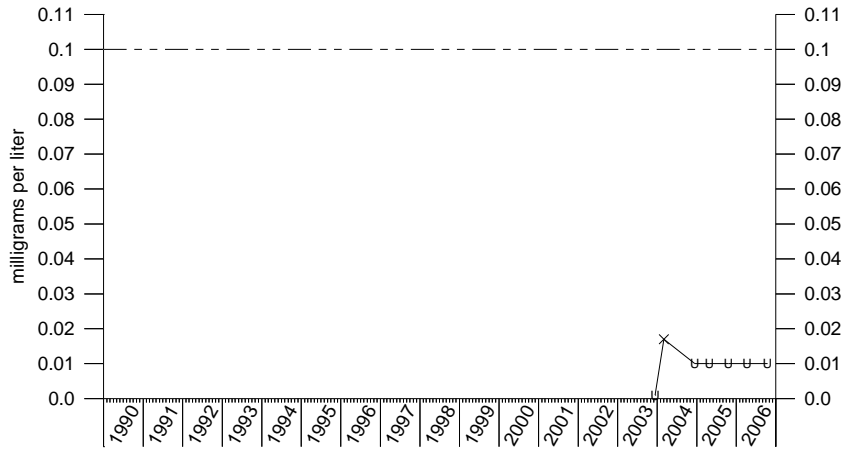
**Chromium
IRA-19**

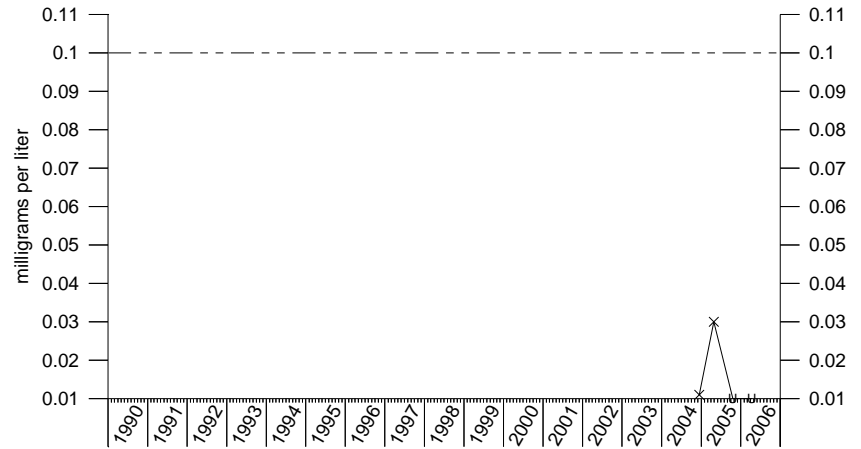
**Chromium
IRA-20**

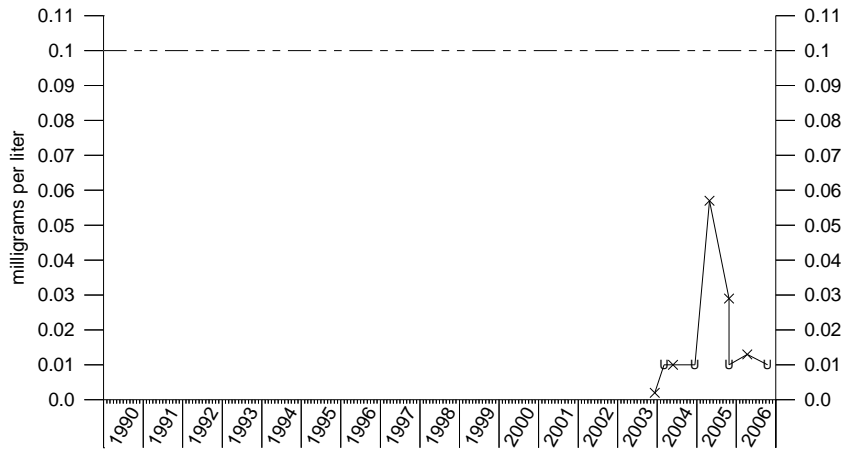
**Chromium
IRA-21**

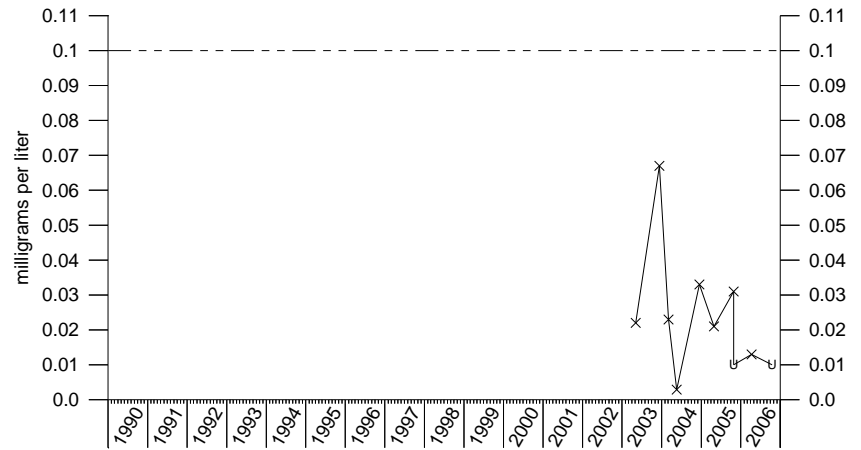
**Chromium
IRA-22**

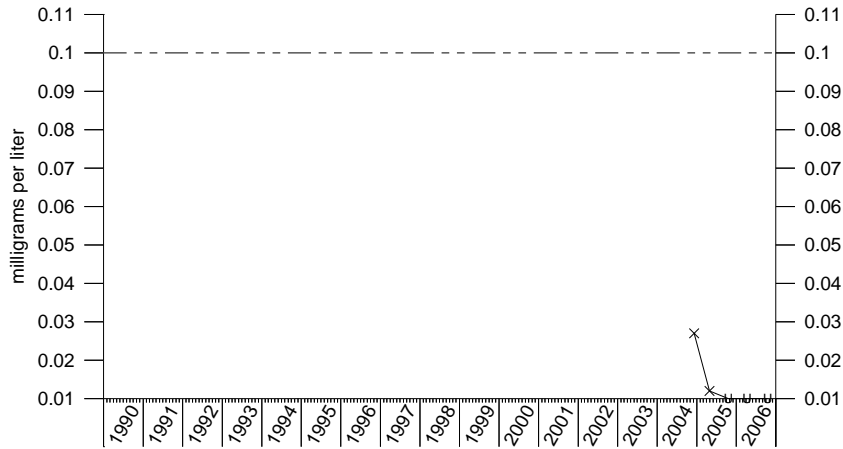
**Chromium
IRA-27**

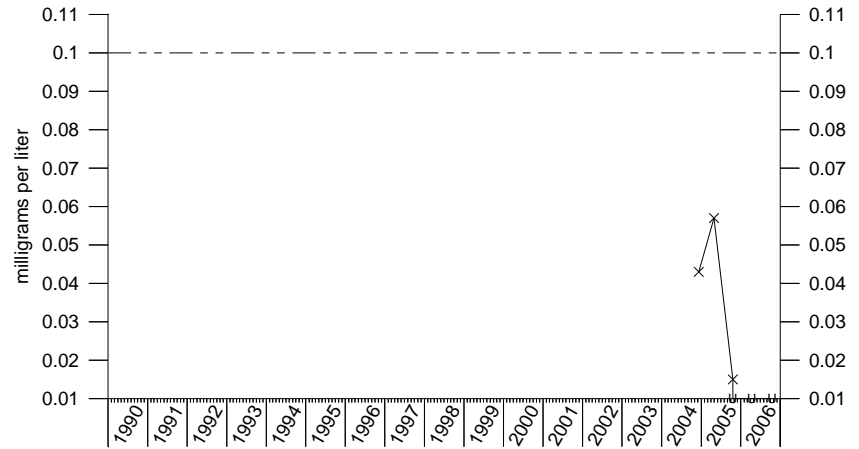
**Chromium
IRA-29**

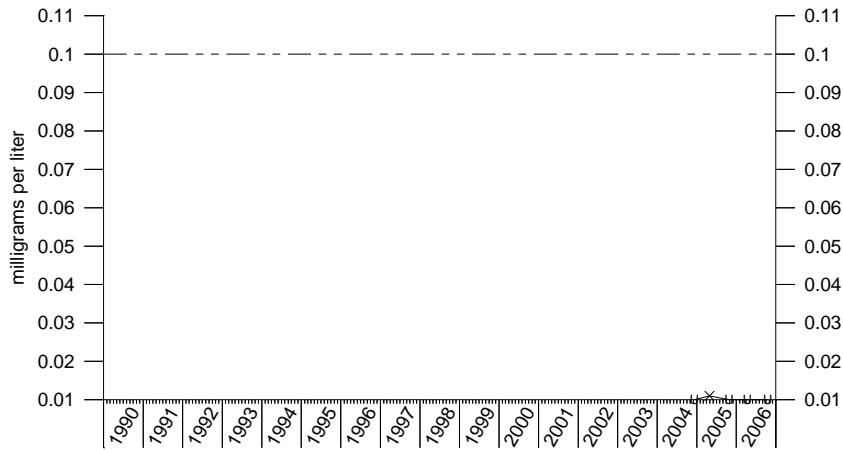
**Chromium
IRA-30**

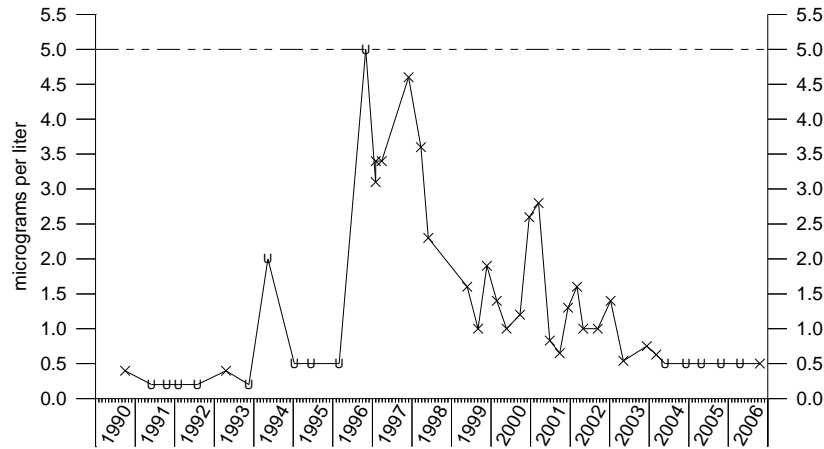
**Trichloroethene
IRA-3**

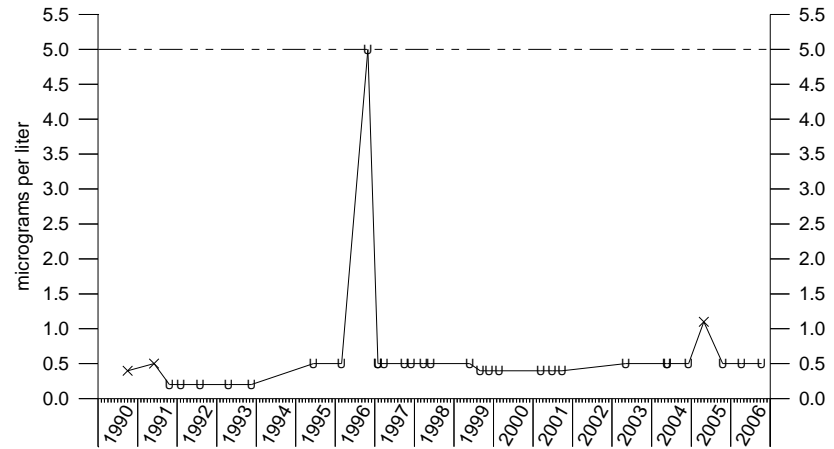
**Trichloroethene
IRA-4**

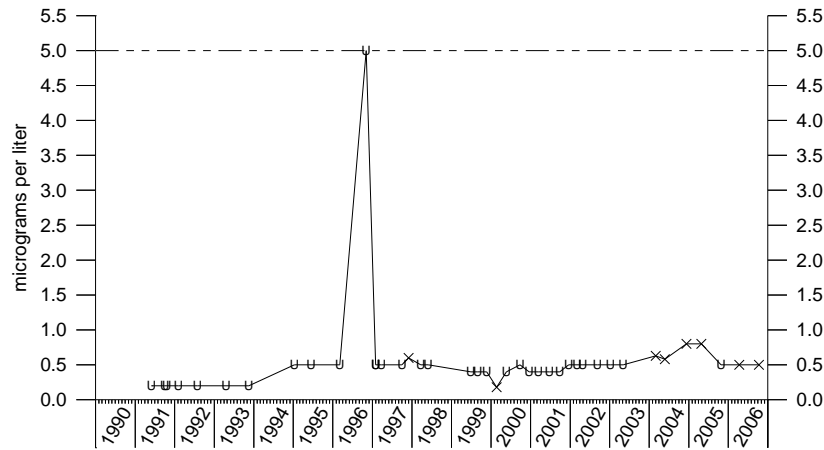
**Trichloroethene
IRA-5**

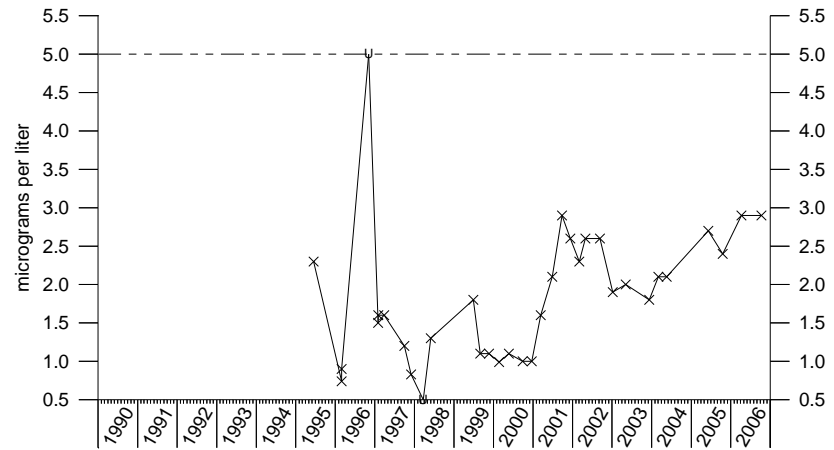
**Trichloroethene
IRA-6**

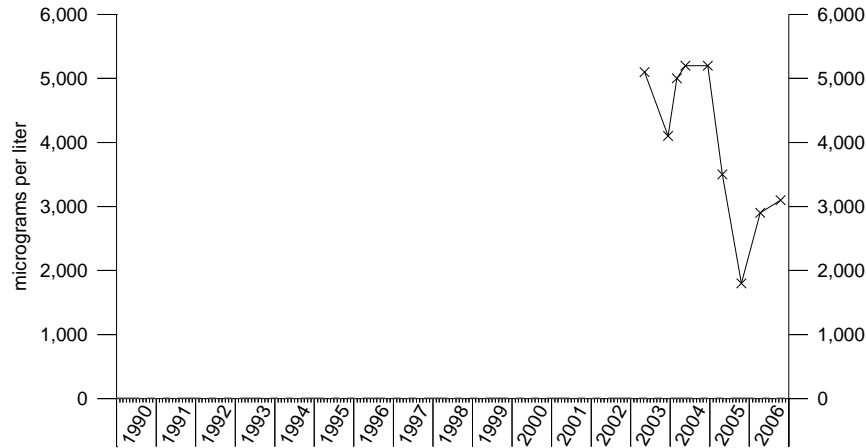
**Trichloroethene
IRA-19**

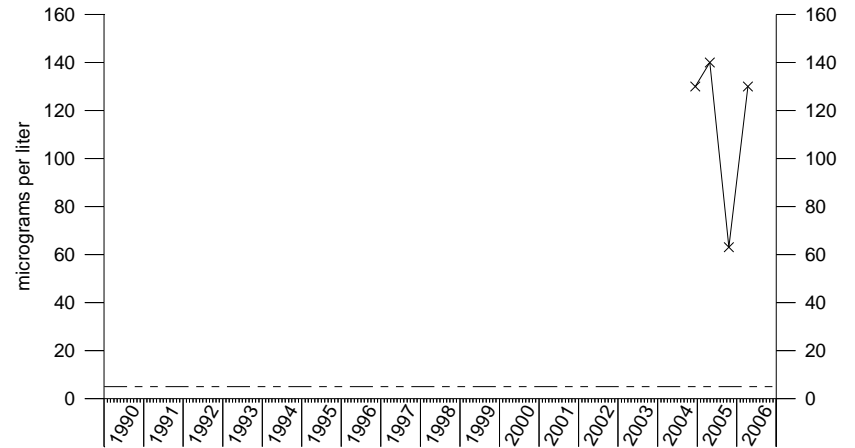
**Trichloroethene
IRA-20**

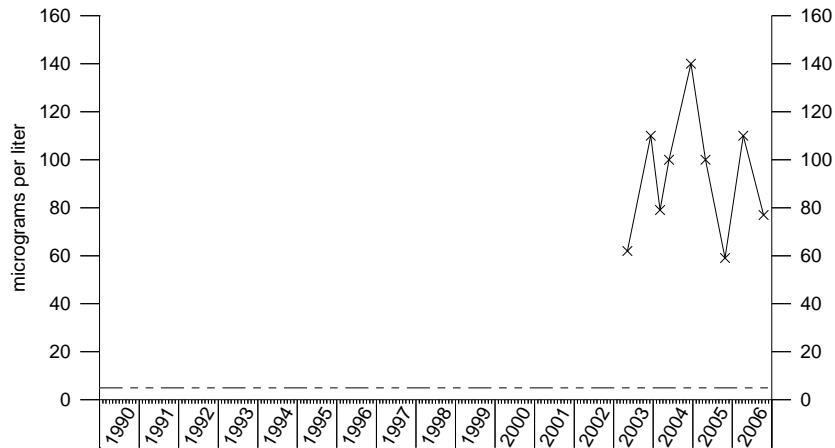
**Trichloroethene
IRA-21**

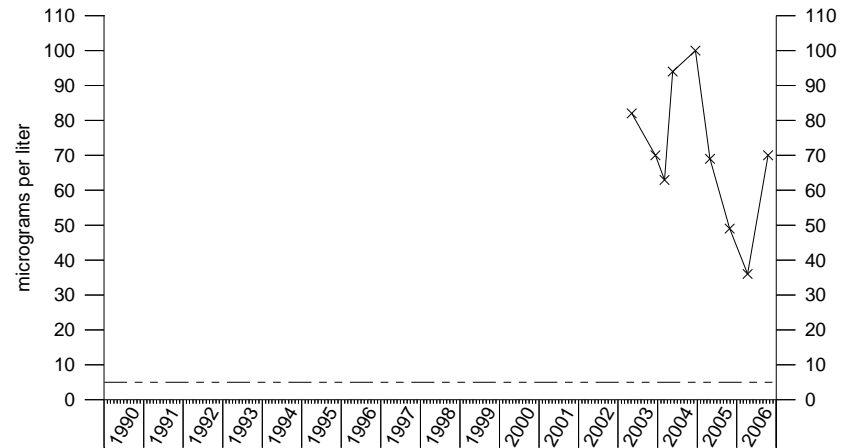
**Trichloroethene
IRA-22**

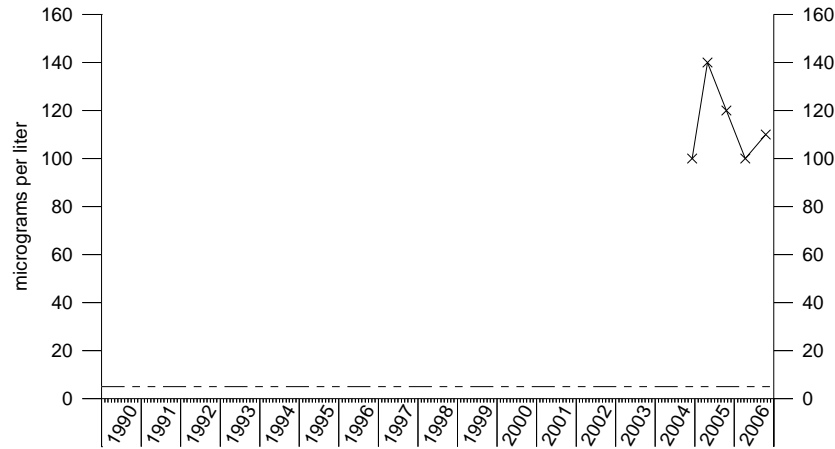
**Trichloroethene
IRA-27**

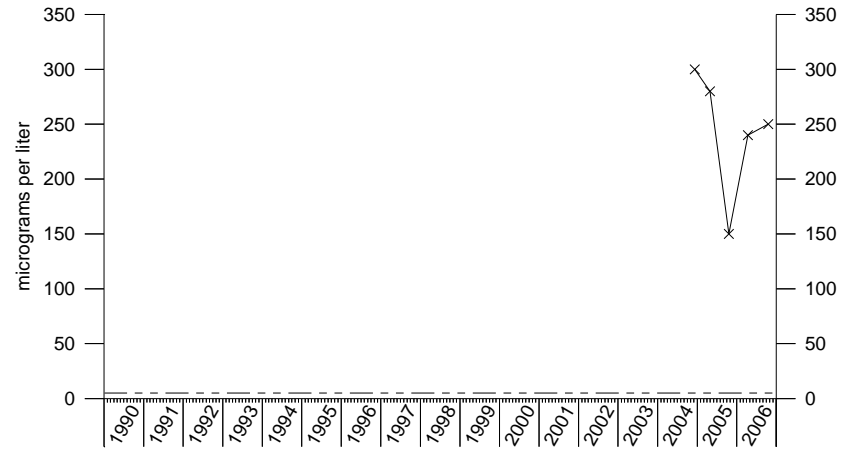
**Trichloroethene
IRA-29**

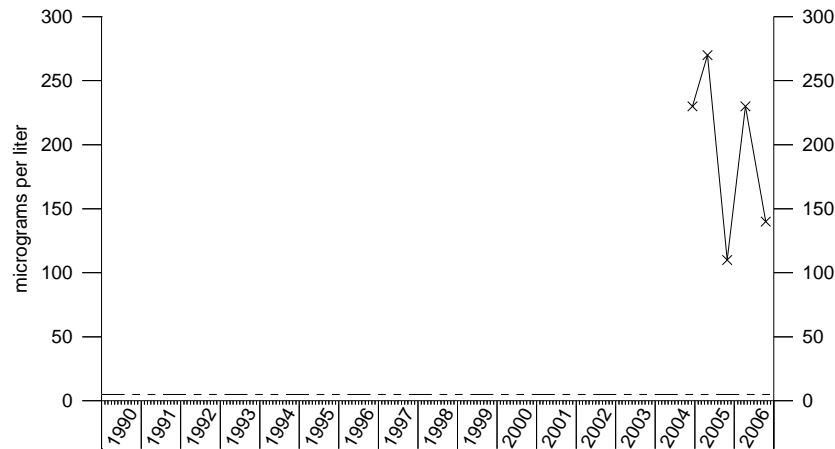
**Trichloroethene
IRA-30**
