Ambient Groundwater Quality of the Meadview Basin: A 2000-2003 Baseline Study - January 2005

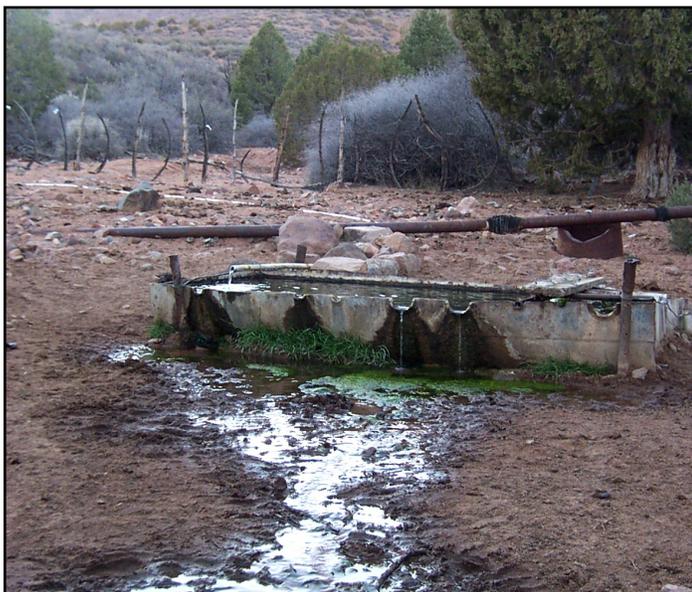
Figure 3 - Willow Spring is piped into an overflowing trough for stockwatering use. In the background is a portion of the 10 mile long King Tut Mine Pipeline that supplied water from 1931-1942 to a gold placer mine in the Lost Basin Mining District.

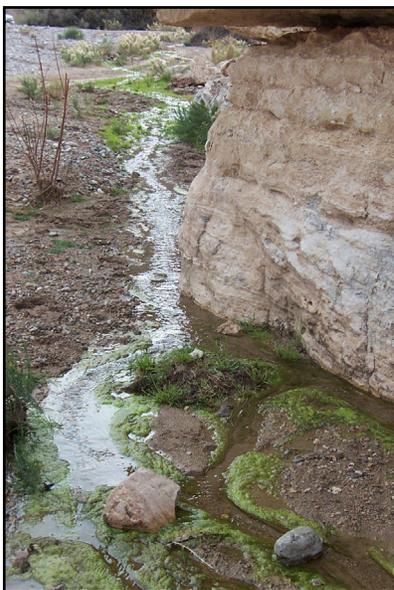
Figure 2 - The short perennial reach of Grapevine Wash is the result of discharge from Grapevine Spring. In the 1980s, the spring discharge was estimated at 60 gallons per minute.

The basin is drained by Grapevine Wash, an intermittent streambed that debouches into Lake Mead. A short perennial reach in the wash is caused by

discharge from Grapevine Spring.¹ Lake Mead was formed when Hoover Dam impounded the Colorado River in 1935. Pearce Ferry, a historical crossing on the Colorado River, was later used as a debarkation point for boat tours of Lake Mead and currently serves as the primary terminus for Grand Canyon river rafters. The Meadview basin is within the Colorado-Grand Canyon Watershed and contains no impaired surface waters on Arizona's 2004 303 (d) list of impaired waters.

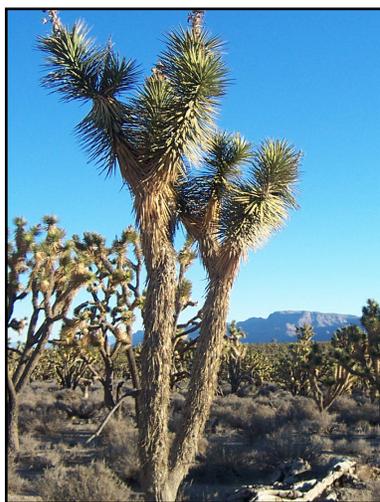
Figure 4 - The southern part of the Meadview basin is characterized by Joshua trees and the granitic geology of the Garnet Mountains.

As frequently occurs, sample sites in granite rock often exceeded health-based water quality standards for gross alpha and uranium.² Exceedances of aesthetic-based standards for fluoride and TDS also occurred.

exceedances came from the northern flanks of the Garnet Mountains within or near an occurrence of granite, which is frequently associated with elevated radiochemistry concentrations in groundwater.² Because of these results, ADEQ strongly recommends that any domestic water sources in this area be tested for radiochemistry constituents.
